***Federal Railroad Administration
Office of Safety
Headquarters Assigned
Accident Investigation Report
HQ-2006-71***

***Paducah & Louisville Railway Company
Calvert City, KY
August 3, 2006***

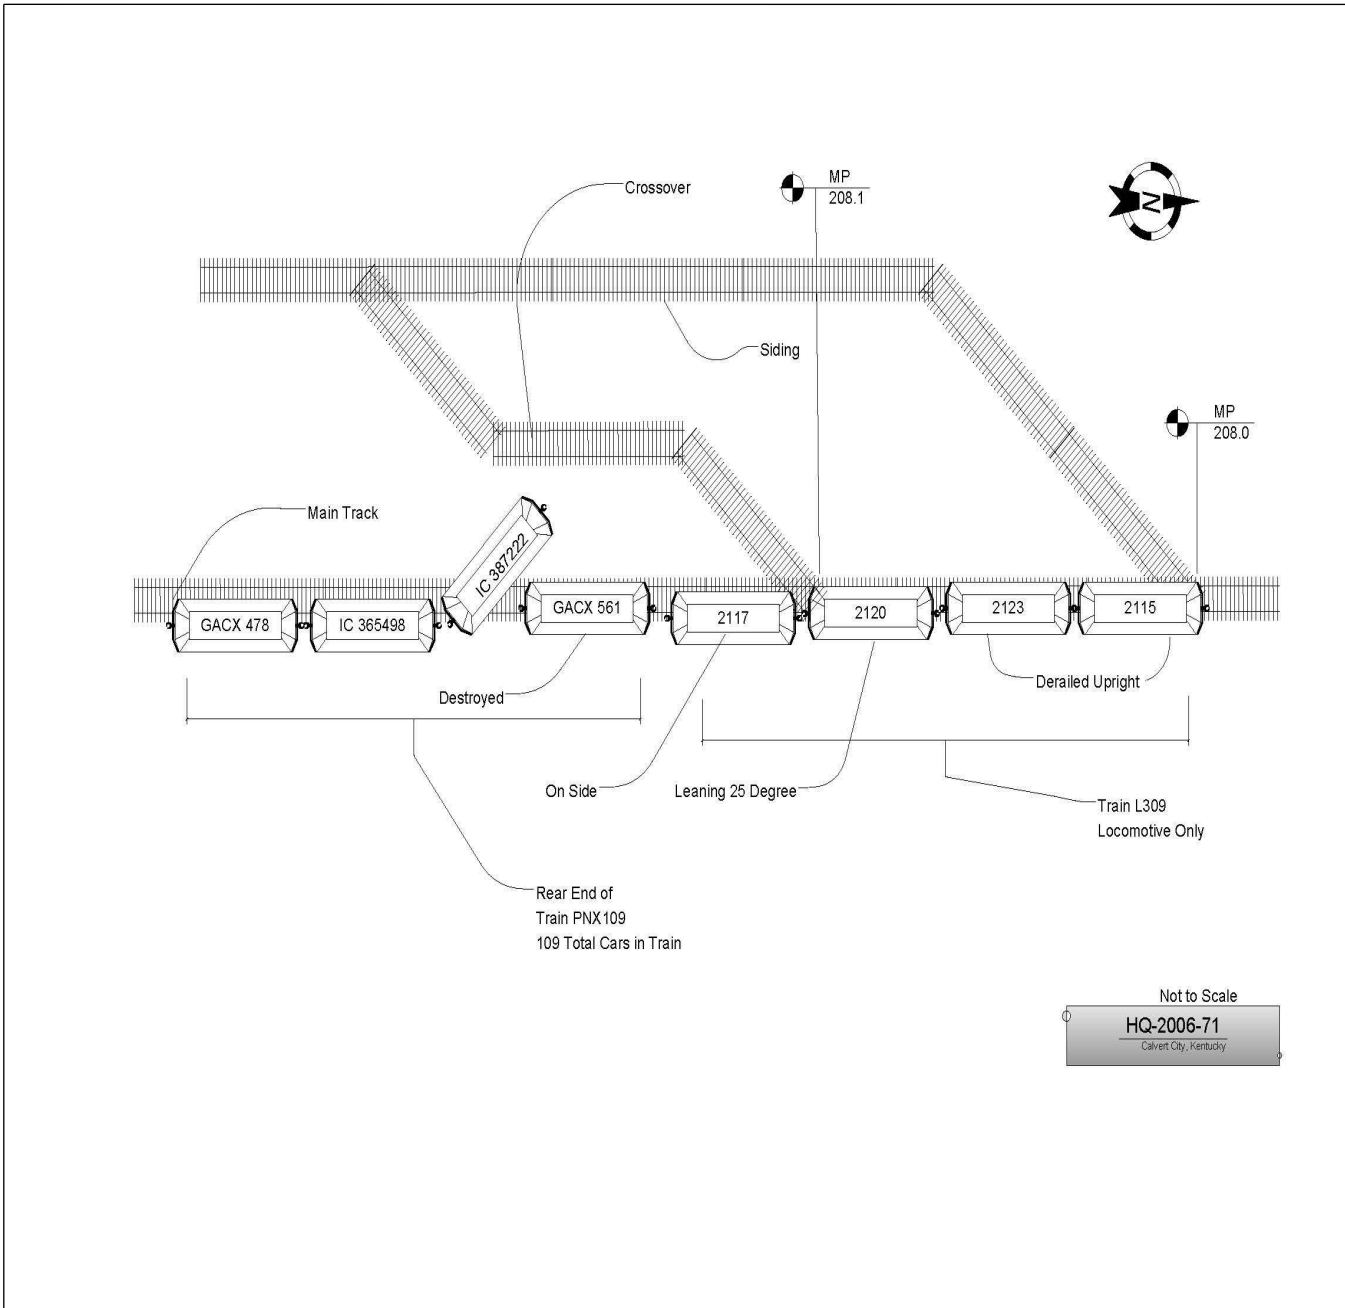
HQ-2006-
71
sketch.jpg

On August 10, 2006, about 7 a.m. Central Standard Time (CST), a Paducah and Louisville Railway Company (PAL) through freight Train LP-309 struck the rear of PAL Train PNX-109 at milepost (MP) 208.5 near Calvert City, Kentucky (KY). The accident occurred on the Paducah District of the PAL at MP 208.5. The Paducah District extends from MP 226.0 to North Central City, KY, MP 124.5. Yard limits are established between MP 205.8 and MP 213.0. Track warrant control is in effect between MP 124.5 and MP 221.0, and automatic block signals are in effect between MP 205.8 and MP 224.1.

As a result of the collision, the lead locomotive of Train LP-309 derailed on its side. The second locomotive derailed, leaning; and the third locomotive derailed, upright. The rear four loaded coal hoppers of Train PNX-109 were damaged during the collision. Three crew members received medical attention.
