***Federal Railroad Administration
Office of Safety
Headquarters Assigned
Accident Investigation Report
HQ-2006-74***

***Florida East Coast Railway Company
Ft. Lauderdale, FL
August 22, 2006***

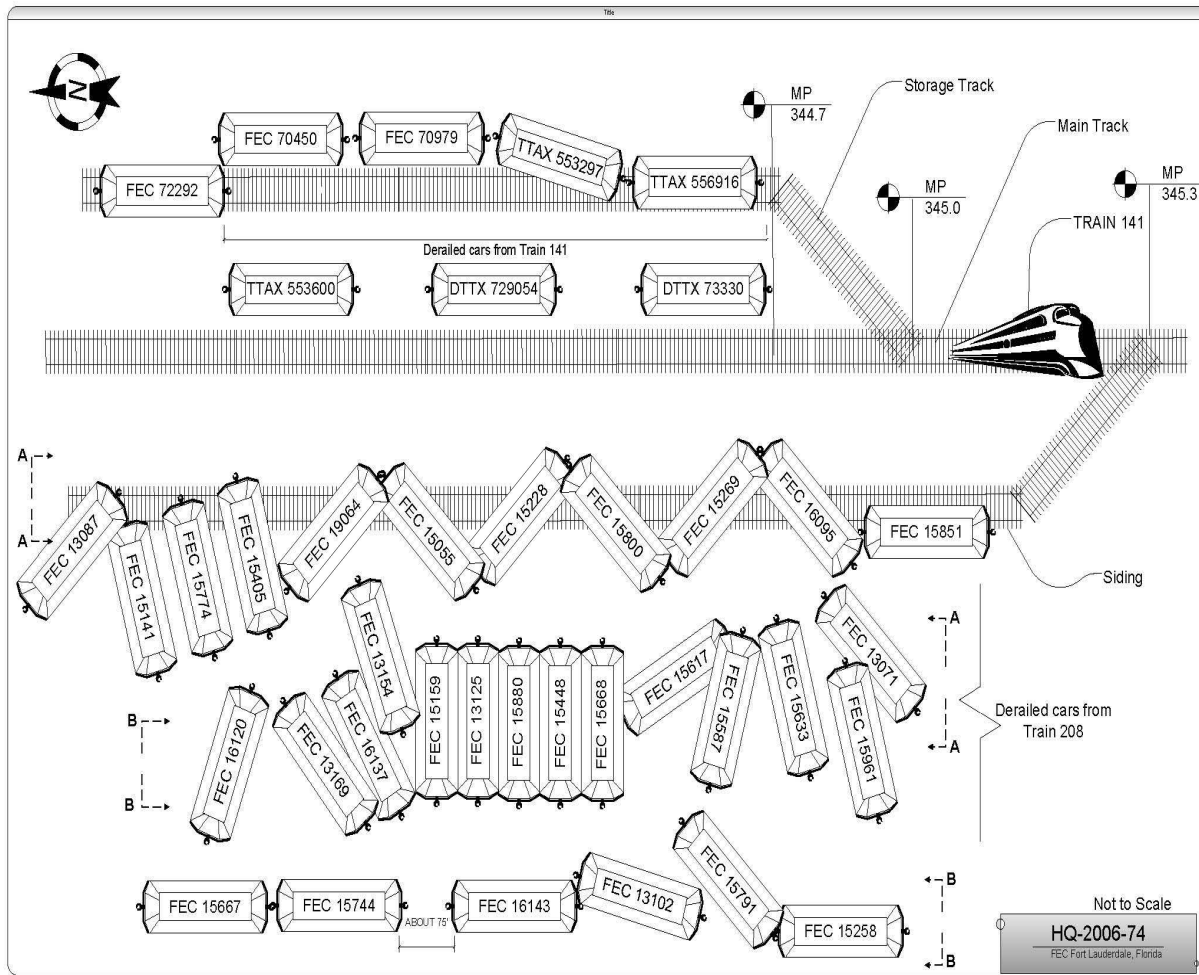
HQ-2006-74 Sketch
rev.jpg

On August 22, 2006, a Florida East Coast (FEC) Train FEC 20822 was traveling northbound on the main track from Hialeah, Florida (FL) to Jacksonville, FL. This train received a diverging signal at the airport siding, milepost (MP) 345.1, to pass southbound Train FEC 14121 that was stopped on the main track. At 12:01 p.m. Eastern Standard Time (EST), Train FEC 20822, operating on the Airport Side Track, derailed 31 freight cars at MP 344.7. As a result of the derailment, several cars collided into the Train FEC 14121 consist derailing an additional three cars. The impact from this collision struck another cut of standing cars on the No. 1 Storage Track located east and adjacent to the main track. All the derailed cars were in a general pileup.
