***Federal Railroad Administration
Office of Safety
Headquarters Assigned
Accident Investigation Report
HQ-2006-75***

***Union Pacific
Redlands, CA
August 27, 2006***

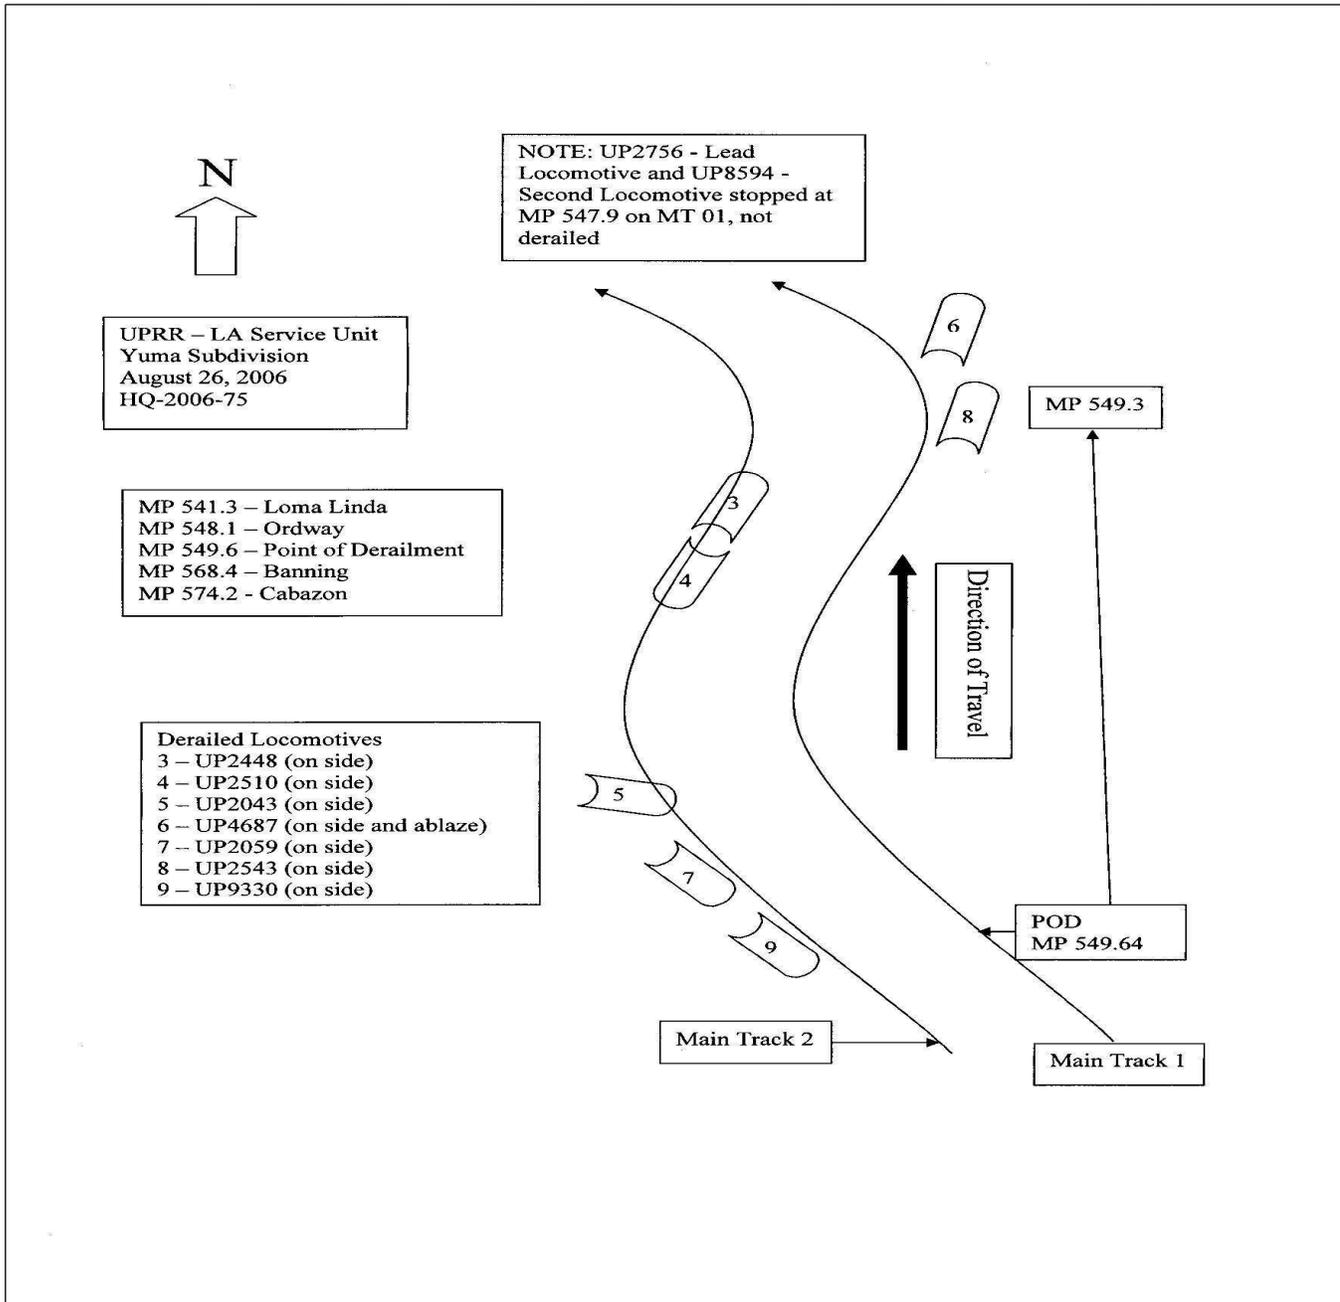
Redlands.
jpg

108. DRAW A SKETCH OF ACCIDENT AREA INCLUDING ALL TRACKS, SIGNALS, SWITCHES, STRUCTURES, OBJECTS, ETC., INVOLVED.
