***Federal Railroad Administration
Office of Safety
Headquarters Assigned
Accident Investigation Report
HQ-2006-79***

***Burlington Northern Santa Fe
Cactus, TX
October 9, 2006***

U.S. Department of Transportation
Federal Railroad Administration
FRA FACTUAL RAILROAD ACCIDENT REPORT
FRA File # HQ-79-2006
108. DRAW A SKETCH OF ACCIDENT AREA INCLUDING ALL TRACKS, SIGNALS, SWITCHES, STRUCTURES, OBJECTS, ETC., INVOLVED.

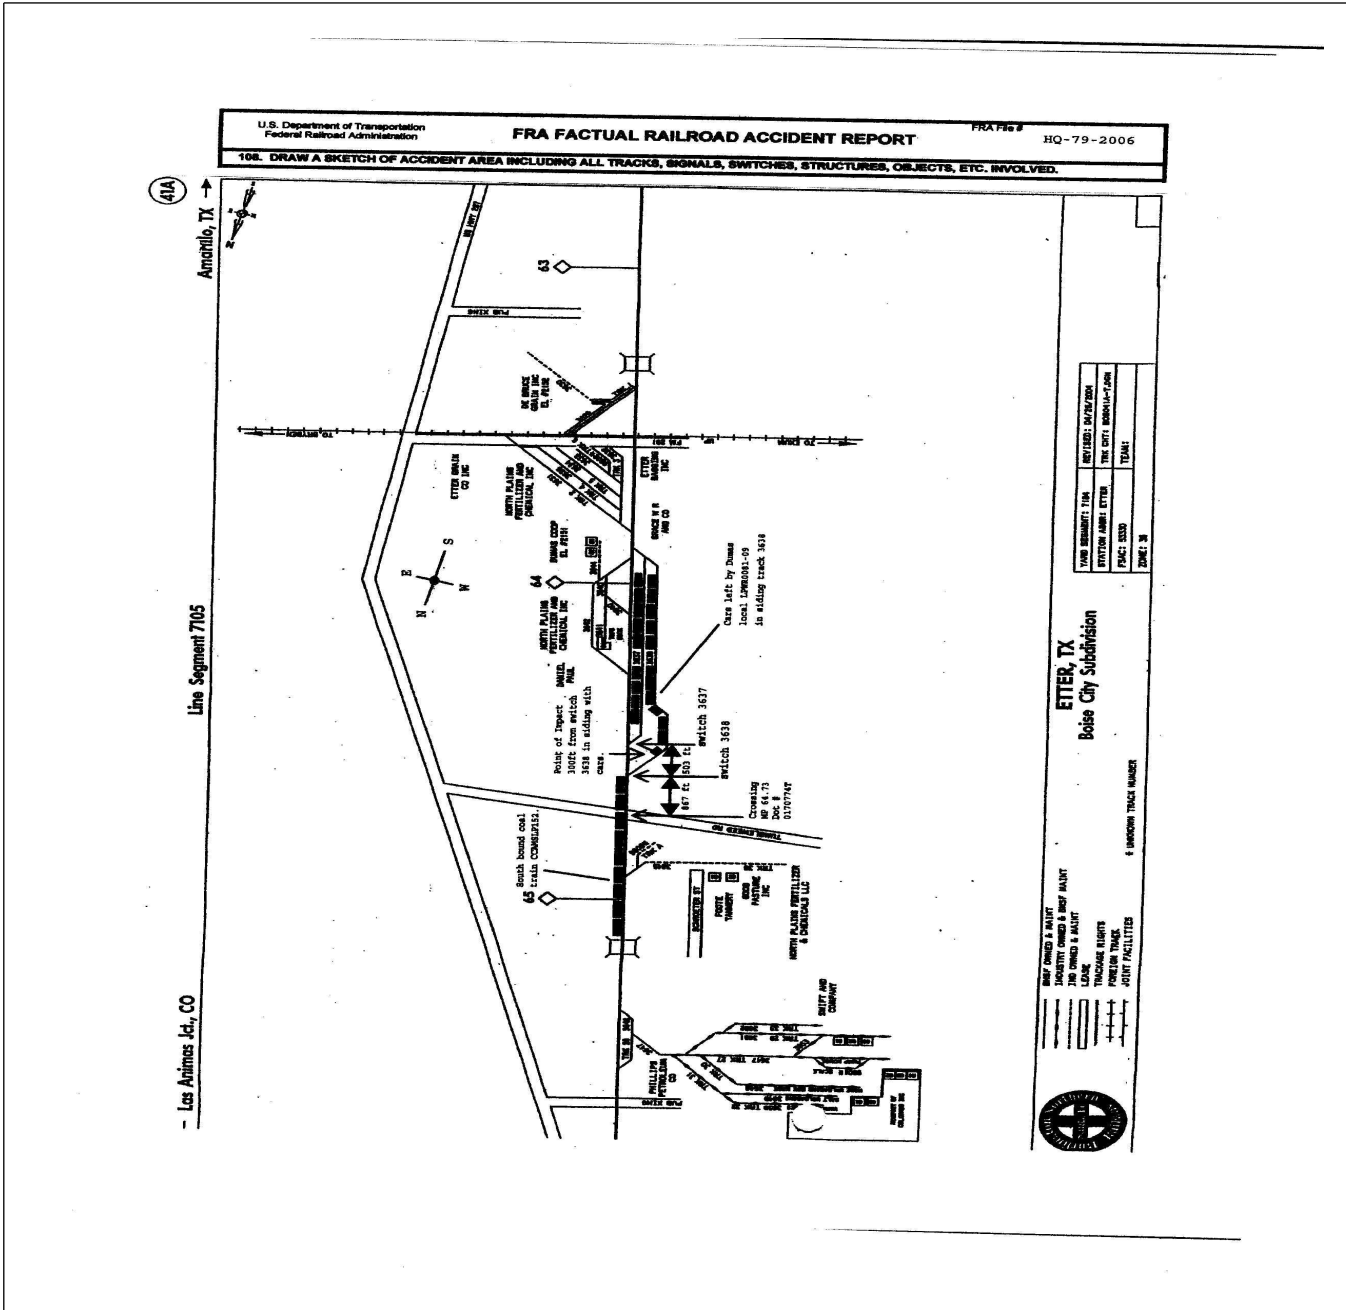
108. DRAW A SKETCH OF ACCIDENT AREA INCLUDING ALL TRACKS, SIGNALS, SWITCHES, STRUCTURES, OBJECTS, ETC., INVOLVED.
HQ-79-2006.jpg

BNSF train CCAMSLP152 was traveling south bound on single main track on the Boise City subdivision, under track warrant 6555. The south bound coal train found open north storage track switch north of Etter resulting in train impacting 57 cars previously spotted at that track by the local train LPWR0081-09. This impact resulted in the derailment of a total of 2 locomotives, 17 loaded coal cars, and 9 empty cars that were located in the siding, two of which were empty hazardous material cars.

The train struck the standing set of 53 cars in the side track, 3638, at approximately 1167 feet from the grade crossing Tumbleweed road at approximately 7:30 PM CST. The train continued south on track 3638 through the set of standing cars for about 500 feet coming to rest on the southwest side of the track leaving the lead locomotive on its side and second unit upright. This impact resulted in the derailment of a total of 2 locomotives, 17 loaded coal cars, and 9 empty cars that were located in the siding, two of which were empty hazardous material cars.

The south bound coal train, CCAMSLP152, as a result of the local, LPWR0081-09, failure to line main line track switch 3638 in normal position in non-signal territory traveled into the north storage track and struck the standing cut of cars and derailed. The railroad collected samples as require by FRA's post-accident toxicological test requirements from the engineer and conductor, of the CCAMSLP152. The results of the test, both alcohol and drug, showed negative for both crew members. No post-accident toxicological test were done on the local crew, LPWR0081-09, due to the covered employees were already released from duty. No evaluation of the lead locomotive, of the CCAMSLP152, were performed by BNSF. The download and the analysis of the recorder data was performed by BNSF on the second locomotive due to the severity of the damage and unable to use the recorder on the lead locomotive. The south bound coal train, CCAMSLP152, was equipped with a speed indicator and event recorder as required. The relevant event recorder data was downloaded from the second unit and analyzed by the Road Foreman Colorado division at Amarillo TX. The analysis disclosed that the locomotive engineer was in compliance with railroad operating and train handling requirements there on the Boise City Subdivision. The FRA reviewed the results of this analysis, and concurred with the conclusions. Also the lead unit, BNSF 5942, of the south bound coal train was equipped with an on board camera. The down load from the camera was analyzed by the Road Foreman Colorado division at Amarillo TX and showed that the main line switch in non-signal territory 3638 was lined and locked for other than main line movement. The FRA reviewed the camera down load and concurred with observations and conclusions concerning video down load. There was no FRA test done on track or locomotive equipment but visual inspection of accident area, siding, and equipment were done at accident site as well as accident photographs.
