***Federal Railroad Administration
Office of Safety
Headquarters Assigned
Accident Investigation Report
HQ-2006-83***

***Massachusetts Bay Commuter Railroad Company
Franklin, MA
October 23, 2006***

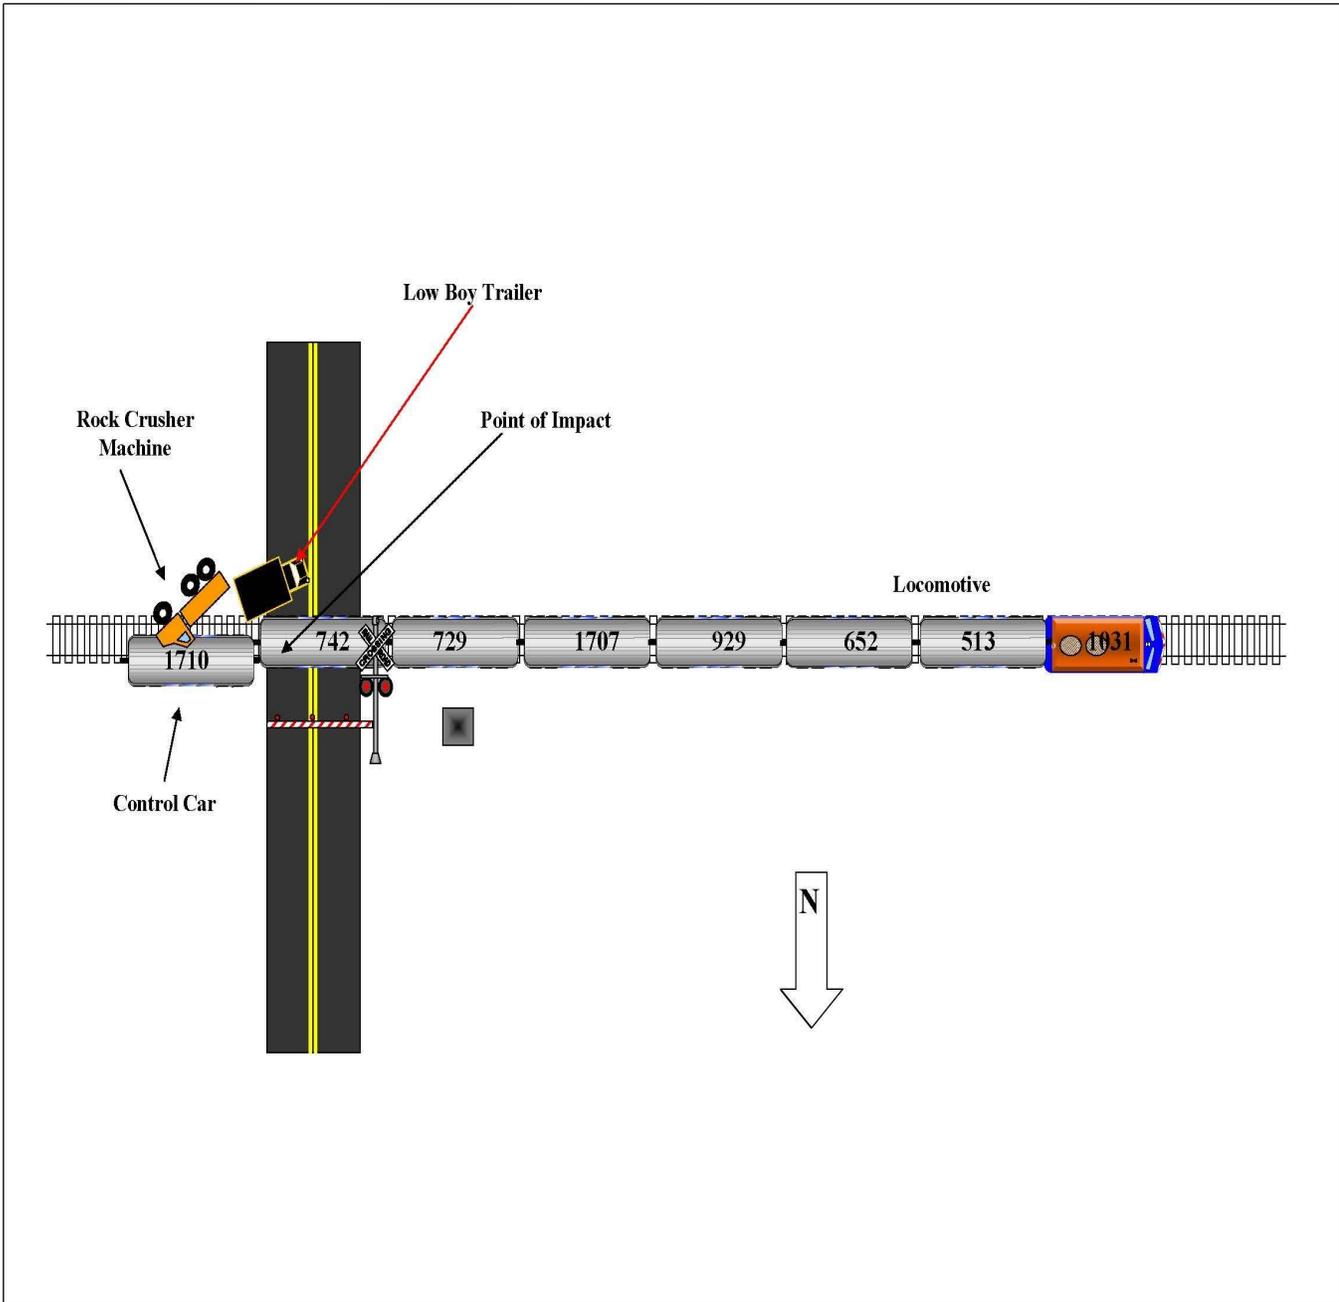
HQ-2006-
83
Sketch.jpg

108. DRAW A SKETCH OF ACCIDENT AREA INCLUDING ALL TRACKS, SIGNALS, SWITCHES, STRUCTURES, OBJECTS, ETC., INVOLVED.
