***Federal Railroad Administration
Office of Safety
Headquarters Assigned
Accident Investigation Report
HQ-2006-88***

***Union Pacific
Midas, CA
November 9, 2006***

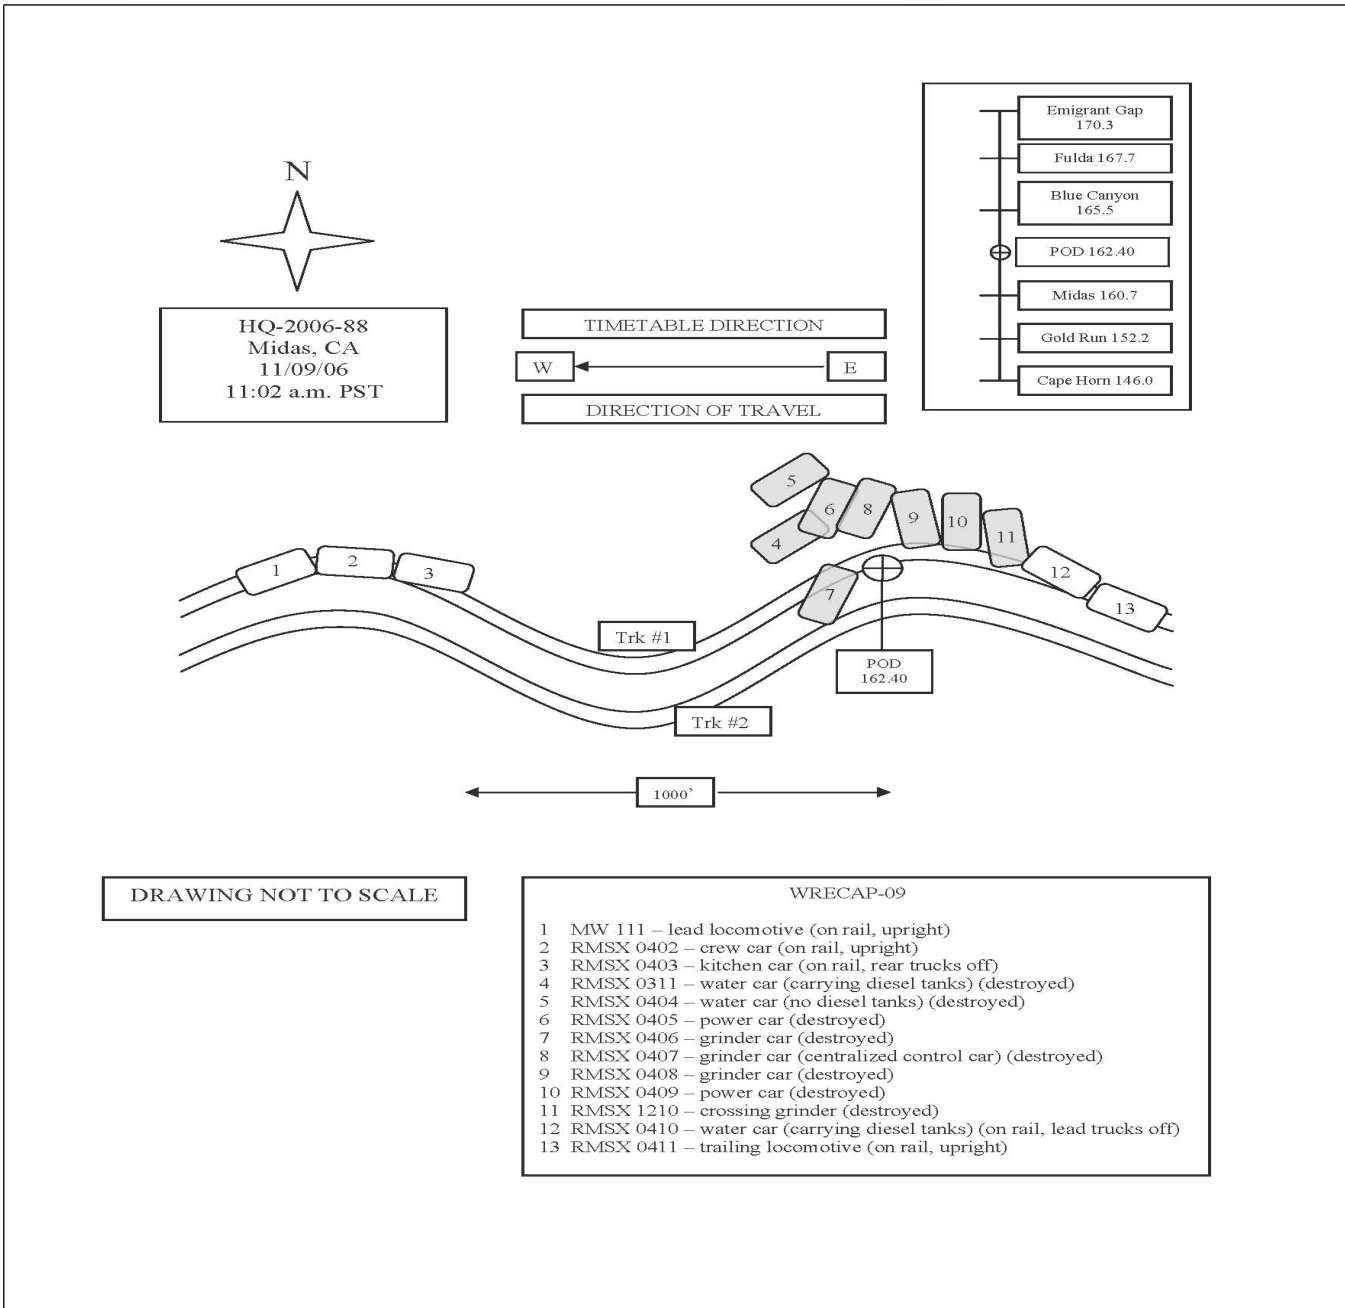
108. DRAW A SKETCH OF ACCIDENT AREA INCLUDING ALL TRACKS, SIGNALS, SWITCHES, STRUCTURES, OBJECTS, ETC., INVOLVED.

On November 9, 2006 at approximately 11:02 a.m. PST, Harsco Track Technologies (Harsco) rail grinding train WRECAP-09 being operated by a Harsco crew on Union Pacific Railroad (UP) trackage, derailed while in transit from Sparks, Nevada to Bakersfield, California.

The grinding train, identified as a work train by virtue of its train symbol "W", was operating in a westward direction on a ruling 2.2% descending grade at mile post (MP) 162.4, near UP timetable station Midas, CA when the train initially derailed. Midas station is located at MP 161.4 near the town of Baxter, California, which is approximately 20 miles east of Colfax, California. The grinding train consisted of two locomotives and eleven cars and enlisted a crew of nine contract employees plus one UP Conductor Pilot. Ten of the 11 cars in the consist derailed and both locomotives remained upright and on the track. Two Harsco employees suffered fatal injuries in the derailment; all other crew members, including the UP employee, sustained either minor injuries or were uninjured.
