***Federal Railroad Administration
Office of Safety
Headquarters Assigned
Accident Investigation Report
HQ-2006-90***

***Canadian National
Marissa, IL
November 20, 2006***

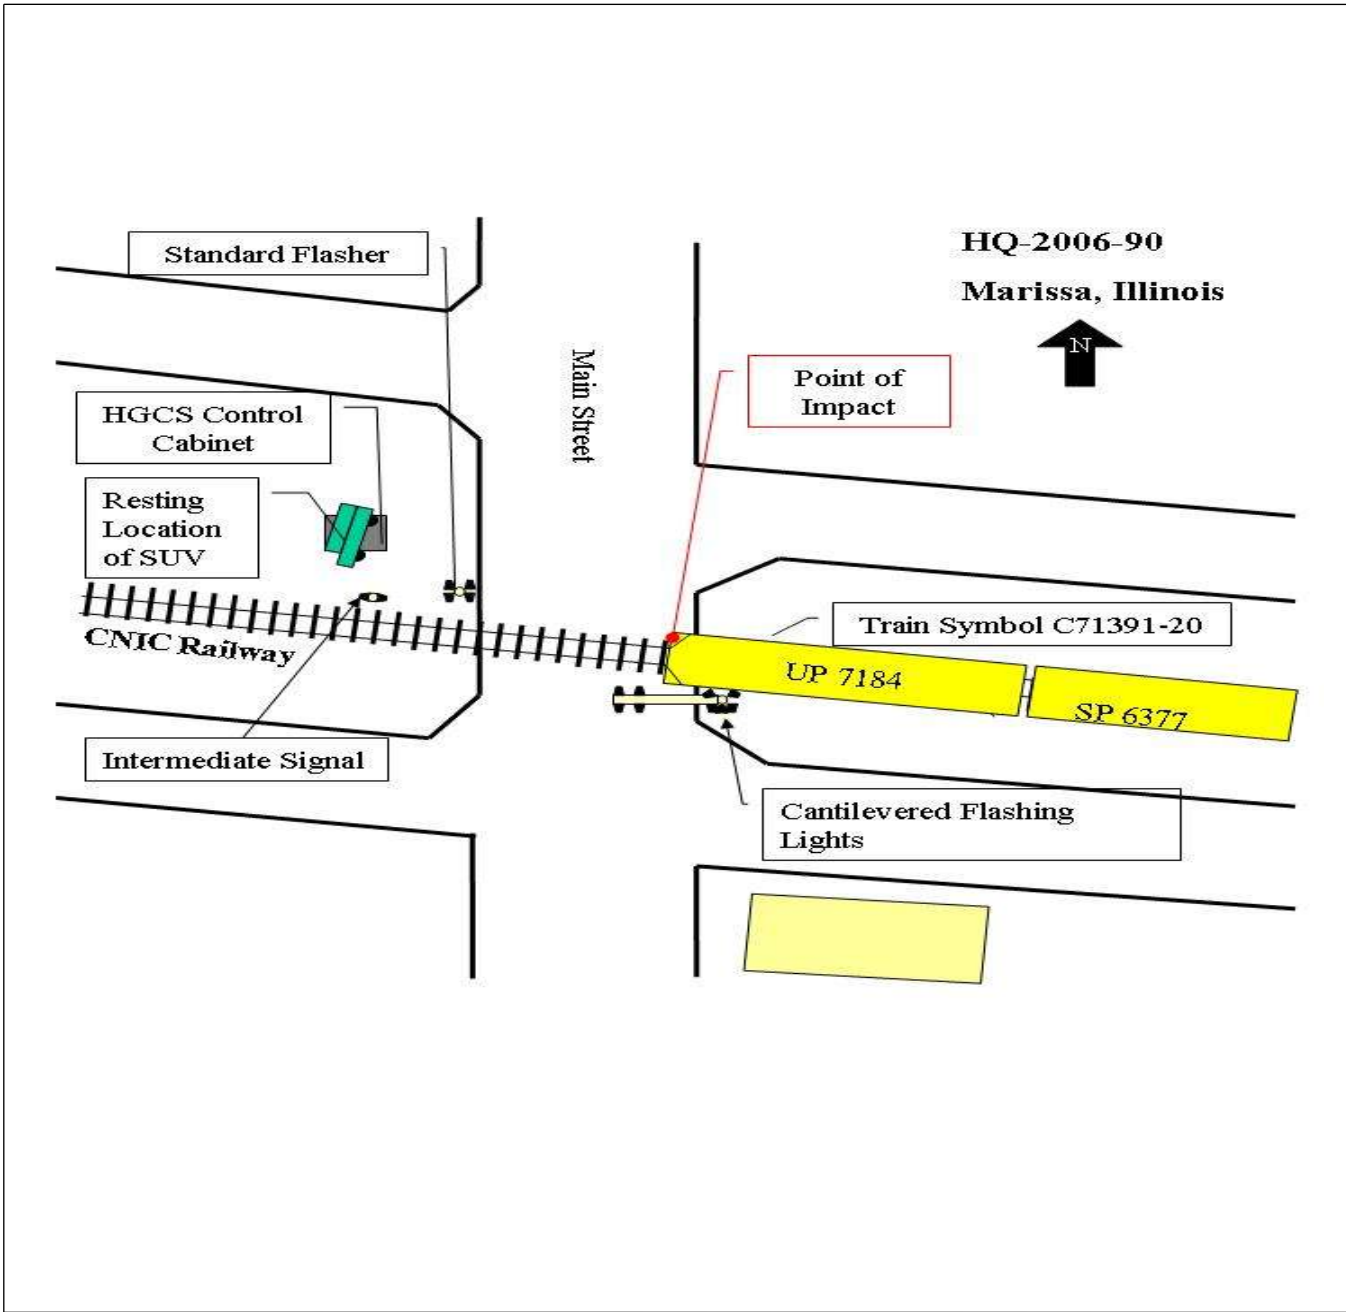
HQ-90
sketch_b.
jpg

108. DRAW A SKETCH OF ACCIDENT AREA INCLUDING ALL TRACKS, SIGNALS, SWITCHES, STRUCTURES, OBJECTS, ETC., INVOLVED.
