***Federal Railroad Administration  
Office of Safety  
Headquarters Assigned  
Accident Investigation Report  
HQ-2006-91***

***Union Pacific/Burlington Northern Santa Fe  
Memphis, TN  
November 22, 2006***

HQ-91-2006  
UP/BNSF Head-On Collision  
November 22, 2006  
UP Memphis NS West Main  
UP Memphis, TN  
MP 378.49

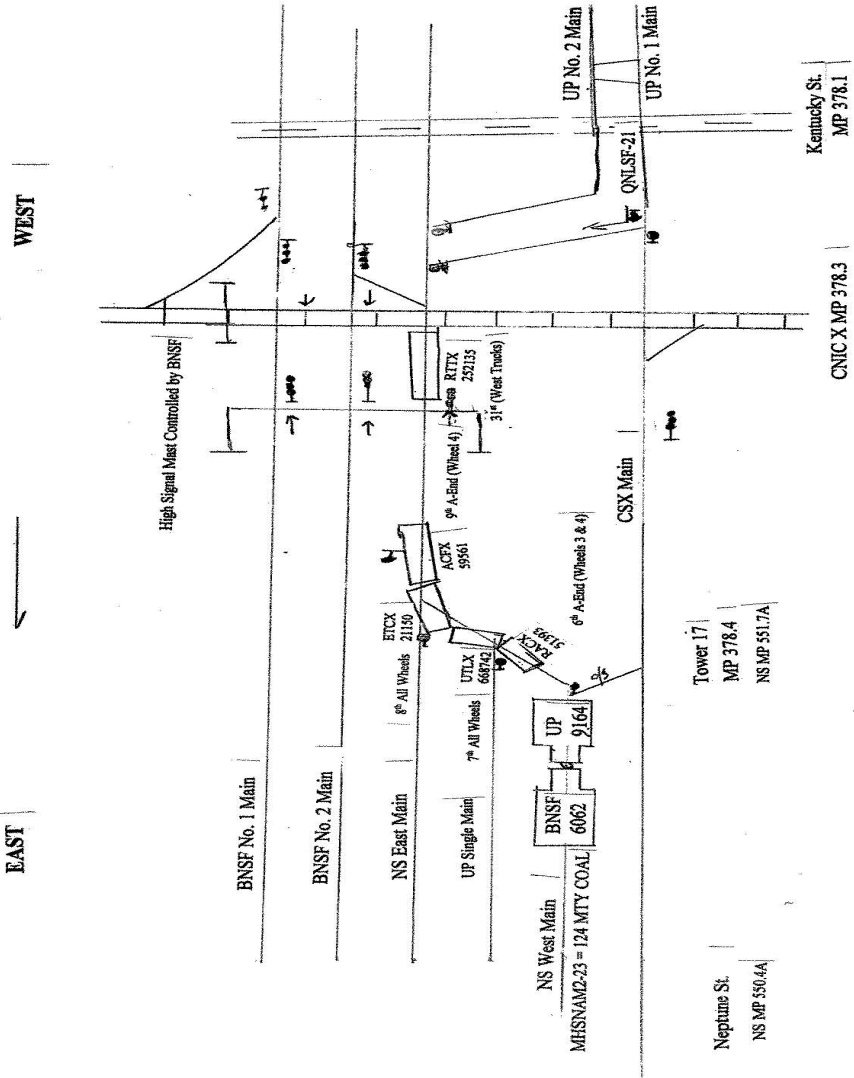
U.S. Department of Transportation  
Federal Railroad Administration  
**FRA FACTUAL RAILROAD ACCIDENT REPORT**  
108. DRAW A SKETCH OF ACCIDENT AREA INCLUDING ALL TRACKS, SIGNALS, SWITCHES, STRUCTURES, OBJECTS, ETC., INVOLVED.

About 2:05 a.m. UP train QNLSF21 called the NS yardmaster requesting a track. The NS yardmaster instructed UP QNLSF21 to use the East Main from Tower 17 to Neptune Street (MP 550.4) en route to the UP's Sargent Yard. The UP crew on QNLSF21 called the train dispatcher via radio advising him of the designated track. The request given by QNLSF21 over the radio was unclear. The train dispatcher repeated the instructions, but thought the crew requested the West Main at the Southern instead of East Main. The crew of QNLSF21 confirmed the instructions repeated by the train dispatcher by ending the conversation with, "UP 9164 out." The repeat by the train dispatcher clearly stated West Main. After QNLSF21 ended the radio transmission the train dispatcher lined the switches from the UP No. 1 Main Track to the NS West Main. The UP train dispatcher did not have prior knowledge that NS had interchanged an empty coal train to the BNSF on the NS West Main at Tower 17.

Eastbound UP trains arriving Memphis, TN must operate across the CNIC (Canadian Central/Illinois Central) railroad crossing at grade, MP 376.3. Union Pacific operating rules designate that Yard Limit Rules govern movement between Kentucky Street (MP 378.1 and Sargent Yard (MP 380.7). Authority to occupy the main track is Centralized Traffic Control. The maximum authorized speed between these limits is 10 mph. UP QNLSF21 was operating on a restricted signal when it impacted head-on with BNSF EMTSNAM2-23. The recorded speed as determined by the event recorder on lead locomotive UP 9164, indicated that QNLSF21 was operating at 22 mph when the engineer initiated an emergency brake application. Impact was recorded at 16 mph.
