***Federal Railroad Administration
Office of Safety
Headquarters Assigned
Accident Investigation Report
HQ-2006-102***

***Union Pacific
Peck, KS
December 22, 2006***

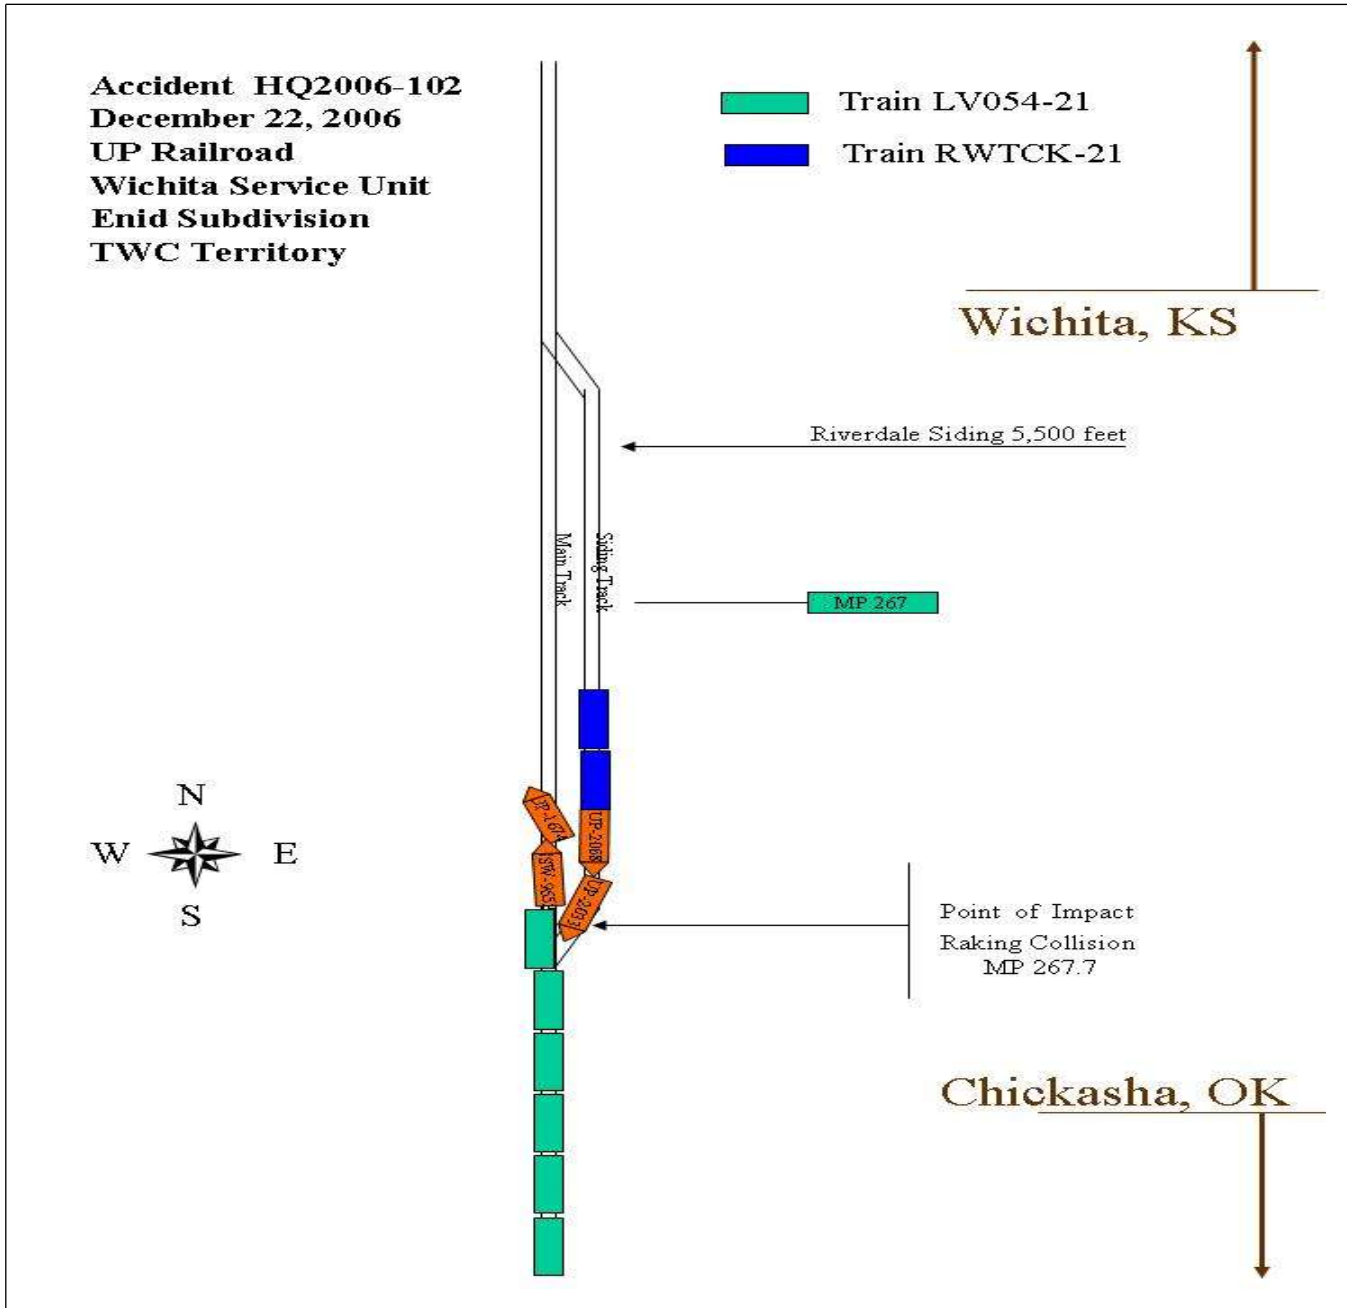
HQ-
2006102_S
ketch.jpg

The train came to rest approximately 30 feet from the switch, fouling the main track. At this time the crew of Train Symbol RWTCK-21 could see the northbound train approaching. The engineer made a third attempt to contact the northbound train and warn them to stop. The engineer of the northbound train replied that he had placed his train in emergency. A few seconds later, the conductor went to the other side of the locomotive cab and stood behind the engineer's seat.

Impact followed, and the northbound train came to rest approximately four car-lengths north of the lead locomotive of Train Symbol RWTCK-21.
