***Federal Railroad Administration
Office of Safety
Headquarters Assigned
Accident Investigation Report
HQ-2005-06***

***CSX Transportation (CSX)
Banks, Alabama
January 11, 2005***

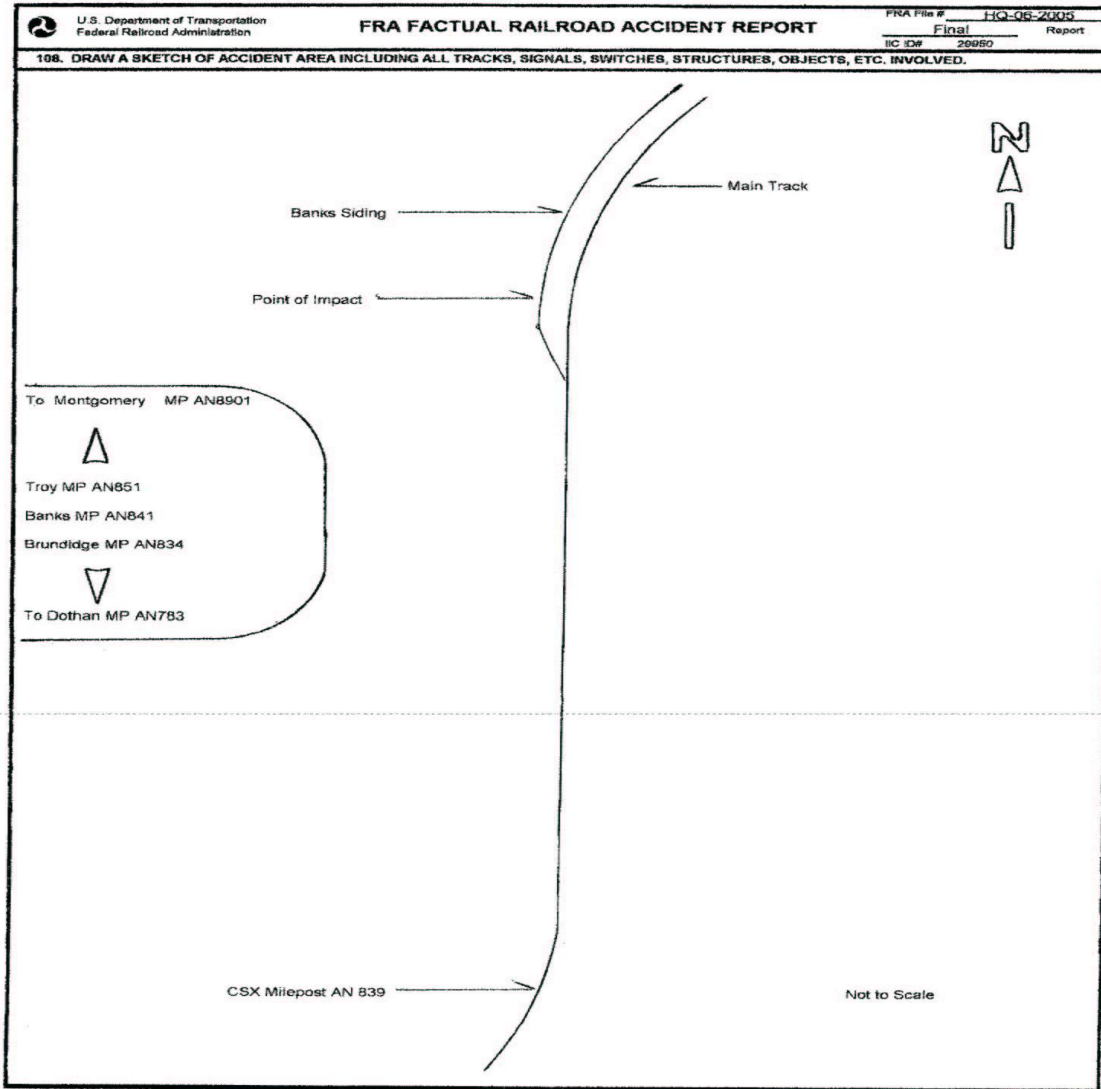
108. DRAW A SKETCH OF ACCIDENT AREA INCLUDING ALL TRACKS, SIGNALS, SWITCHES, STRUCTURES, OBJECTS, ETC., INVOLVED.

On January 11, 2005, at 6:05 a.m. Eastern Standard Time (EST) a head on collision occurred on the CSX Transportation (CSX) Jacksonville Division, Dothan Subdivision at CSX milepost (MP) AN 0839.8 at Banks, Alabama (AL). The method of operation for the Dothan Subdivision is Direct Traffic Control (DTC).

The probable cause of the accident was the switch not being restored to the normal position after use. The normal position for the switch is lined and locked for movement on the main track.
