***Federal Railroad Administration
Office of Safety
Headquarters Assigned
Accident Investigation Report
HQ-2005-08***

***Southern California Regional Rail Authority (SCRX)
Glendale, California
January 26, 2005***

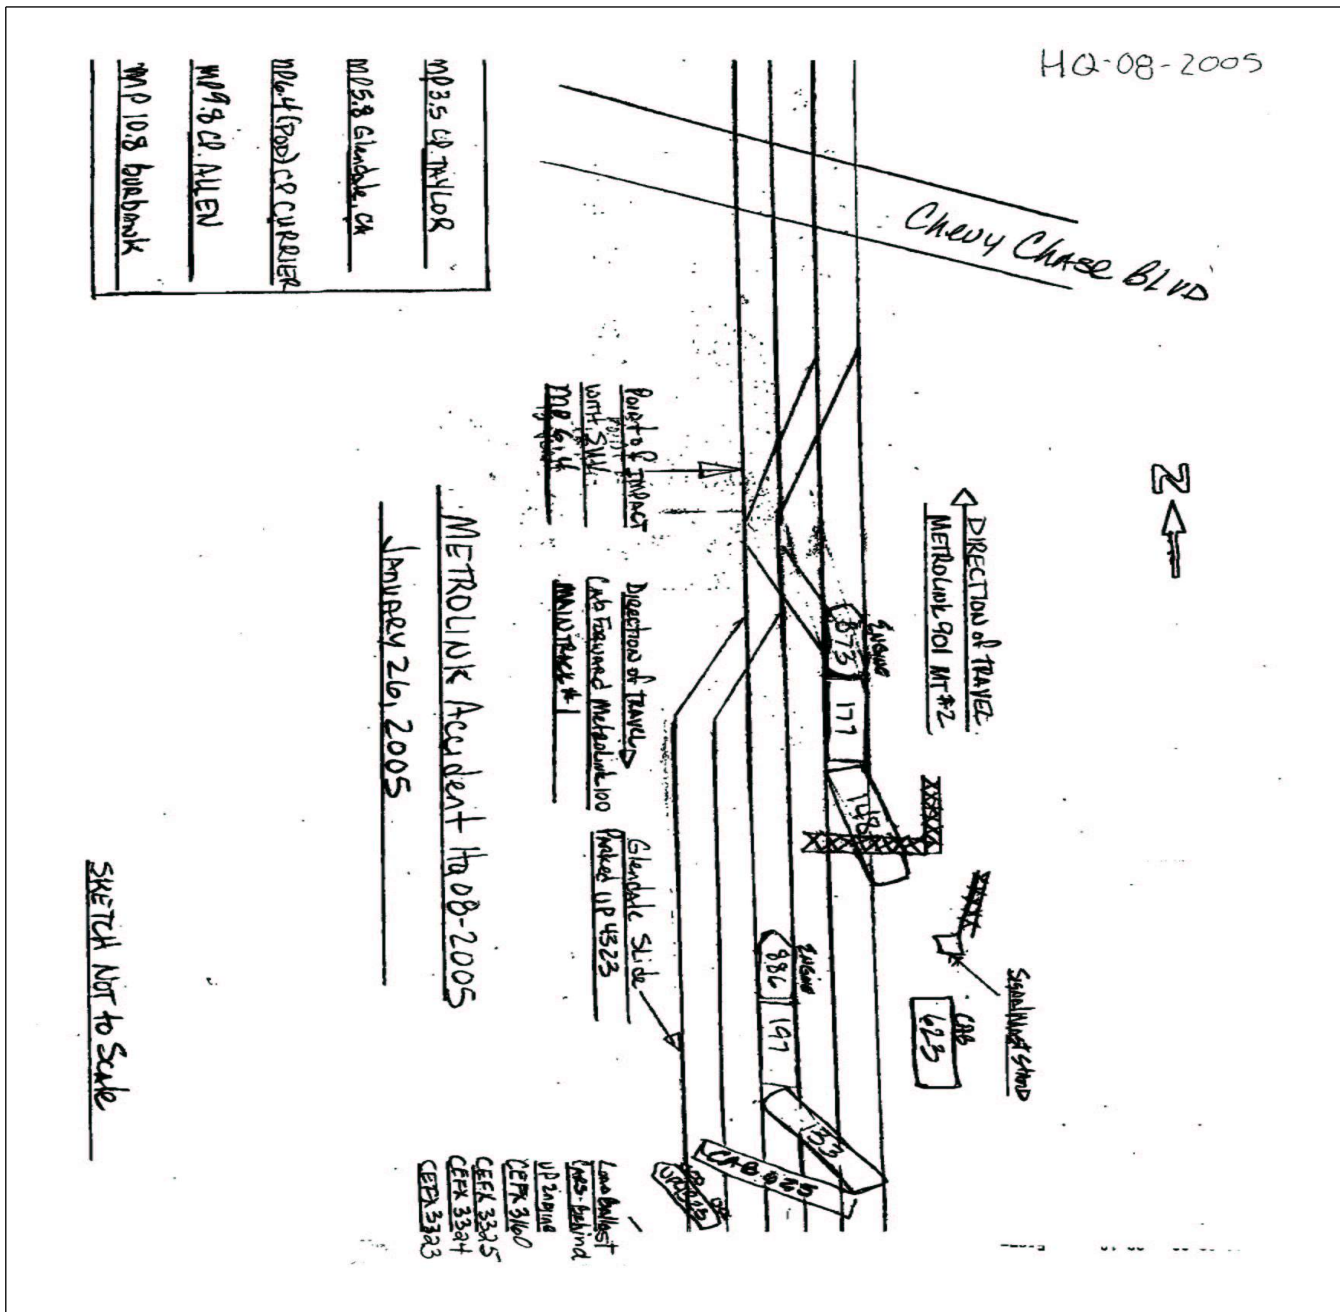
METROLINK Accident HQ-08-2005
January 26, 2005

Point of Impact
with SUV
1171
197

Train no. 1, traveling with cab car forward, struck a Jeep Cherokee SUV at a measured distance of 155 feet east of the Chevy Chase highway-rail crossing (DOT 746812T, MP 6.51). The impact with the SUV caused Train no. 1 to derail and strike standing Train no. 3, derailing the lead locomotive of Train no. 3. The collision then caused two cars in Train no. 1 to jackknife, striking the side of two of the cars in westbound Train no. 2 and derailing them, as well.
