***Federal Railroad Administration  
Office of Safety  
Headquarters Assigned  
Accident Investigation Report  
HQ-2005-09***

***Norfolk Southern (NS)  
Tarentum, Pennsylvania  
January 31, 2005***

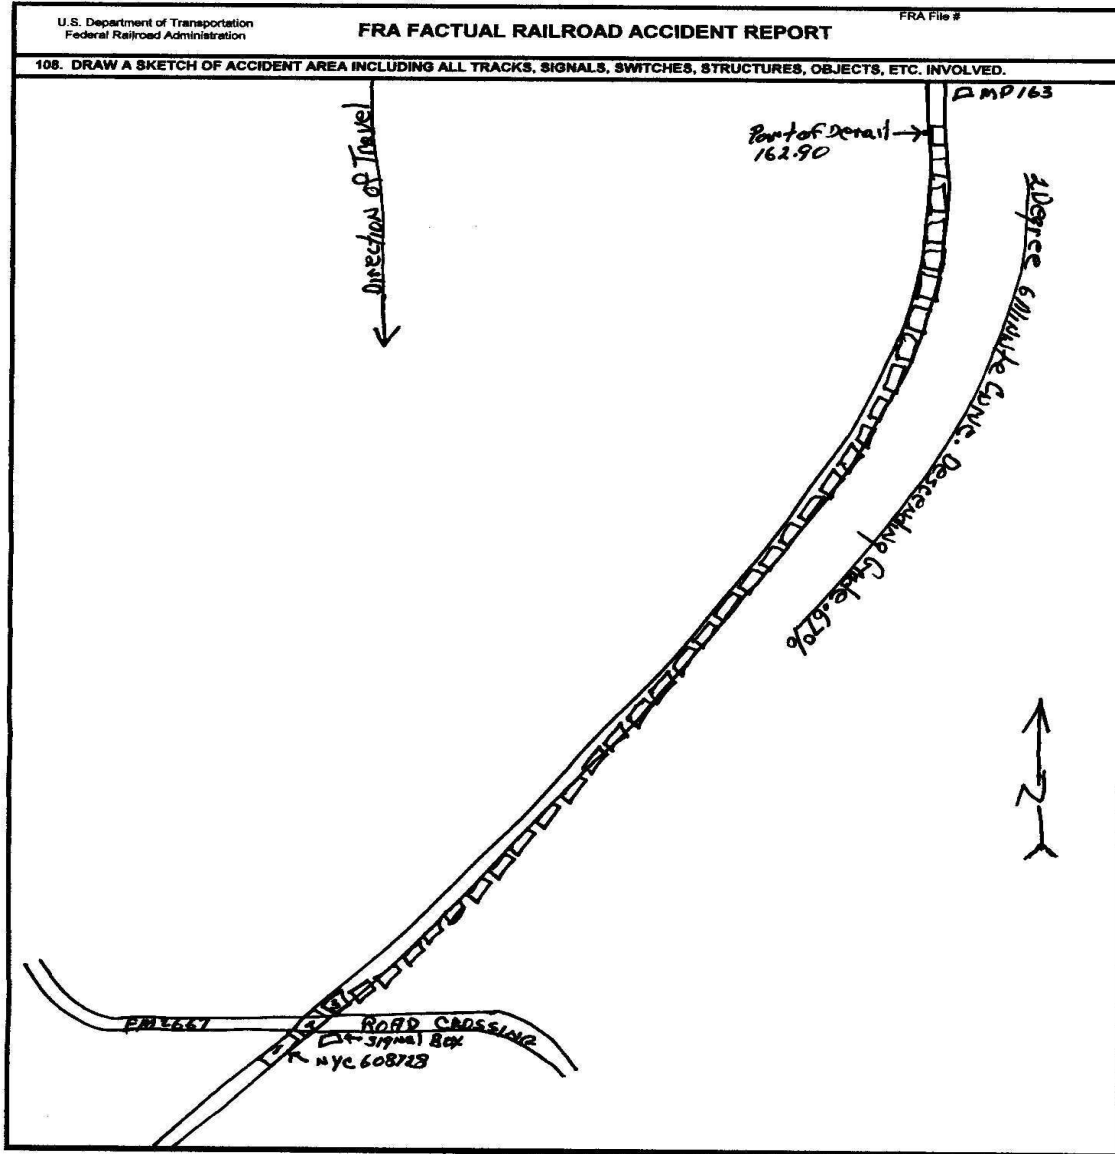
108. DRAW A SKETCH OF ACCIDENT AREA INCLUDING ALL TRACKS, SIGNALS, SWITCHES, STRUCTURES, OBJECTS, ETC., INVOLVED.  
HQ-09-  
2006.jpg

A Southbound Union Pacific Freight Train traveling at a recorded speed of 28 mph, derailed 37 cars, all remaining upright, on January 31, 2006, at 11:45 am. The accident occurred 2.1 miles South of Timpson, TX at UP milepost 162.9 on the UP's Southern Region, Livonia Service Unit, Lufkin Subdivision. The train had been operating on a 25 mph speed restriction for the previous 4 miles. The reason for the speed restriction was defective tie conditions.

In this area of the railroad there is over 4000 feet of tangent track leading into a right hand 2 degree 6 minute curvature with a descending grade of .67% at the point of derailment.
