***Federal Railroad Administration
Office of Safety
Headquarters Assigned
Accident Investigation Report
HQ-2005-11***

***Burlington Northern Santa Fe (BNSF)
Wellsville, Kansas
February 11, 2005***

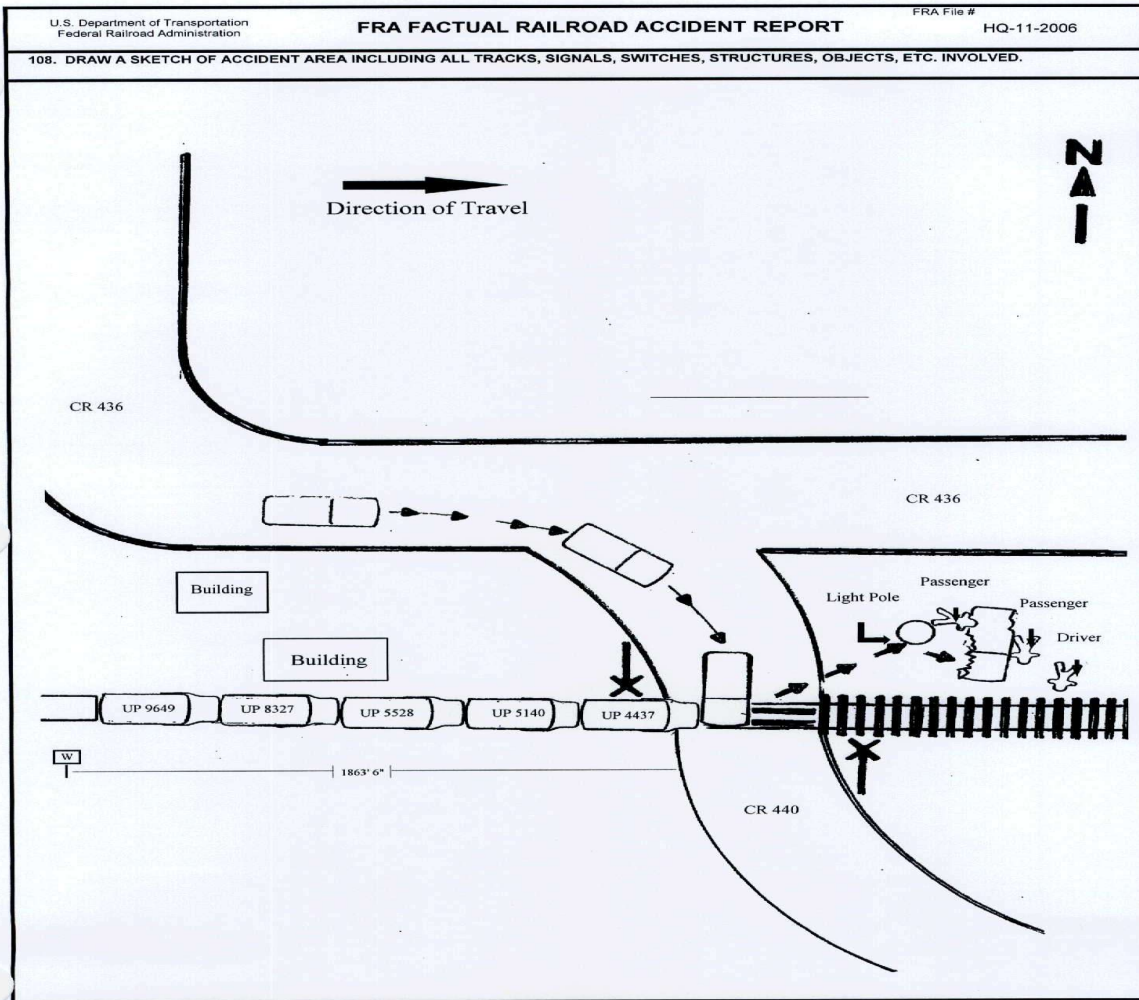
108. DRAW A SKETCH OF ACCIDENT AREA INCLUDING ALL TRACKS, SIGNALS, SWITCHES, STRUCTURES, OBJECTS, ETC., INVOLVED.
HQ-11-
2006.jpg

The train struck the right side of the pick-up truck about midpoint of the right front fender. The pick-up truck was carried east, along the track, for about 75 feet striking a light pole before coming to rest about 85 feet east of the impact point on the northeast side of the track. The driver and two of the three passengers were not wearing seat belts and were ejected from the pick up truck. The train came to a stop about 2,050 feet east of this point.
