***Federal Railroad Administration
Office of Safety
Headquarters Assigned
Accident Investigation Report
HQ-2005-29***

***Union Pacific (UP)
Dixon, Illinois
April 5, 2005***

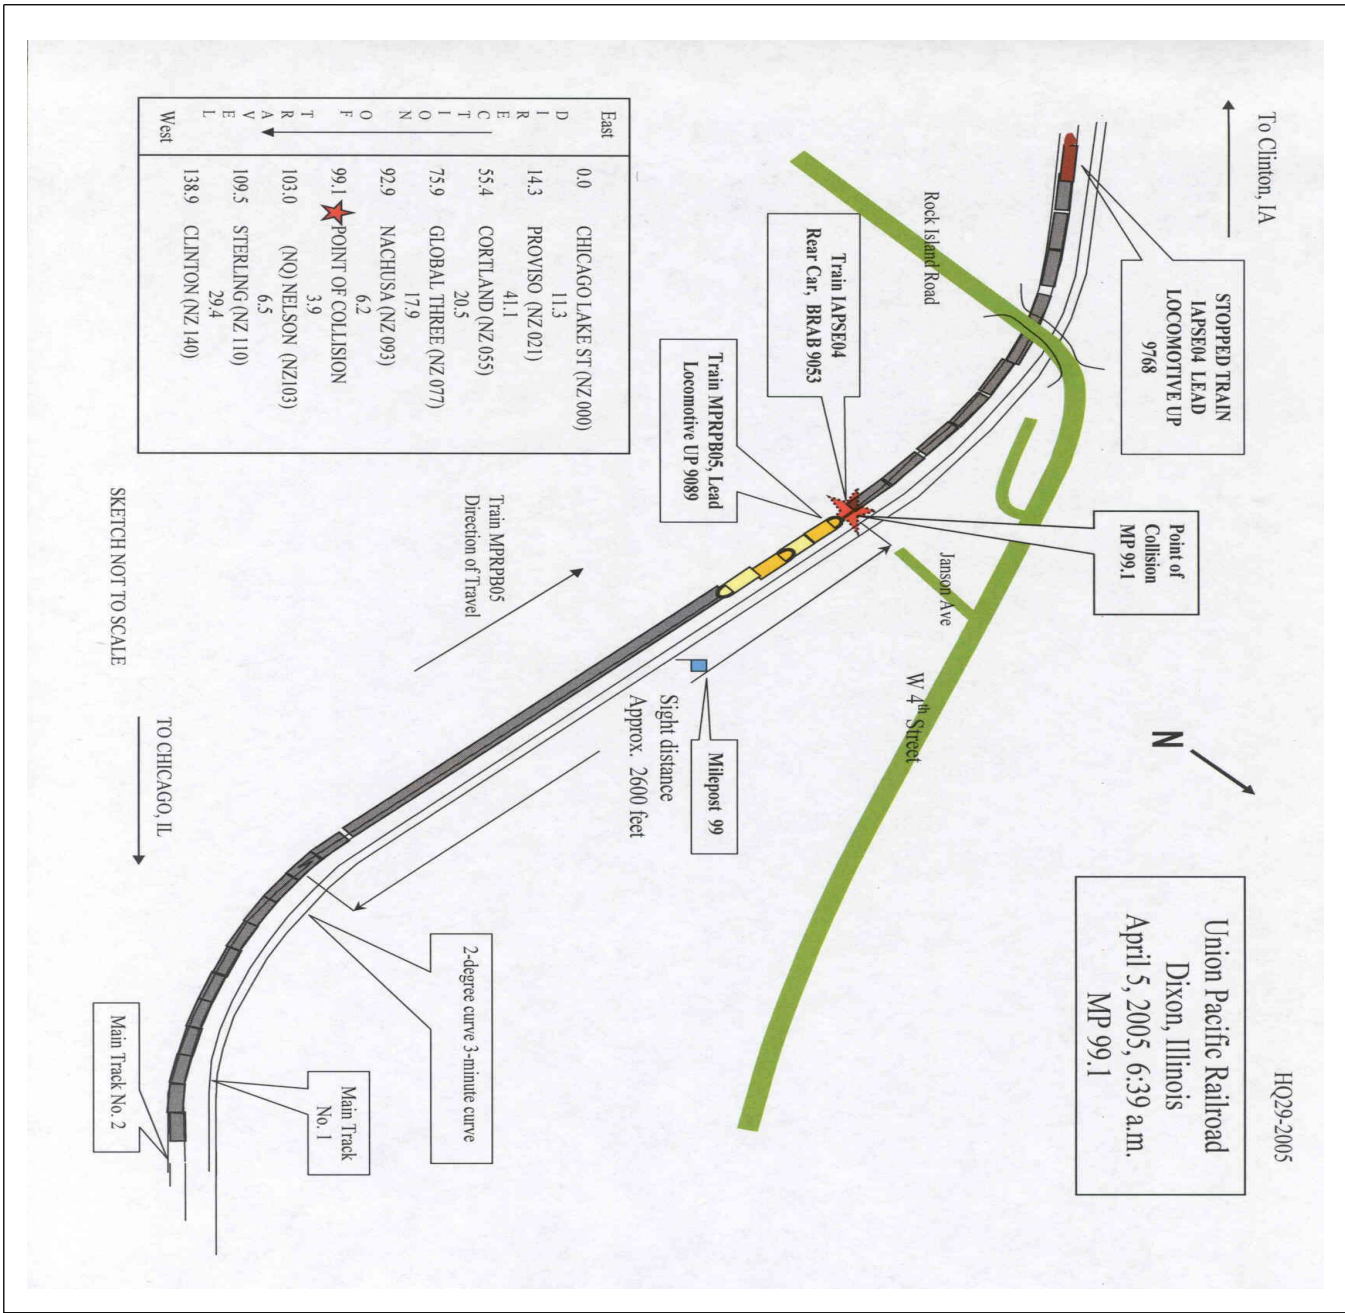
HQ-29-
2005
Accident
Sketch.jpg

A westbound Union Pacific Railroad (UP) freight train (MPRPB05) collided with the rear car of another UP westbound freight train (IAPSE04) operating ahead of it on the same main track on April 5, 2005, at 6:39 a.m. CDT. The accident occurred in Dixon, Illinois (IL), at Milepost 99.1, on the UP Geneva Subdivision, Main Track No. 2.

Approaching the accident site from a point one mile east at milepost 98.1, there are, in succession, a tangent of 1,465 feet, a 2-degree 3-minute curve to the left of 1,172 feet, a tangent of 1,755 feet and then a 2-degree curve to the right of 888 feet to the point of collision. There is a 0.74 percent descending grade for 3,168 feet then a 0.00 percent grade for 2,112 feet to the point of accident. The grade then continues as a 0.63 percent descending grade for a considerable distance beyond.

The train crew's view was obstructed by the 2-degree 3-minute curve east of the accident site. As the train rounded the curve, the crew saw a train about one-half mile ahead. At first the crew thought the train was on Main Track No. 1, but then realized that the train was also on Main Track No. 2. It was at this time that the student locomotive engineer applied the train's emergency brakes, using both the automatic brake valve and the toggle switch for the end-of-train device.
