***Federal Railroad Administration
Office of Safety
Headquarters Assigned
Accident Investigation Report
HQ-2005-32***

***Canadian Pacific (CP)
Columbus, Wisconsin
April 10, 2005***

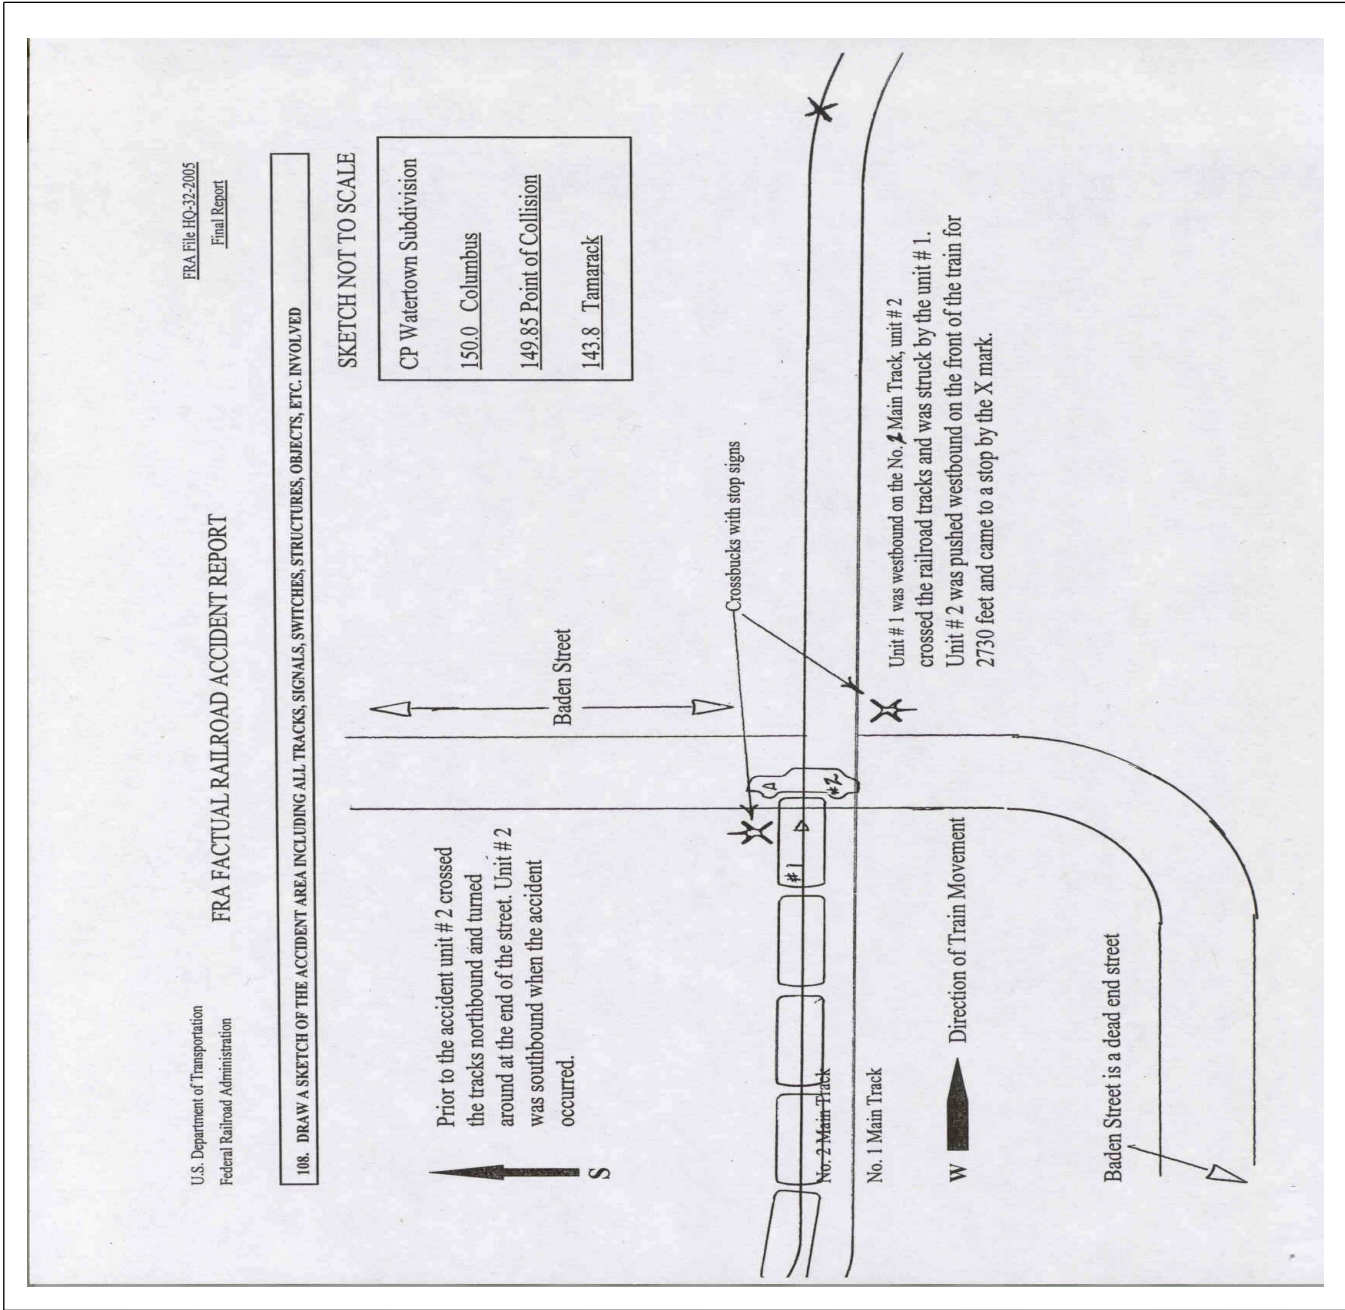
39-2005
Accident
Sketch.jpg

The train struck the left side of the motor vehicle about midpoint of the left front door. The vehicle was pushed west on the front of the lead locomotive until the train came to a stop about 2,730 feet west of the collision.
