***Federal Railroad Administration
Office of Safety
Headquarters Assigned
Accident Investigation Report
HQ-2005-33***

***Union Pacific (UP)
Blairstown, Iowa
April 13, 2005***

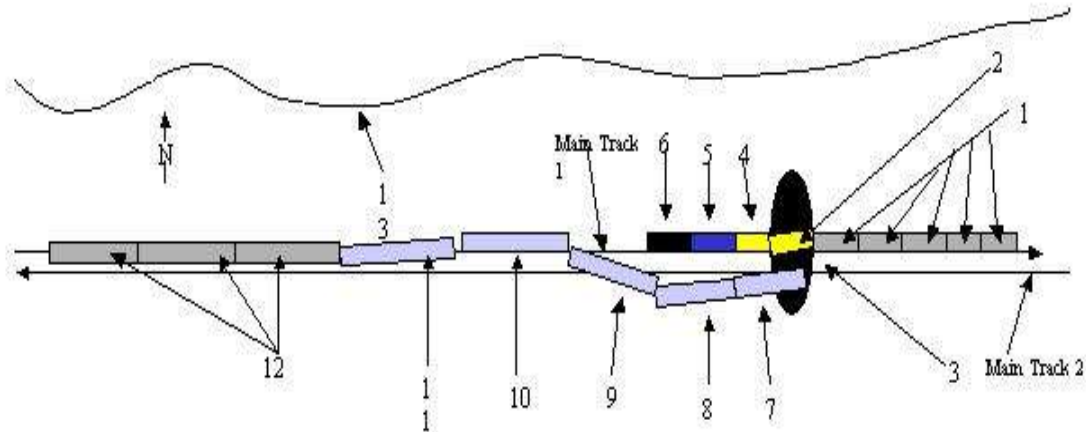
HQ-33
Sketch.jpg

#1 - cars on CNAPW-11 NOT derailed.

#2 - DPU on CNAPW-11(UP 5591)

#3 - Pile of coal and remains of CWEX 2202.

#4 - Lead unit on QNPCH-12 (UP 9458)

#5 - Second Unit on QNPCH-12 (GCFX 3095)

#6 - Trailing unit on QNPCH-12 (NS 9170)

#7 - First Car in consist of QNPCH-12 (ETTX 904224 laying on side)

#8 - Second car in consist of QNPCH-12 (ETTX 902475 laying on side)

#9 - Third car in consist of QNPCH-12 (ETTX 851058 laying on side)

#10 - Fourth car in Consist of QNPCH-12 (ETTX 860268 derailed upright)

#11 - Fifth car in consist of QNPCH-12 (TTGX 99337) east truck only derailed

#12 - Cars in consist of QNPCH that did NOT derail.

#13 - Stream approximately 30 feet from tracks.

NOTE: There was rail damage between TTGX 993375 and coal pile on Main Track No 1 and between EETX 851058 and ETTX 902475 on Main Track No 2.
