***Federal Railroad Administration
Office of Safety
Headquarters Assigned
Accident Investigation Report
HQ-2005-35***

***CSX Transportation (CSX)
Waycross, Georgia
April 21, 2005***

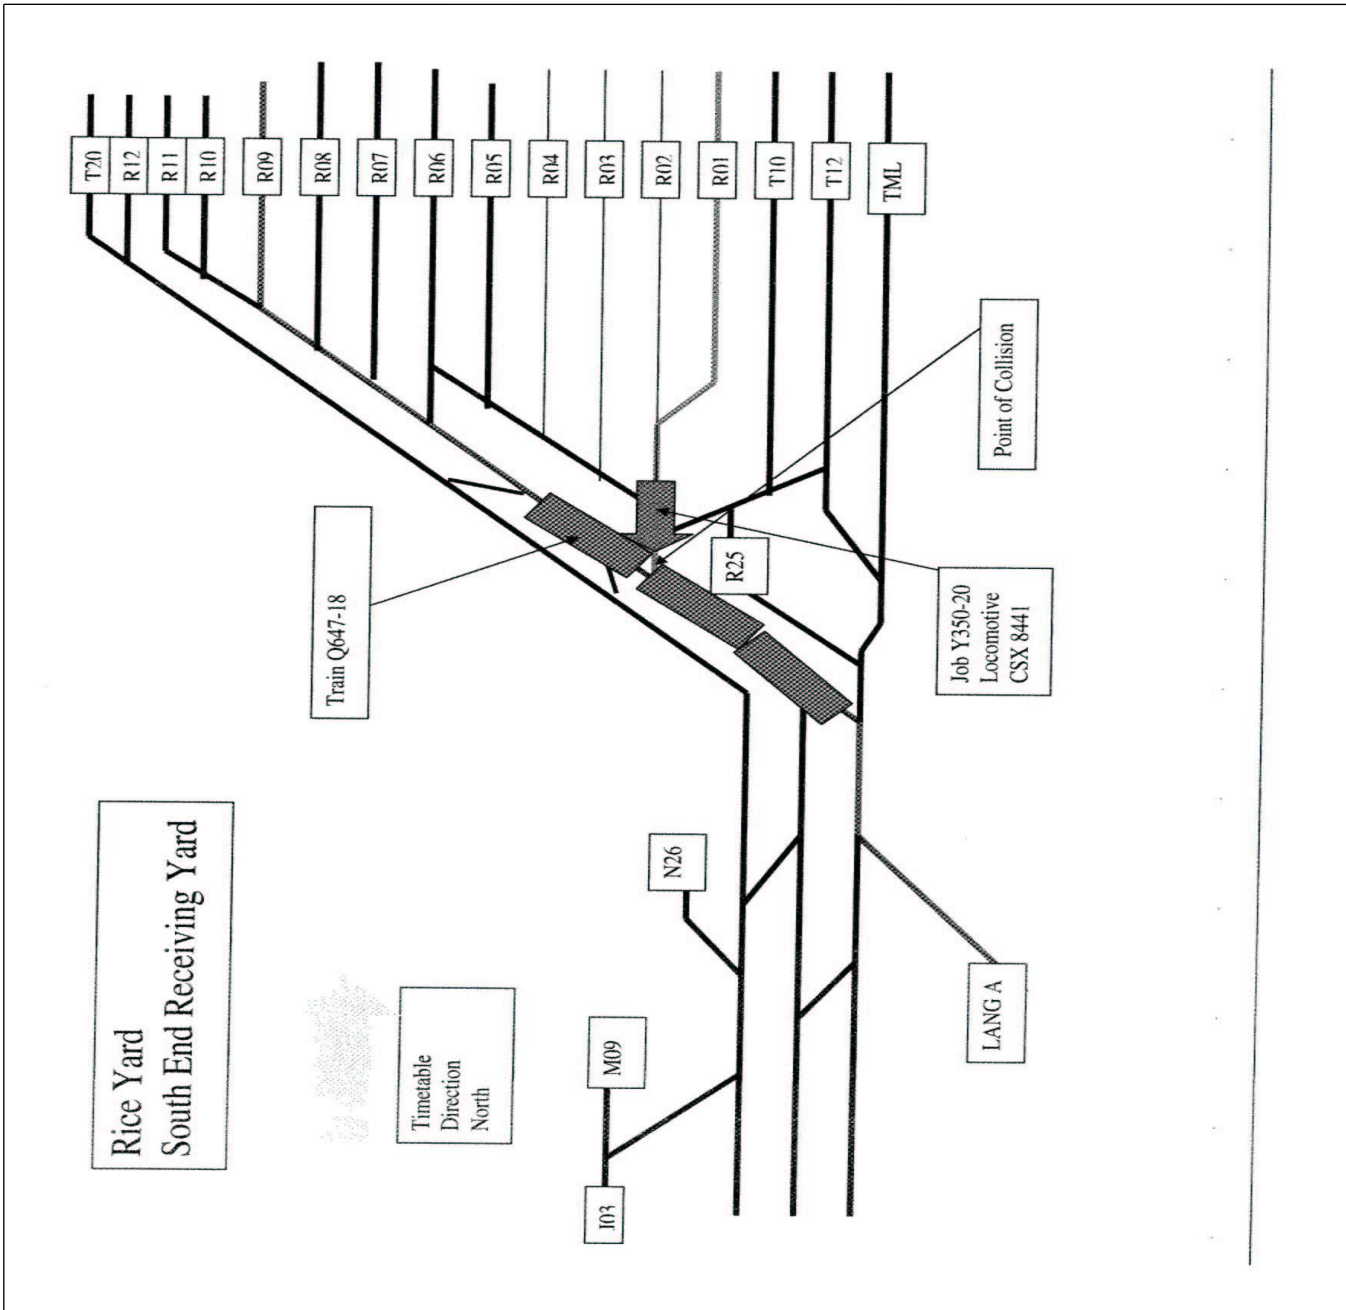
HQ-35-
2005
sketch.JPG

108. DRAW A SKETCH OF ACCIDENT AREA INCLUDING ALL TRACKS, SIGNALS, SWITCHES, STRUCTURES, OBJECTS, ETC., INVOLVED.

Based on information obtained from the locomotive event recorders, about 4:49 a.m., the southeast corner of the lead locomotive of Y350-20 CSXT 8441 struck the northwest corner of the 51st head car WLO 528315 of Train Q647-18. The impact resulted in the derailment of nine cars, the 45th through 53rd head cars of Train Q647-18 and the lead locomotive CSXT 8441 of Train Y350-20. The impact also resulted in the spilling of 2,000 gallons of diesel fuel from CSXT 8441 when its fuel tank ruptured.
