***Federal Railroad Administration
Office of Safety
Headquarters Assigned
Accident Investigation Report
HQ-2005-37***

***Montana Rail Link (MRL)
Helena, Montana
April 28, 2005***

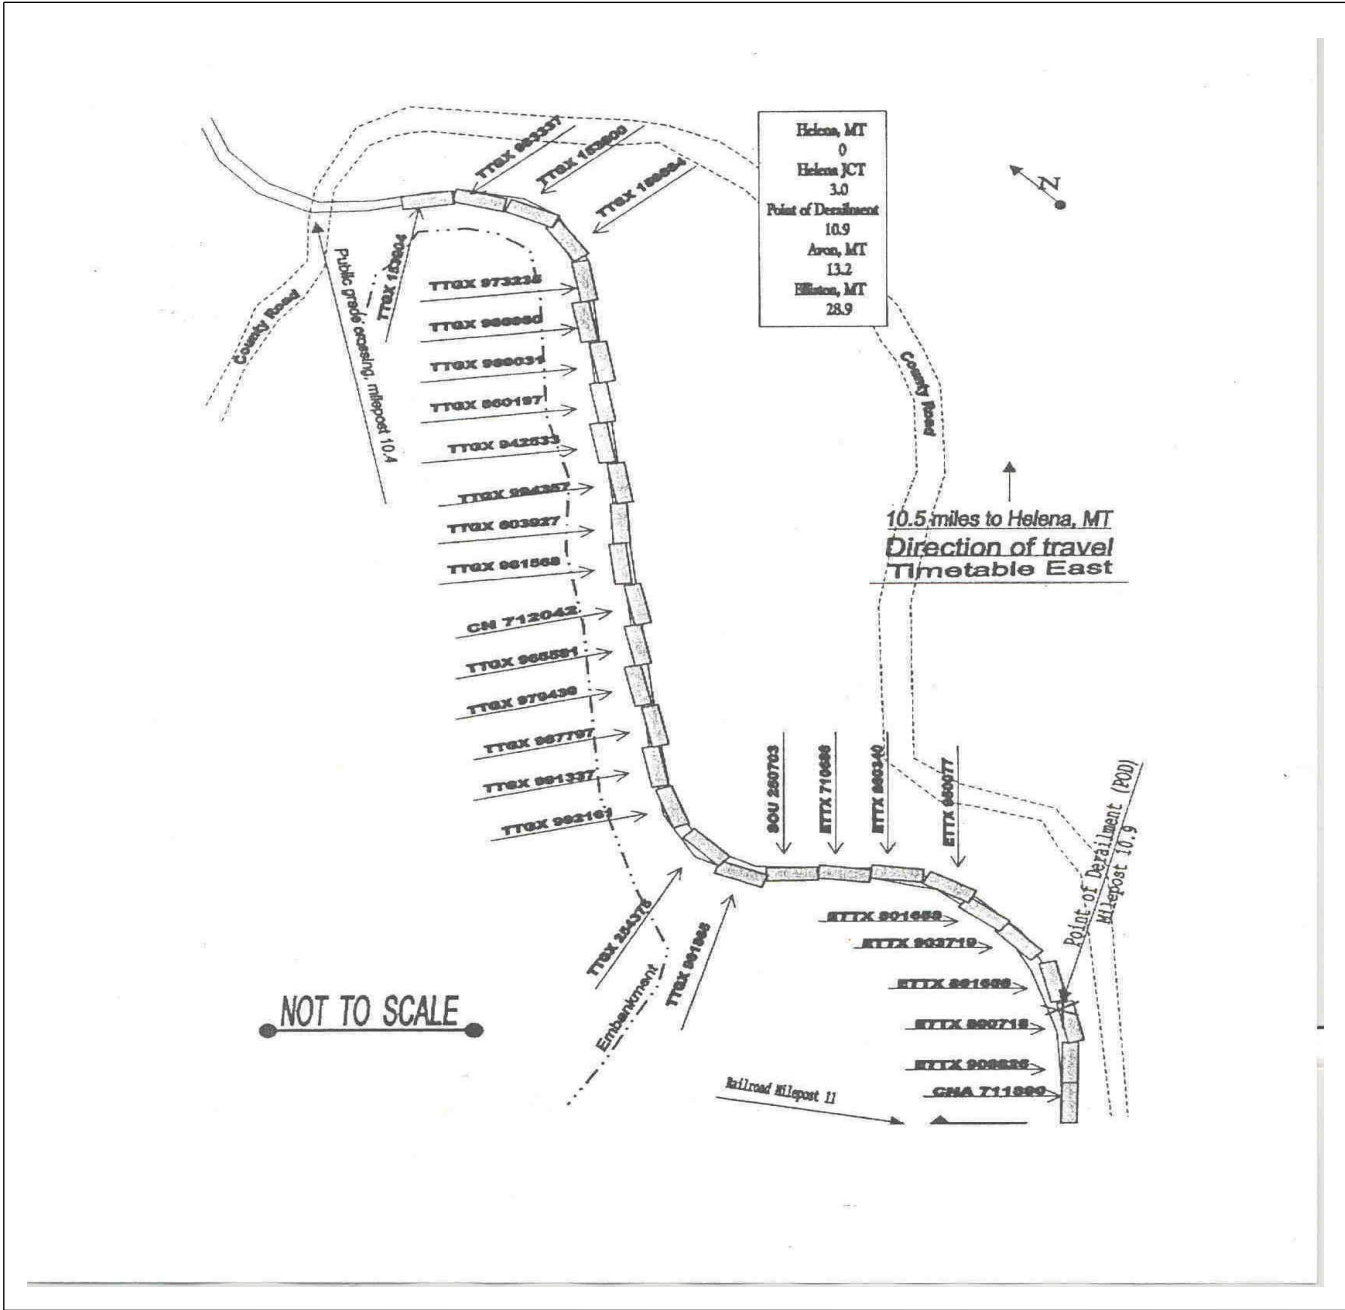
HQ-37-
2005
sketch.jpg

The crew discovered that 30 cars (19th through 48th) had derailed. The cars were loaded tri-level automobile transport containers and all remained upright. Initial determination indicated the top of the south rail in a 4-degree curve to the left, had rolled outward allowing the north wheels of the cars to fall into the gage of the track.
