***Federal Railroad Administration  
Office of Safety  
Headquarters Assigned  
Accident Investigation Report  
HQ-2005-82***

***Union Pacific (UP)  
Sibyl, Arizona  
September 25, 2005***

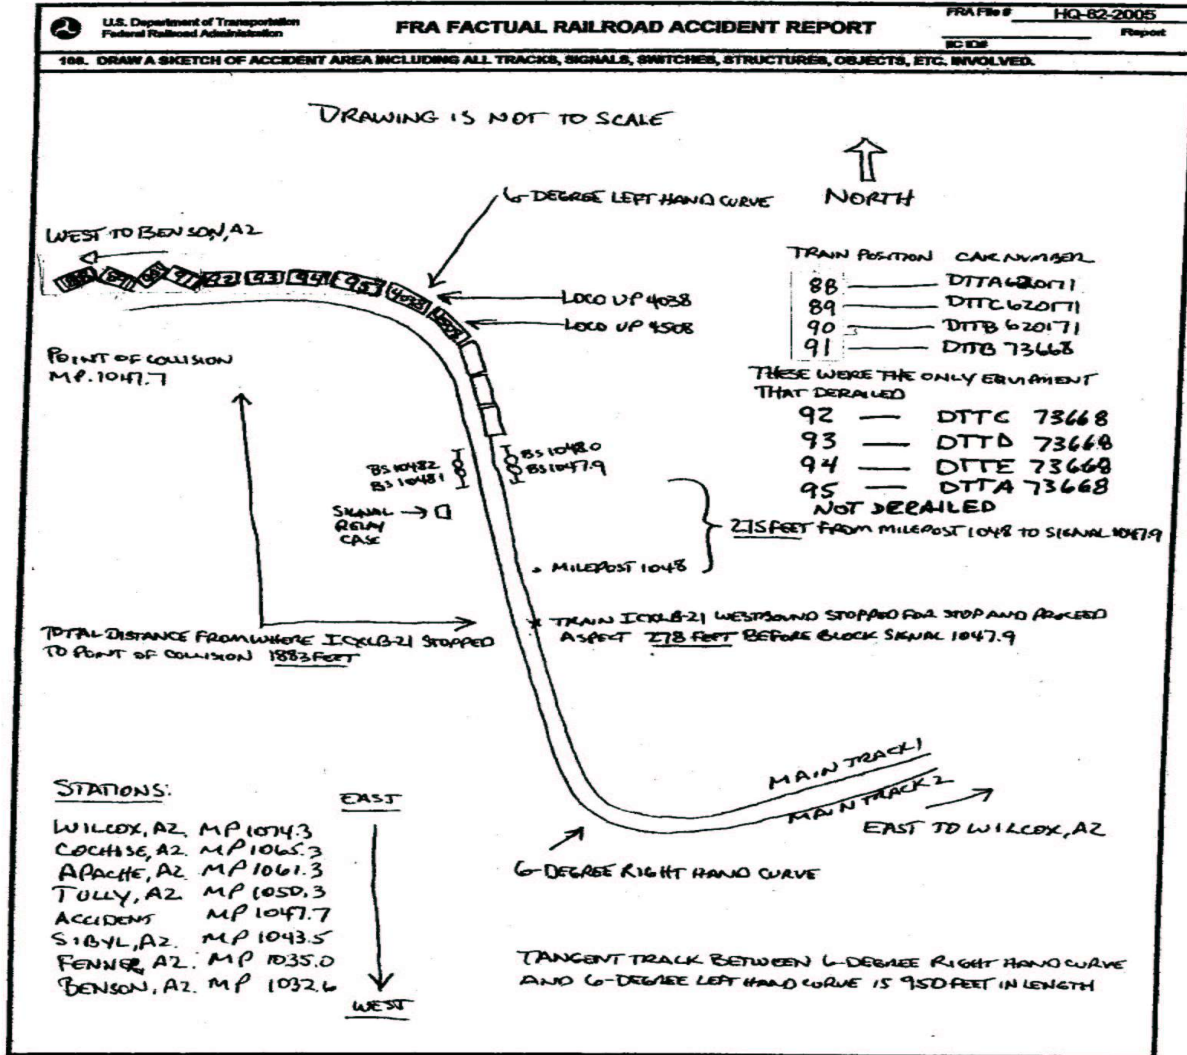
108. DRAW A SKETCH OF ACCIDENT AREA INCLUDING ALL TRACKS, SIGNALS, SWITCHES, STRUCTURES, OBJECTS, ETC., INVOLVED.  
HQ-82-2005.jpg

From the east, approaching the accident site, there is a 6-degree right hand curve, followed by a tangent segment approximately 950 feet long, and a left hand 6-degree curve. Signal 1047.9 is located at Milepost 1047.9 approximately 200 feet west of Milepost 1048 on the tangent track between the two 6-degree curves. The point of collision occurred at a point near the west end of the left-hand curve on a descending 0.75 degree grade. The distance from Signal 1047.9 in a westward direction to the point of collision is approximately 1605 feet.
