***Federal Railroad Administration  
Office of Safety  
Headquarters Assigned  
Accident Investigation Report  
HQ-2005-94***

***Union Pacific (UP)  
Lorraine, Wyoming  
October 24, 2005***

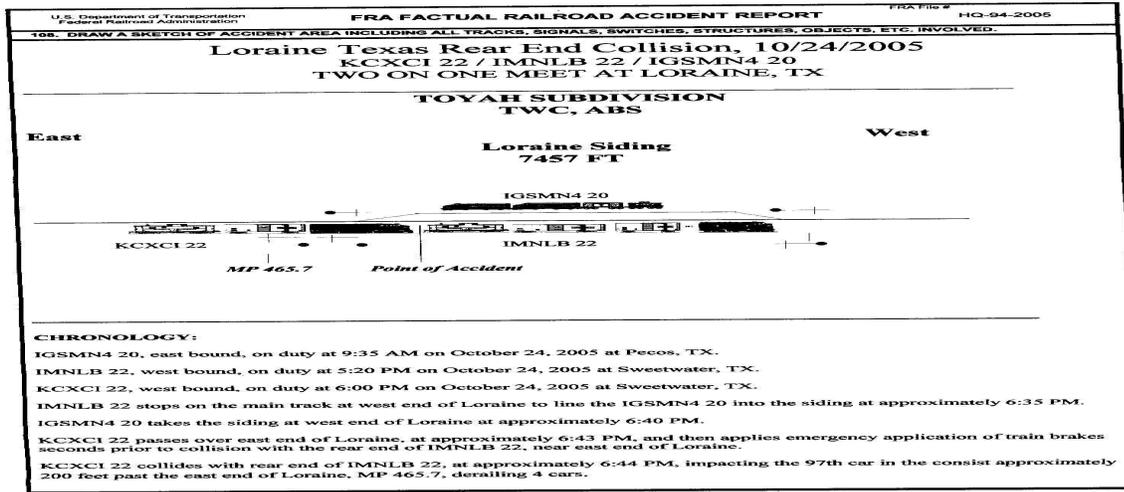
108. DRAW A SKETCH OF ACCIDENT AREA INCLUDING ALL TRACKS, SIGNALS, SWITCHES, STRUCTURES, OBJECTS, ETC., INVOLVED.  
HRX-94-  
2005.jpg

Union Pacific train KCXCI-22, was traveling west bound on the main track Toyah subdivision, under a restricting signal at approximately 18 mph. Union Pacific train IMNLB-22 was stopped on the main track between switches at Loraine, TX. As the crew of KCXCI-22 approached the rear of the IMNLB-22, they applied an emergency application of the train brakes, approximately 5 cars prior to impact. Union Pacific train IMNLB-22 had several empty intermodal cars on rear of their consist. Due to possibility of the setting sun in their eyes, the crew of the KCXCI-22 alleges they did not see the actual end of the train but rather a loaded intermodal car a head of the empties. The rear-end impact collision resulted in several cars on the IMNLB-22 to derail and impact the side of a 3rd train, east bound IGSMN4-20, which had entered the siding at Loraine.
