***Federal Railroad Administration
Office of Safety
Headquarters Assigned
Accident Investigation Report
HQ-2005-97***

***CSX Transportation (CSX)
Mauk, Georgia
October 31, 2005***

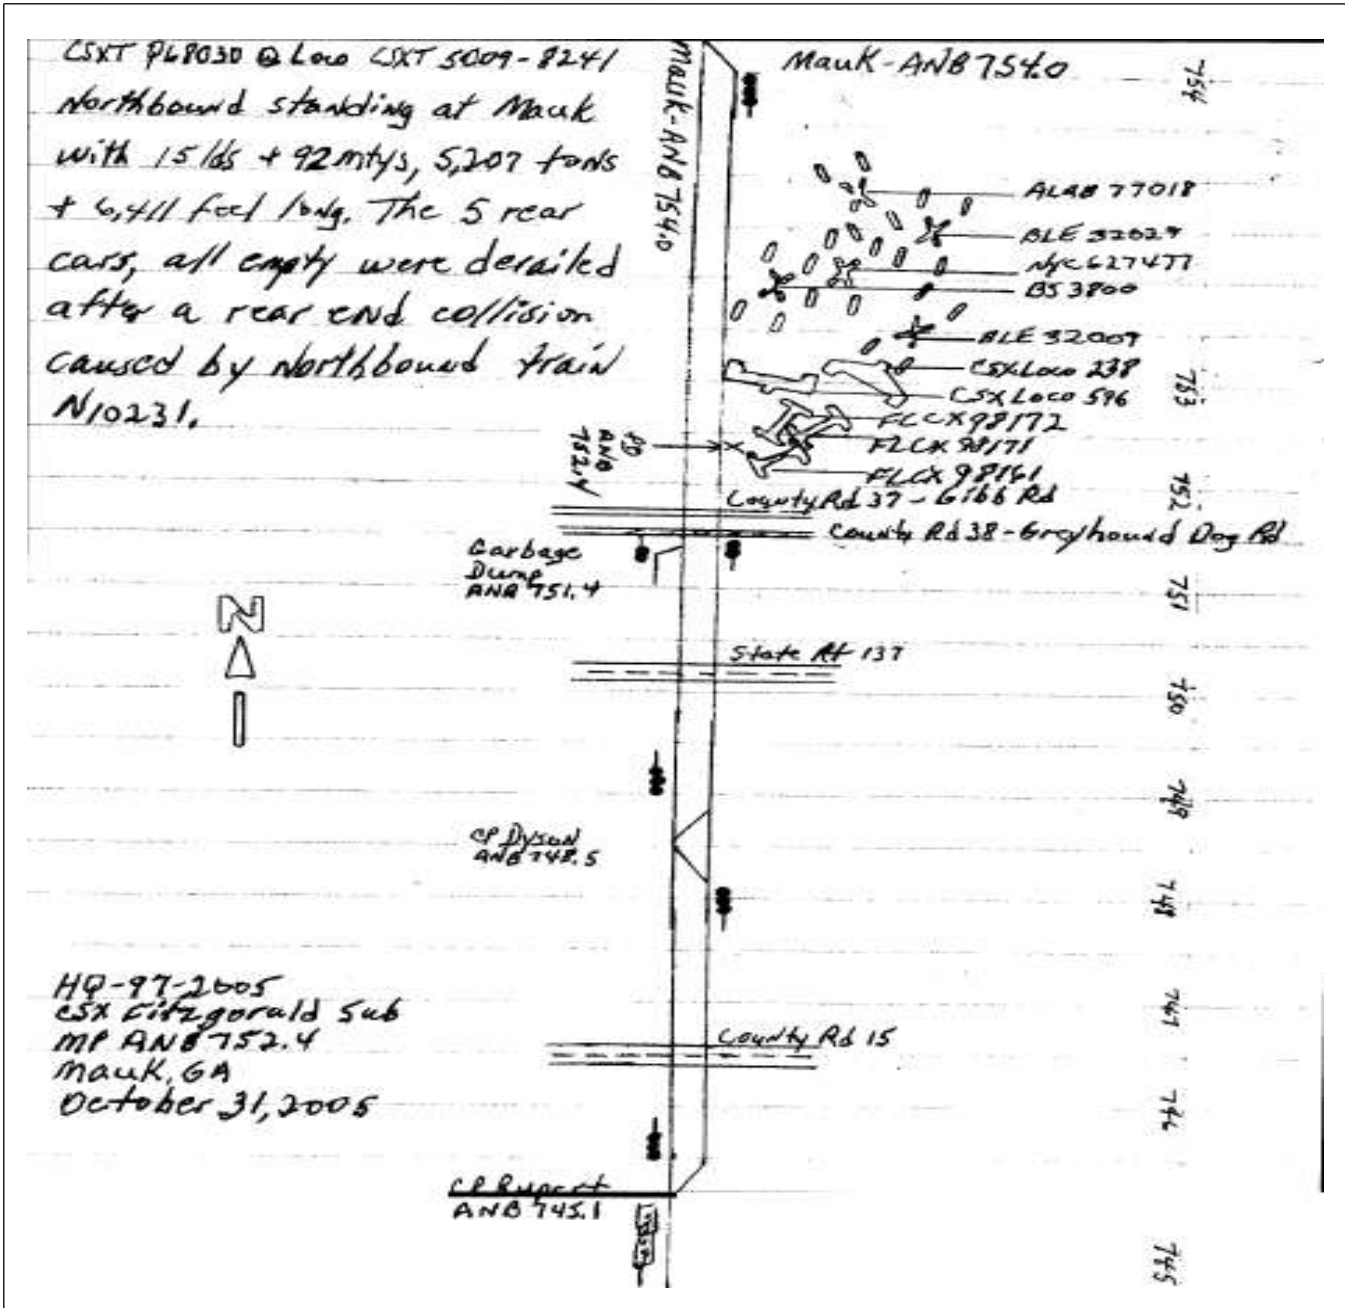
108. DRAW A SKETCH OF ACCIDENT AREA INCLUDING ALL TRACKS, SIGNALS, SWITCHES, STRUCTURES, OBJECTS, ETC., INVOLVED.
97.bmp

Train N10231 passed the intermediate signal at MP ANB 751.4 with an indication of Restricted Proceed. At about 4:30 a.m., Train N10231 collided with the rear end of Train Q68030, derailing both locomotives and the three head cars, all empties. The collision also resulted in the derailment of the five rear cars on Train Q68030, all empties. The method of operation on this subdivision is Traffic Control System.
