***Federal Railroad Administration  
Office of Safety  
Headquarters Assigned  
Accident Investigation Report  
HQ-2005-98***

***CSX Transportation (CSX)  
Oneida, New York  
November 1, 2005***

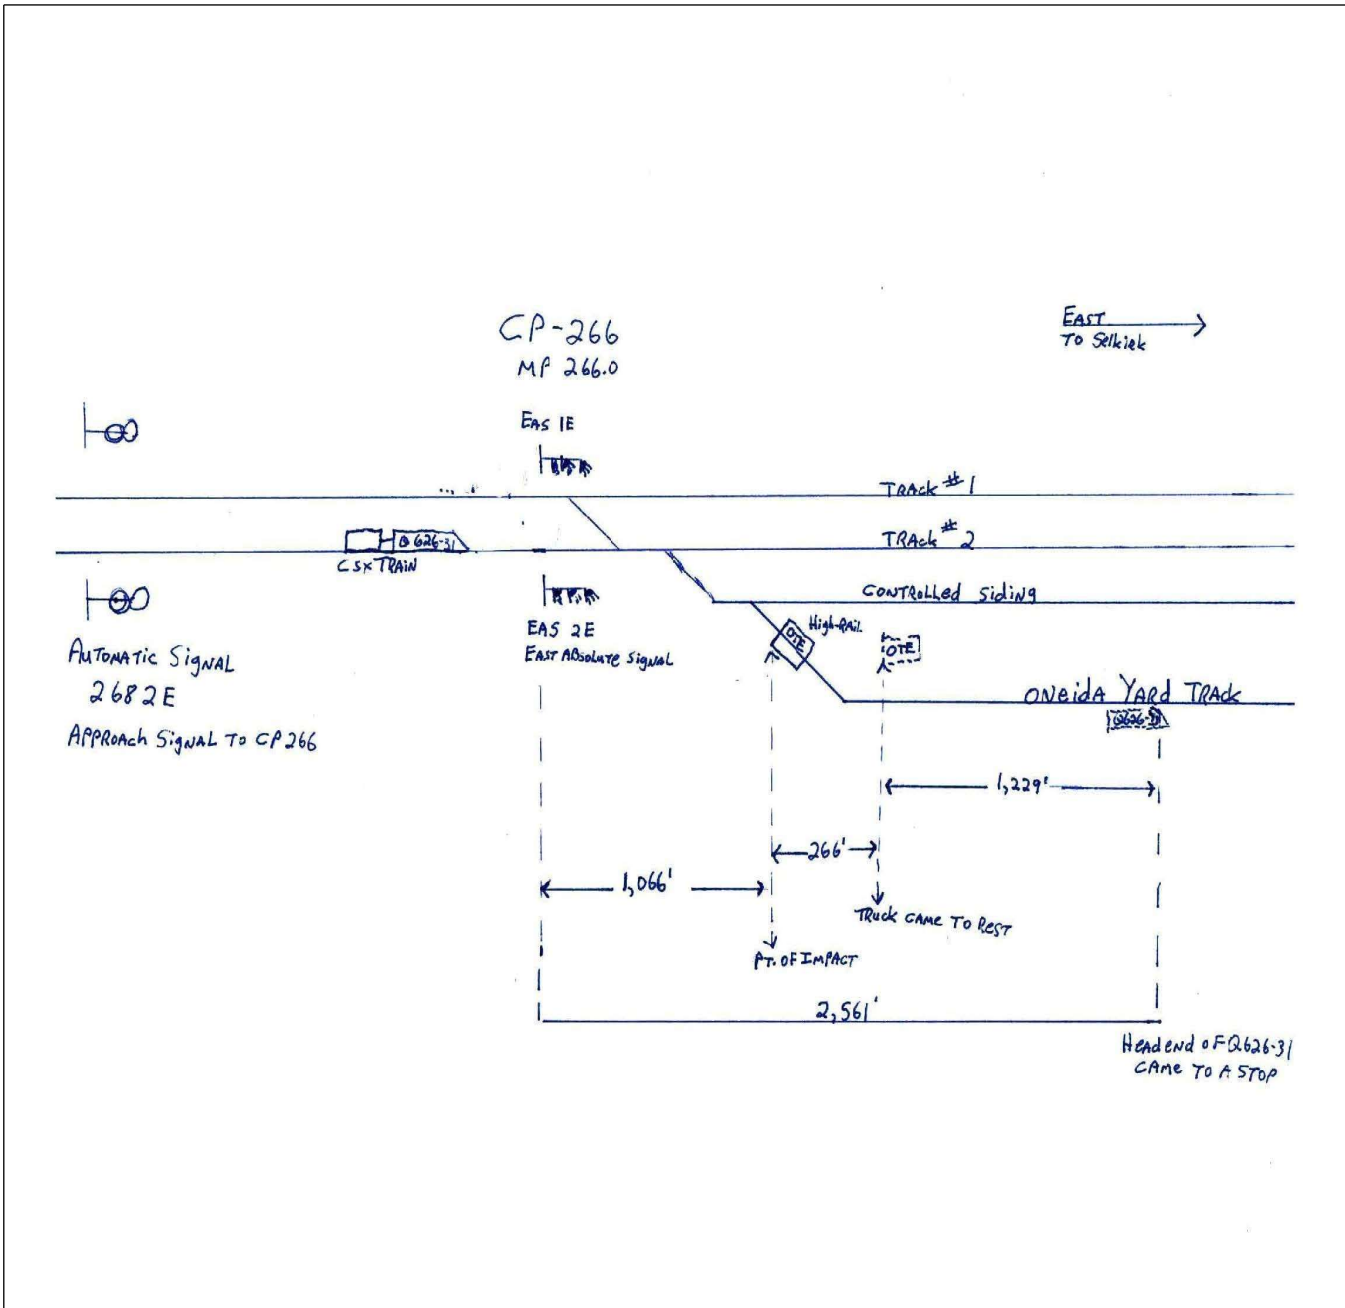
Oneida  
2.jpg

The train impacted the hi-rail vehicle at approximately 47 miles per hour. At the point of impact the high-rail vehicle was located 18 feet east of the siding switch frog, which was 1,066 feet east of the EAS.

The truck came to rest 267 feet east of the point of impact, between the Oneida yard Track and the Controlled Siding. The train continued down the yard track another 1,495 feet, coming to rest 2,561 feet east of the EAS. The dispatcher heard the emergency call and asked who had made the transmission. The crew identified themselves and said they had struck a track vehicle on the siding at Oneida. The dispatcher called an ambulance and notified his superior. The engineer got out and went to check on the men, the conductor stayed on the engine to stay in contact with the dispatcher.
