***Federal Railroad Administration
Office of Safety
Headquarters Assigned
Accident Investigation Report
HQ-2005-105***

***Union Pacific (UP)/Norfolk Southern (NS)
Momence, Illinois
November 24, 2005***

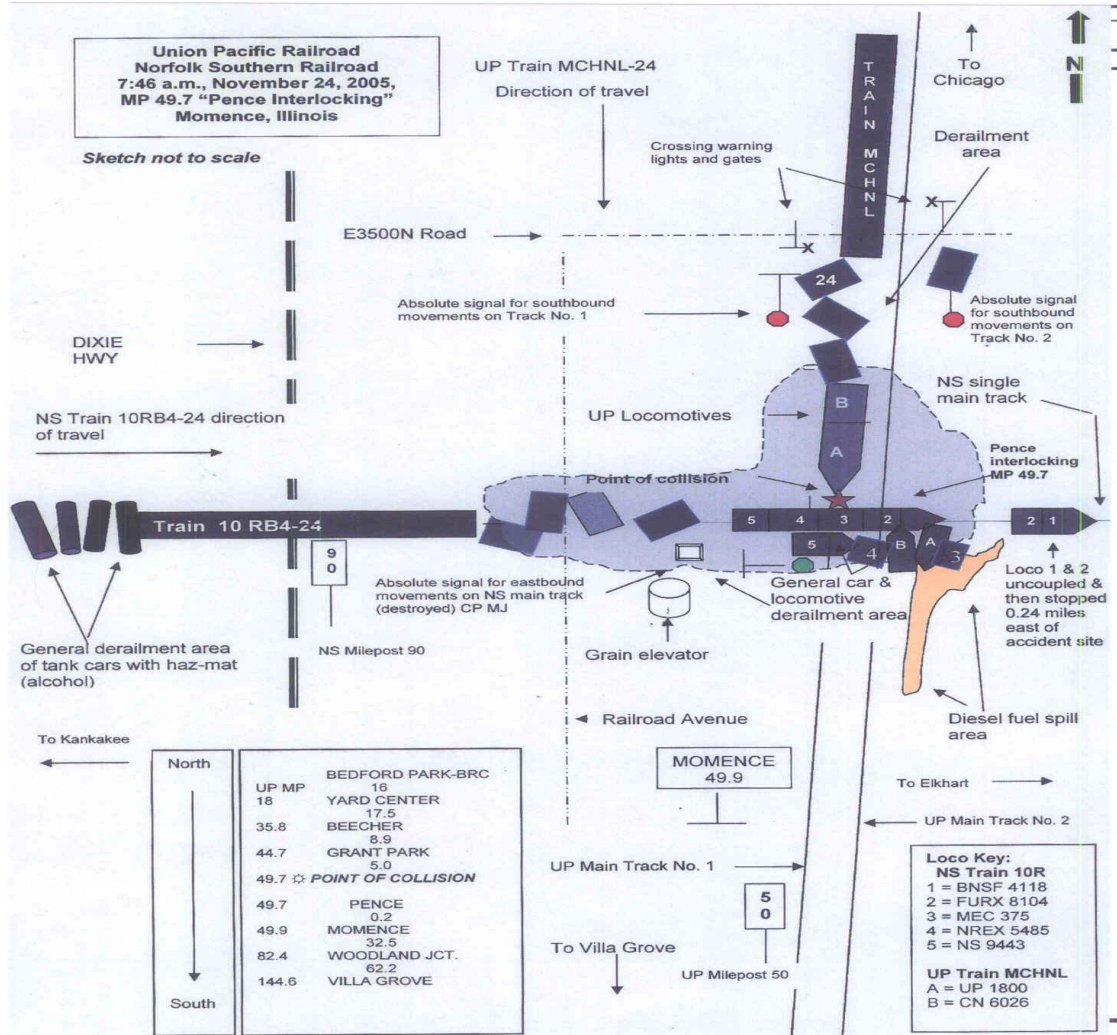
108. DRAW A SKETCH OF ACCIDENT AREA INCLUDING ALL TRACKS, SIGNALS, SWITCHES, STRUCTURES, OBJECTS, ETC., INVOLVED.

A southbound Union Pacific (UP) freight train collided with an eastbound Norfolk Southern (NS) freight train at an interlocking on November 24, 2005, at 7:46 a.m. The accident occurred in Momence, Illinois at UP Milepost 49.8, Pence Interlocking, on the St. Louis Service Unit, Villa Grove Subdivision.

The accident was caused by the failure of the southbound UP train crew to stop for the interlocking signal at Pence Interlocking that displayed a stop indication.
