***Federal Railroad Administration
Office of Safety
Headquarters Assigned
Accident Investigation Report
HQ-2005-109***

***Union Pacific (UP)
Lane, Kansas
December 22, 2005***

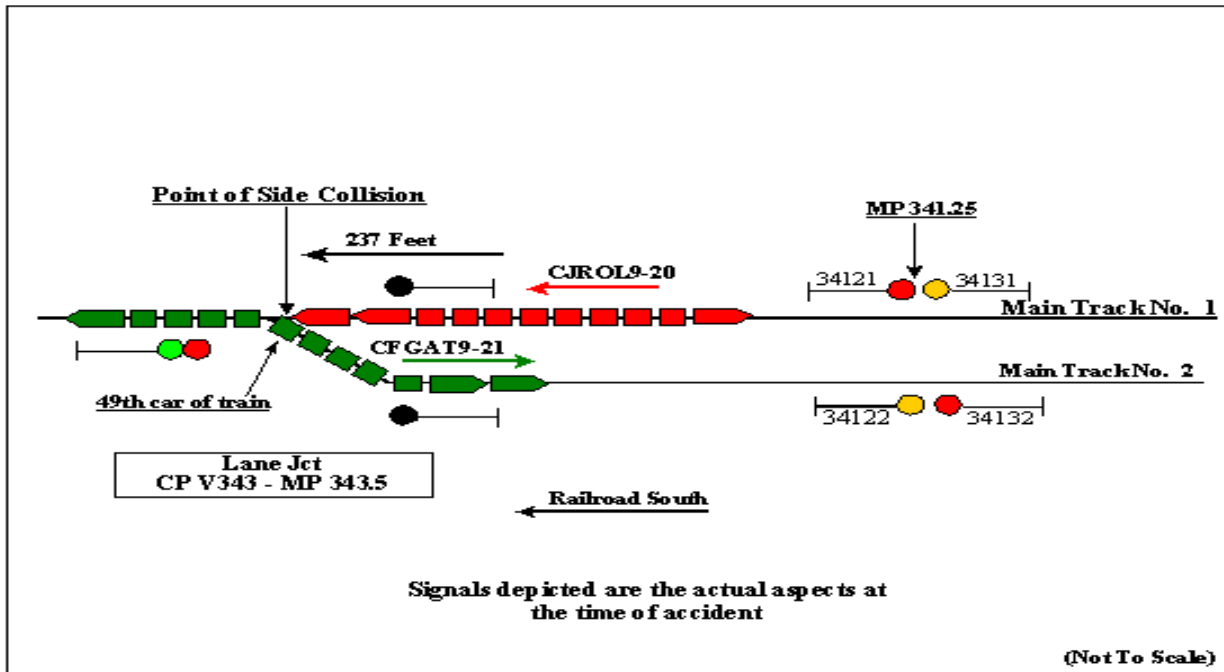
108. DRAW A SKETCH OF ACCIDENT AREA INCLUDING ALL TRACKS, SIGNALS, SWITCHES, STRUCTURES, OBJECTS, ETC., INVOLVED.
HQ-109.gif

On December 22, 2005, a southbound Union Pacific Railroad Company (UP) Train Symbol CJROL9-20, a loaded coal train, operating on main Track No. 1, passed the southbound absolute signal on main Track No. 1 at Control Point (CP) V343, railroad station Lane Jct., milepost 343.5, displaying a "Dark" aspect. The train crew placed the train brakes into "Emergency" when passing this signal while traveling at 12 mph, timetable authorized 55 mph, and proceeded another 237 feet into the "OS" section. This train stopped at 6:22 p.m. CST, upon side swiping a northbound train occupying the "OS" section.

The accident occurred because the train crew of southbound UP Train Symbol CJROL9-20 failed to stop their train in the clear prior to passing the southbound absolute signal on main Track No. 1 at CP V343, Lane Jct., Lane, Kansas.
