Full-Scale Locomotive Dynamic Crash Testing and Correlations: Locomotive Consist Colliding with Steel Coil Truck at Grade Crossing (Test 3)

1. AGENCY USE ONLY (Leave blank)	2. REPORT DATE September 2011	3. REPORT TYPE AND DATES COVERED Technical Report	
4. TITLE AND SUBTITLE Full-Scale Locomotive Dynamic Crash Testing and Correlations: Locomotive Consist Colliding with Steel Coil Truck at Grade Crossing (Test 3)		5. FUNDING NUMBERS

6. AUTHOR(S) Gopal Samavedam and Kash Kasturi			
7. PERFORMING ORGANIZATION NAME(S) AND ADDRESS(ES) Foster-Miller, Inc. 350 Second Avenue Waltham, MA 02451-1196		8. PERFORMING ORGANIZATION REPORT NUMBER DFRA.010328

9. SPONSORING/MONITORING AGENCY NAME(S) AND ADDRESS(ES) U.S. Department of Transportation Federal Railroad Administration Office of Railroad Policy and Development 1200 New Jersey Avenue, SE Washington, DC 20590		10. SPONSORING/MONITORING AGENCY REPORT NUMBER DOT/FRA/ORD-11/16.I

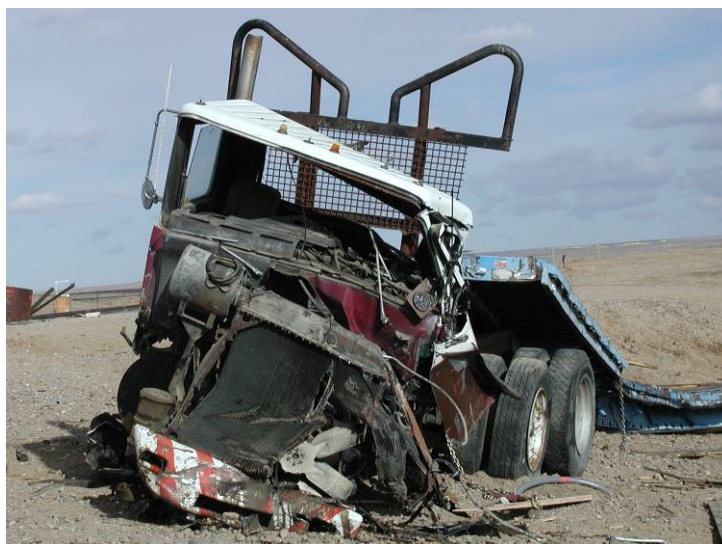
Figure 10. Stationary Vehicle at Grade Crossing after Test Collision

The rear steel coil was embedded in the locomotive after the impact, whereas the truck, trailer, and forward steel coil were pushed to the side of the tracks. Figure 10 shows postcollision damage to the truck and trailer.

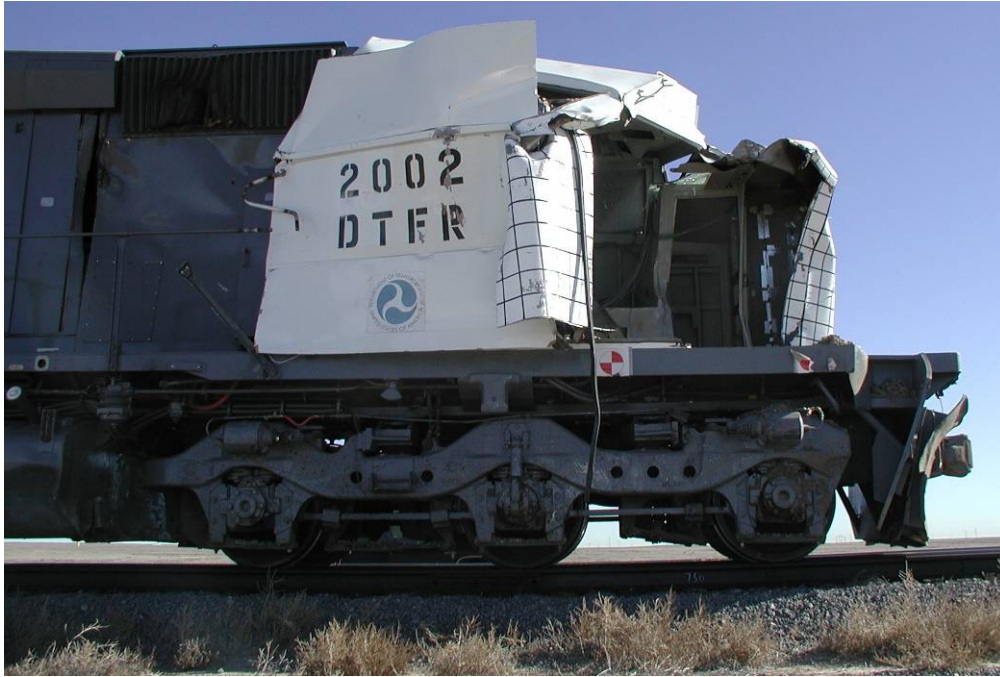
Figure 11. Damage to Locomotive after Collision

After the collision, the locomotive proceeded beyond the grade crossing and was stopped by a ballast obstruction a few hundred yards down the track. Before the locomotive consist stopped, the steel coil got dislodged from the locomotive and fell onto the ground. Figure 11 shows postcollision damage to the front of the locomotive.

- The test showed massive damage to the locomotive, including the short hood, collision posts, and windshield. Complete rupture occurred at the base of the right collision post. The impact significantly penetrated the cab and the firewall collapsed.

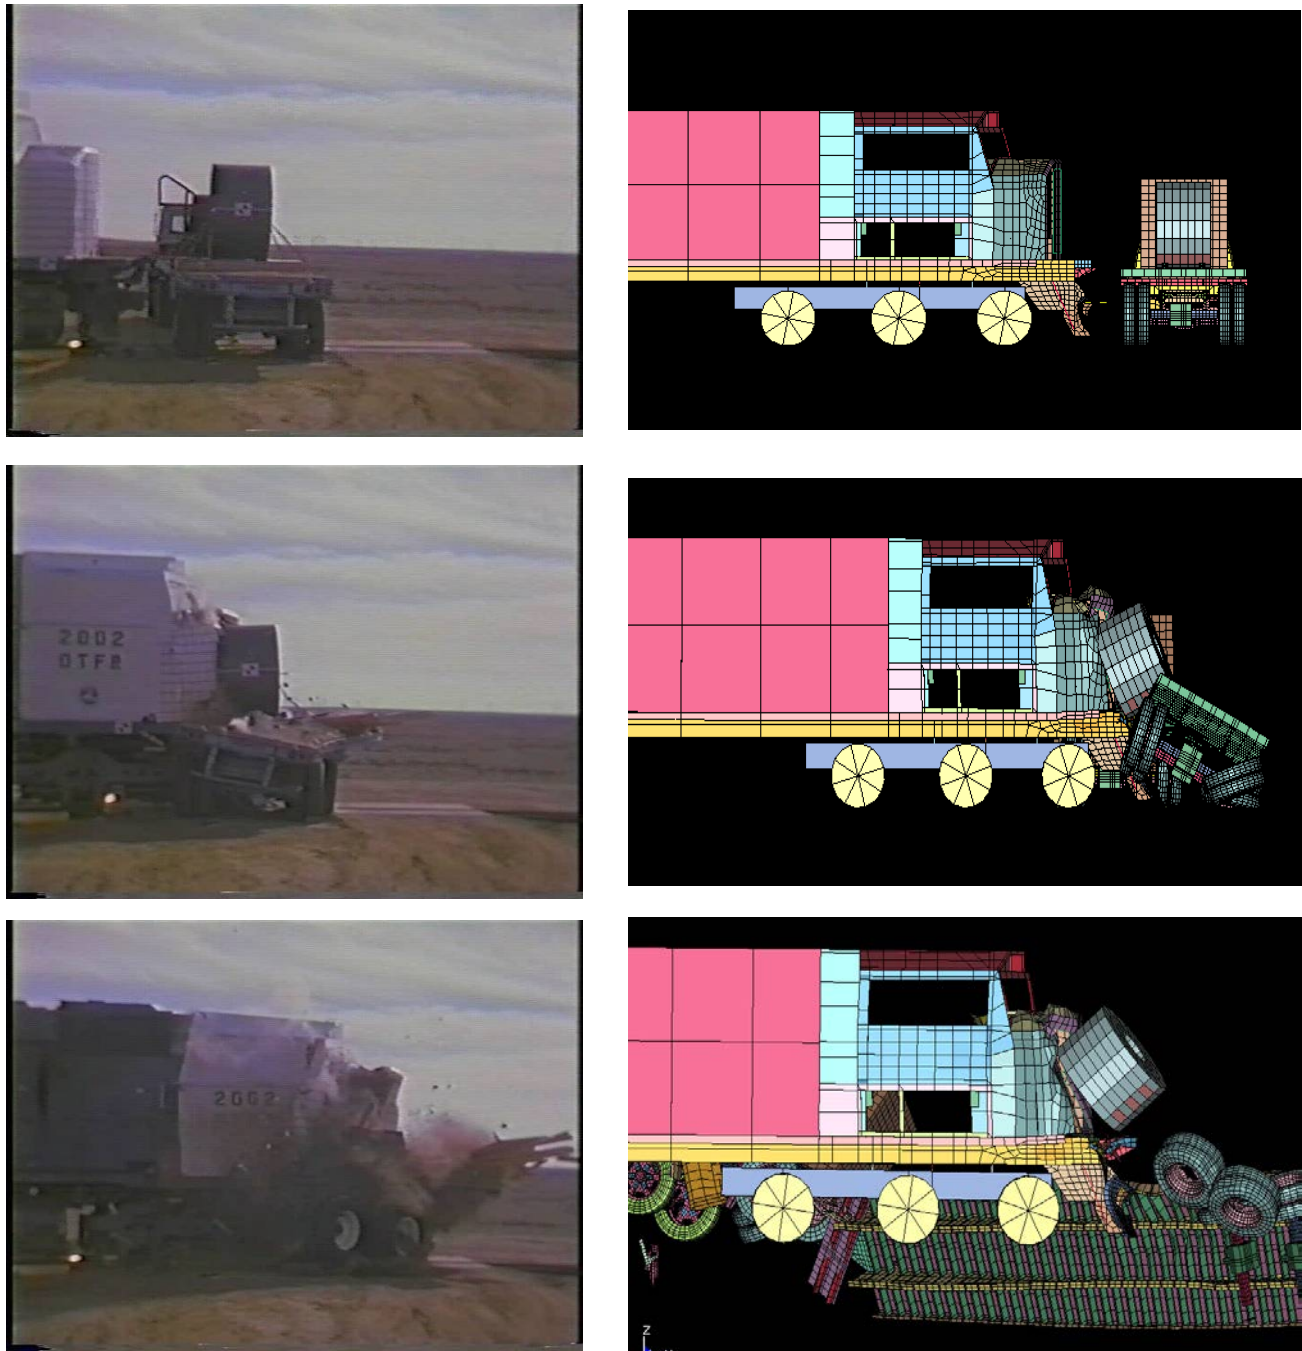
Figure 12. Test 3: Kinematic Comparison between Test and Simulation

the draft gear, coupling system, and plow, were trapped under the trailer. The anticlimber pushed the trailer, causing deformation and damage.

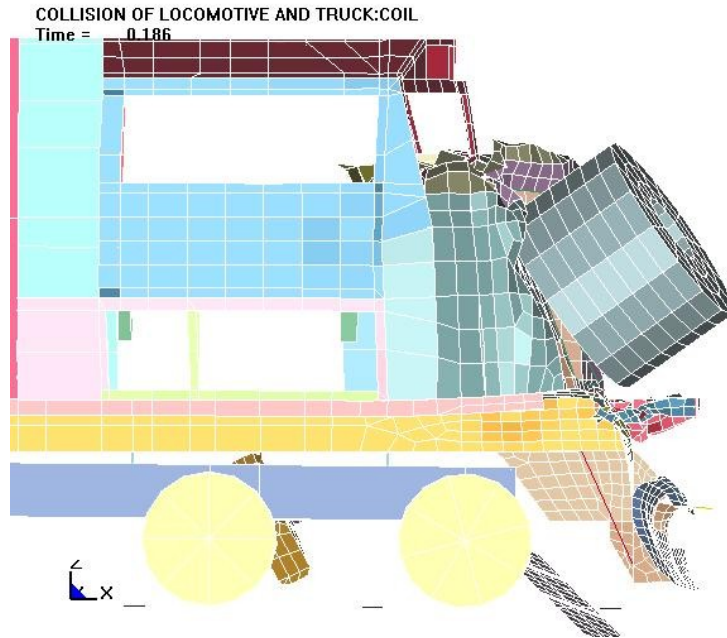
Figure 13. Locomotive Cab Damage Due to Steel Coil

- The outer frame on the right of the anticlimber also buckled. Permanent deformation of the locomotive's vertical front plate occurred. The coil's bottom bent the vertical front plate.

- The contact between the coil and the nose cab destroyed the nose cab's front and hood. The coil crashed into the right collision post. The contact deformed the right collision post into the forward cab area. Simulation results show the collision post yielding but not failing. The impact compromised the forward portion of the cab, yet the operator's seat area is intact. Figure 13 and Figure 14 show the damage to the front end of the locomotive. The truck and trailer are not shown for clarity.

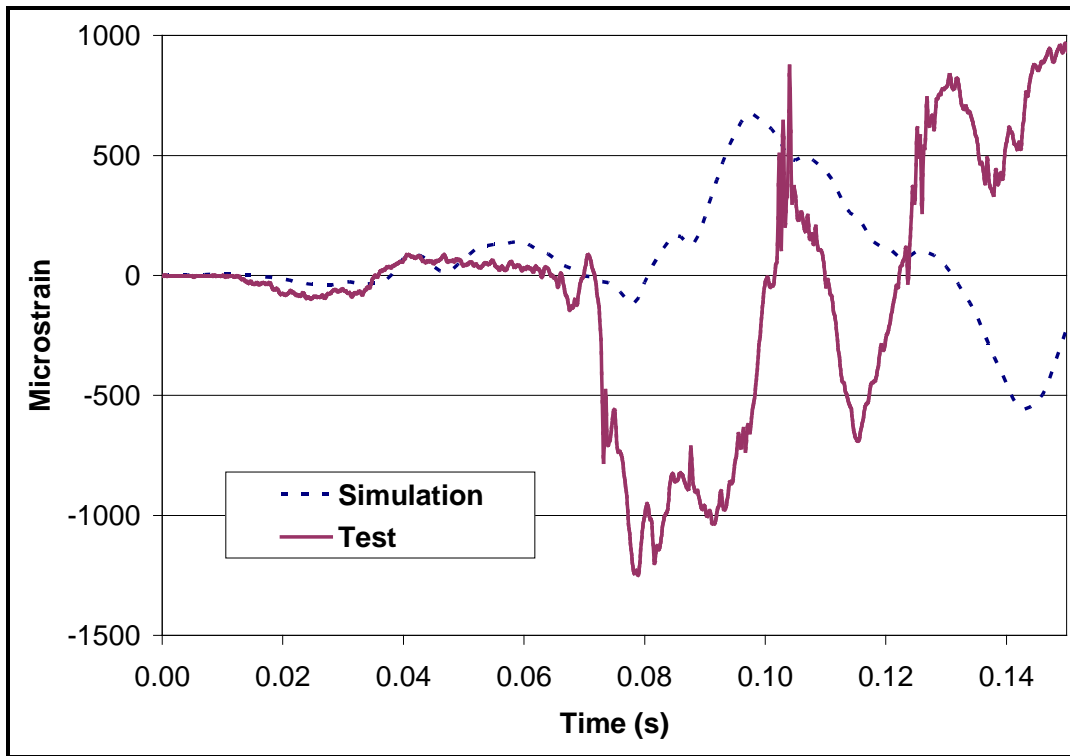
Figure 25. Windshield Postbottom Left Vertical Strain

As shown in Figure 25, simulation results sometimes compare reasonably with test data. A possible reason for disagreement is that the instrumentation was damaged due to the collision. Right collision poststrain correlations at locations 3 (Figure 17) and 10 (Figure 20) confirm the structural failure of the collision post.

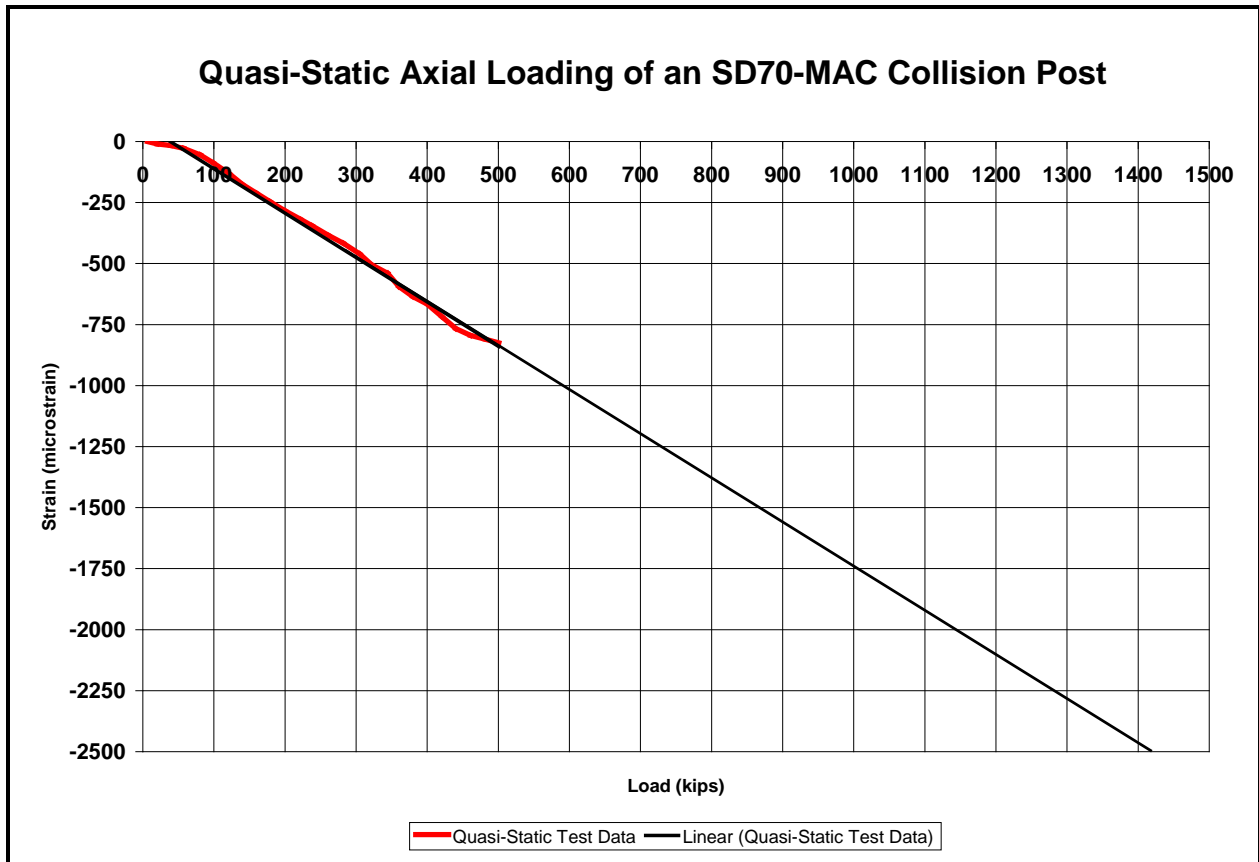
Figure 27. Quasi-Static Longitudinal Load vs. Strain of an SD70-MAC Collision Post

Furthermore, strain data from strain gauge locations 3 and 5 were used to estimate the maximum load applied to the collision posts. However, during the test, strain gauge 3 on the right collision post exceeded the peak value and was therefore damaged after a peak strain of 2,500 microstrain. Using this data, the following observations are made:

- The average maximum strain seen by the right collision post using strain gauges 3 and 5, where the peak value of strain gauge 3 is used before its failure was 1925 microstrain which corresponds to approximately 1,150 kip applied on the right collision post.
- The maximum strain seen by the left collision post using strain gauges 5 (data from strain gauge 3 were not obtained) was 155 microstrain which corresponds to approximately 125 kip applied on the right collision post.
- The right collision post forces exceeded the 2003 S-580 Standard of 500 kip without any undesirable levels of deformation, causing its complete rupture.
- The load applied on the collision posts was not symmetrical because of the test configuration where the steel coil was center with the right collision post.
