Full-Scale Locomotive Dynamic Collision Testing and Correlations: Offset Collisions between a Locomotive and a Covered Hopper Car (Test 4)

Office of Railroad Policy and Development Washington, DC 20590

This report presents the test results and finite element correlations of a full-scale dynamic collision test with rail vehicles as part of the Federal Railroad Administration's research program on improved crashworthiness of locomotive structures. This test involved the 30-mile per hour oblique collision of a locomotive with a stationary covered hopper car fouling the locomotive's right-of-way. The test used an SD70-MAC locomotive.

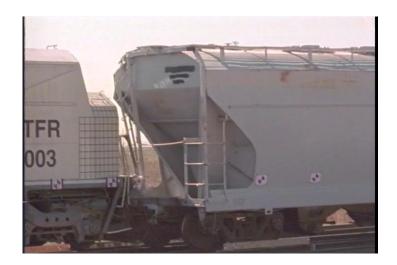
Figure 11. Locomotive Vertical End Plate Contacts Front Truck

• The locomotive vertical end plate made contact with the covered hopper side sill and the horizontal end plate. The side sill was torn away from the horizontal end plate as the left corner of the horizontal end plate was bent downward, making contact with the covered hopper's front truck (Figure 11). The locomotive vertical end-plate sheared off vertically near the draft gear pocket and was bent back underneath the underframe when it came in contact with the front truck. The excessive deformation of the locomotive vertical end-plate caused the plow to completely break free of the end plate.

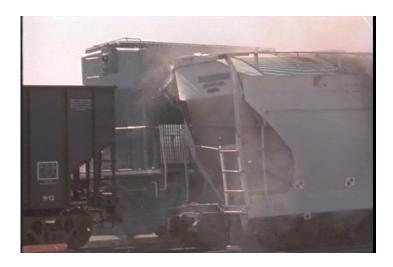
Figure 14. Locomotive Right Rear Contacts Damaged Covered Hopper Car

• The wheels of the locomotive's front truck now derailed, landing on the rail ties as the locomotive continued forward at an angle to its direction of travel. The right rear corner of the locomotive contacted the damaged covered hopper, bending the rear vertical end plate (Figure 14).

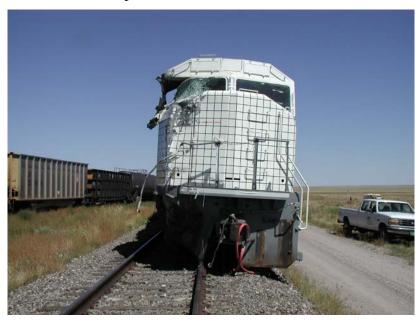
Figure 15. Locomotive after Collision

After the collision, the locomotive came to a stop with its lead truck resting on railroad ties and gravel, having tracked almost one full gauge width to the left after derailing in the collision with the covered hopper. The collision damaged the plow, the right-hand side of the vertical end plate and nose, and the right windshield corner post. Figure 15 shows the derailed, damaged locomotive after impact. Figure 16 provides closeup views of the damage to the windshield corner post, hood, and vertical end plate.

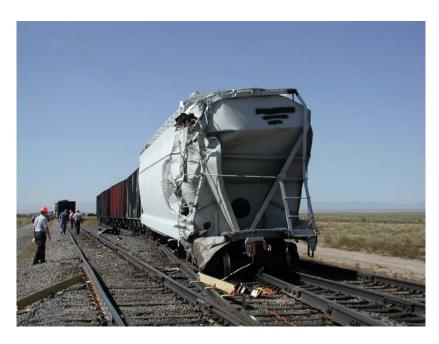
Figure 17. Covered Hopper Car after Collision

Longitudinal translation of the covered hopper car was limited by its being coupled to the remainder of the stationary consist. The collision slightly displaced the second and third stationary cars, which showed damage but did not derail. Figure 17 shows the derailed, damaged covered hopper car after the test. Figure 18 shows the close-up views of the damage of the side sill, horizontal end plate, bolster, and hopper body.

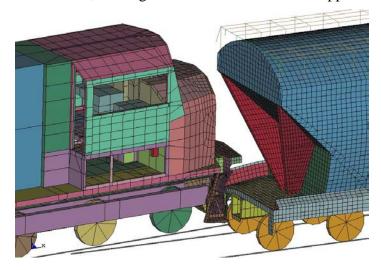
Figure 25. Locomotive and Covered Hopper End Plates in Contact with the Truck

• The locomotive plow and vertical end plate made contact with the covered hopper's side sill and horizontal end plate. The side sill and horizontal end plate were bent downward,

and the side sill torn open. Figure 25 shows that the left corner of the horizontal end plate was bent downward, making contact with the covered hopper's front truck.

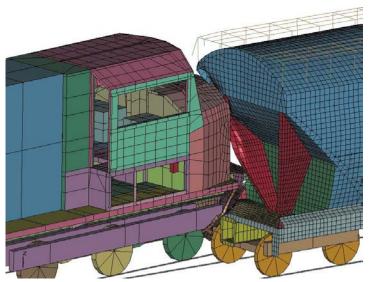
Figure 26. Locomotive Hood in Contact with the Covered Hopper Car

- The locomotive vertical end plate bent back underneath the underframe when it came in contact with the front truck. The locomotive plow was damaged but did not break free from the vertical end plate.
- The deformation and interaction of end plates and trucks on the two cars were sufficient to form a ramp that separated the two cars apart from each other; the locomotive moved to the left, whereas the covered hopper's front truck shifted to the right. Figure 26 shows that the impact end of the covered hopper shifted away from the locomotive as the hood of the locomotive interacted with the body of the covered hopper car.

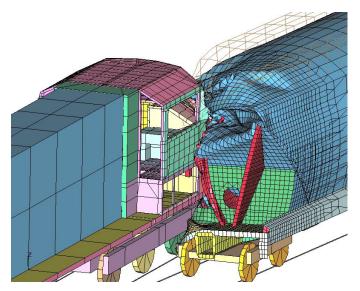
Figure 27. Covered Hopper Car Body Damage

• As the end-plate interaction occurred, the locomotive hood made contact with the sloped end of the covered hopper's body. The locomotive hood was significantly damaged with

plastic deformation at the side of the right collision post. Figure 27 shows that the hopper body side and roof were significantly damaged, exposing the ballast inside the hopper body.

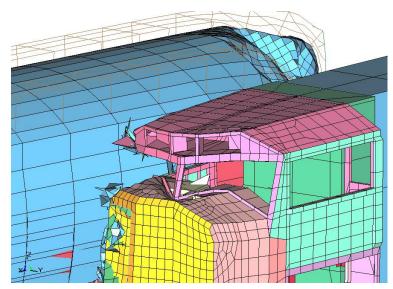
Figure 28. Locomotive Windshield Corner Just after Post Removal

The lateral forces shifted the locomotive and covered hopper away from one another.
 This interaction of the locomotive hood and roof with the hopper body moved the covered hopper toward the locomotive. Figure 28 shows that the tangle of hopper body materials tore the locomotive windshield corner post and deformed the side of the locomotive cab.

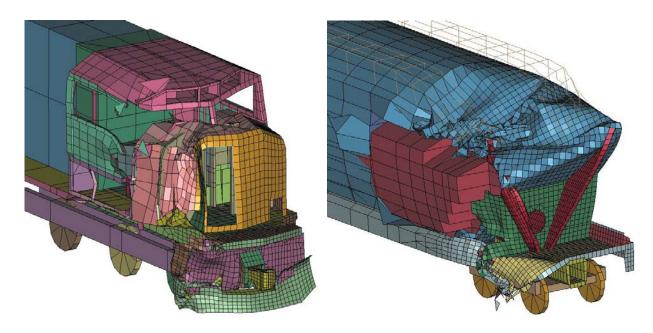
Figure 29. Locomotive and Covered Hopper Car Damage from Simulation

Figure 29 shows the damage to the locomotive and hopper car from the simulated collision.

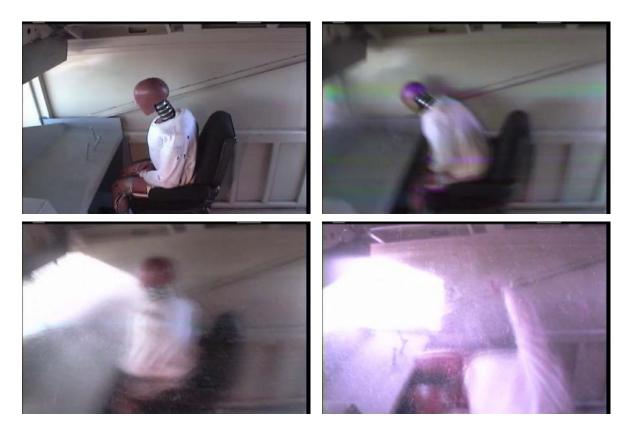
Figure 38. ATD Impact with Corner Post Sequence

Table 6. Maximum Forces and g Loads on ATD in Comparison with Injury Tolerances

Parameter	Test	Injury Tolerance
HIC <sub>15</sub>	1785	700
Neck force (lb)	1353 Vertical	900
Chest acceleration (g)	73 Lateral	60
Femur force (lb)	383 (right leg)	2,250

• Significant damage to the corner post area occurred in this test. The intrusion of the cab is a potential for primary injuries to crew.
