Federal Railroad Administration Office of Safety Headquarters Assigned Accident Investigation Report HQ-2009-12

Southwestern Railroad (SWRR) Rosswell, NM March 30, 2009

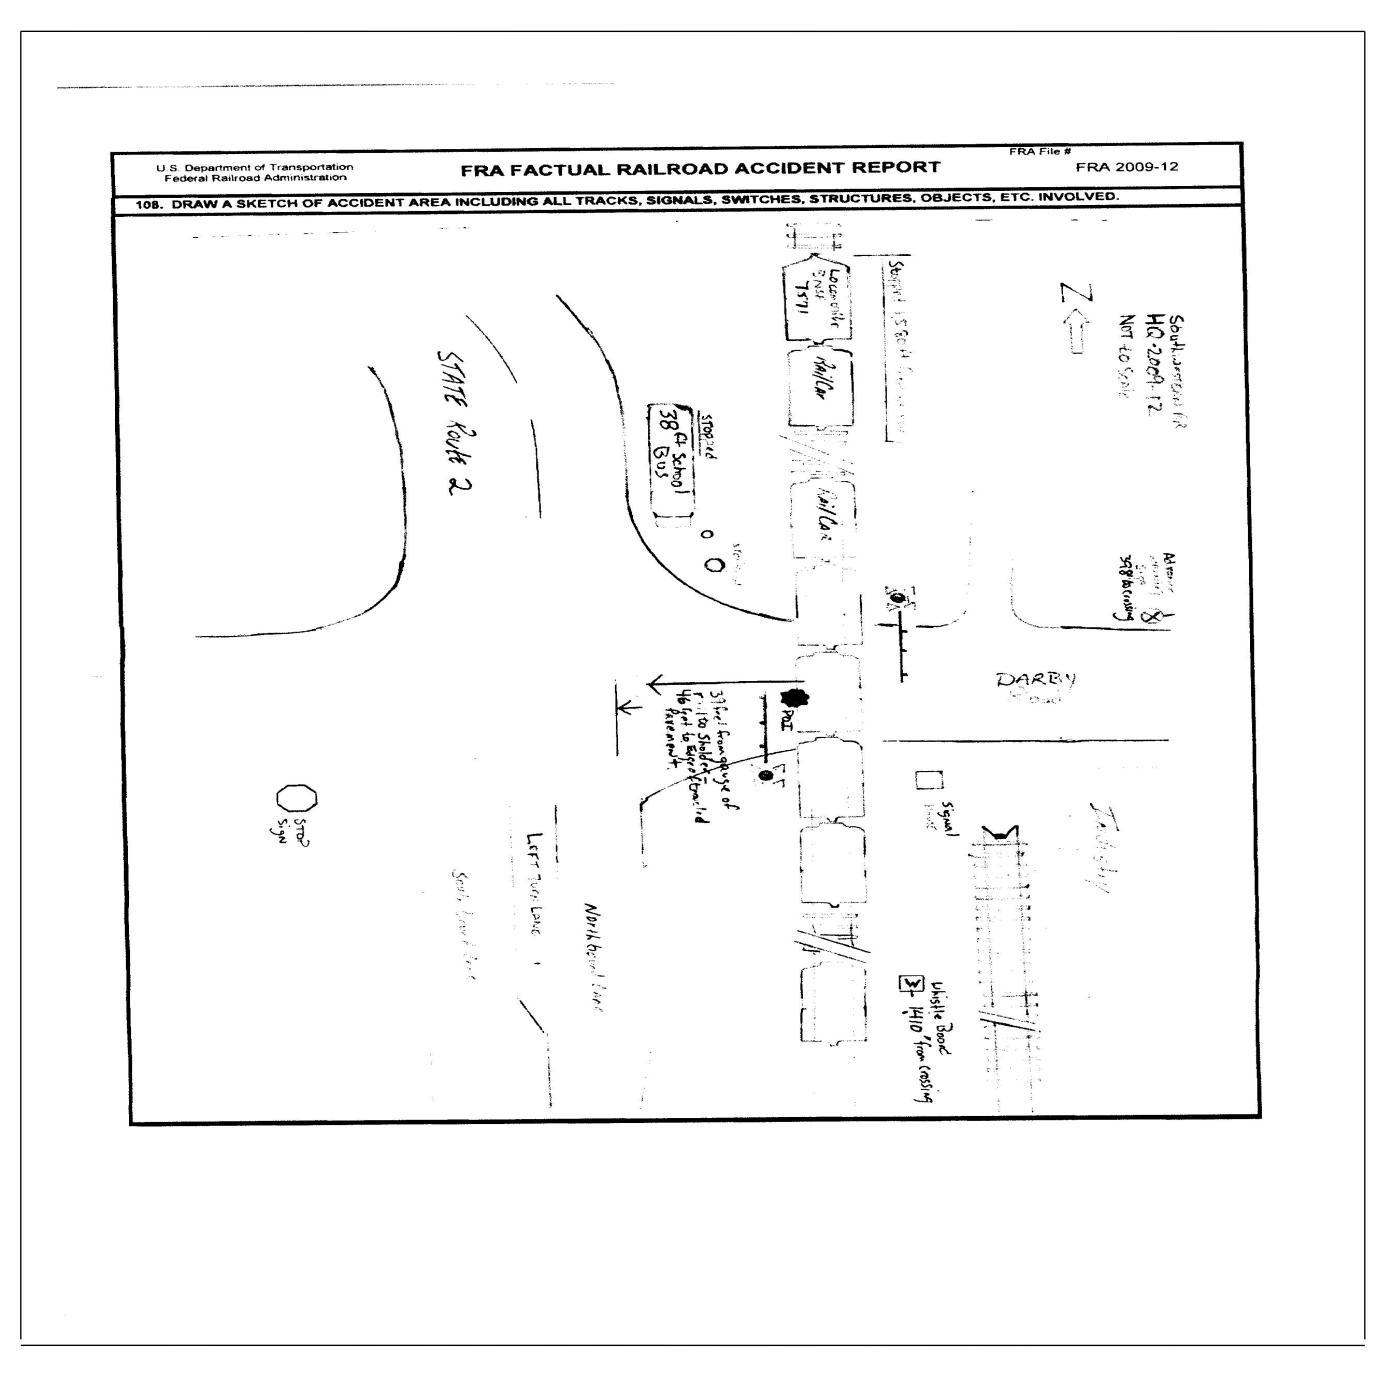
136. DRAW A SKETCH OF ACCIDENT AREA INCLUDING ALL TRACKS, SIGNALS, SWITCHES, STRUCTURES, OBJECTS, ETC., INVOLVED.

The train collided with the bus lifting it and knocking the rear end ninety degrees to land parallel to the tracks. The bus now facing south rolled back several feet before stopping north of the crossing between State Route 2 and the railroad tracks. The train came to a stop about 1,580 feet north of the crossing.
