Federal Railroad Administration Office of Safety Headquarters Assigned Accident Investigation Report HQ-2008-54

Burlington Northern Santa Fe (BNSF) Melrose, IA June 12, 2008

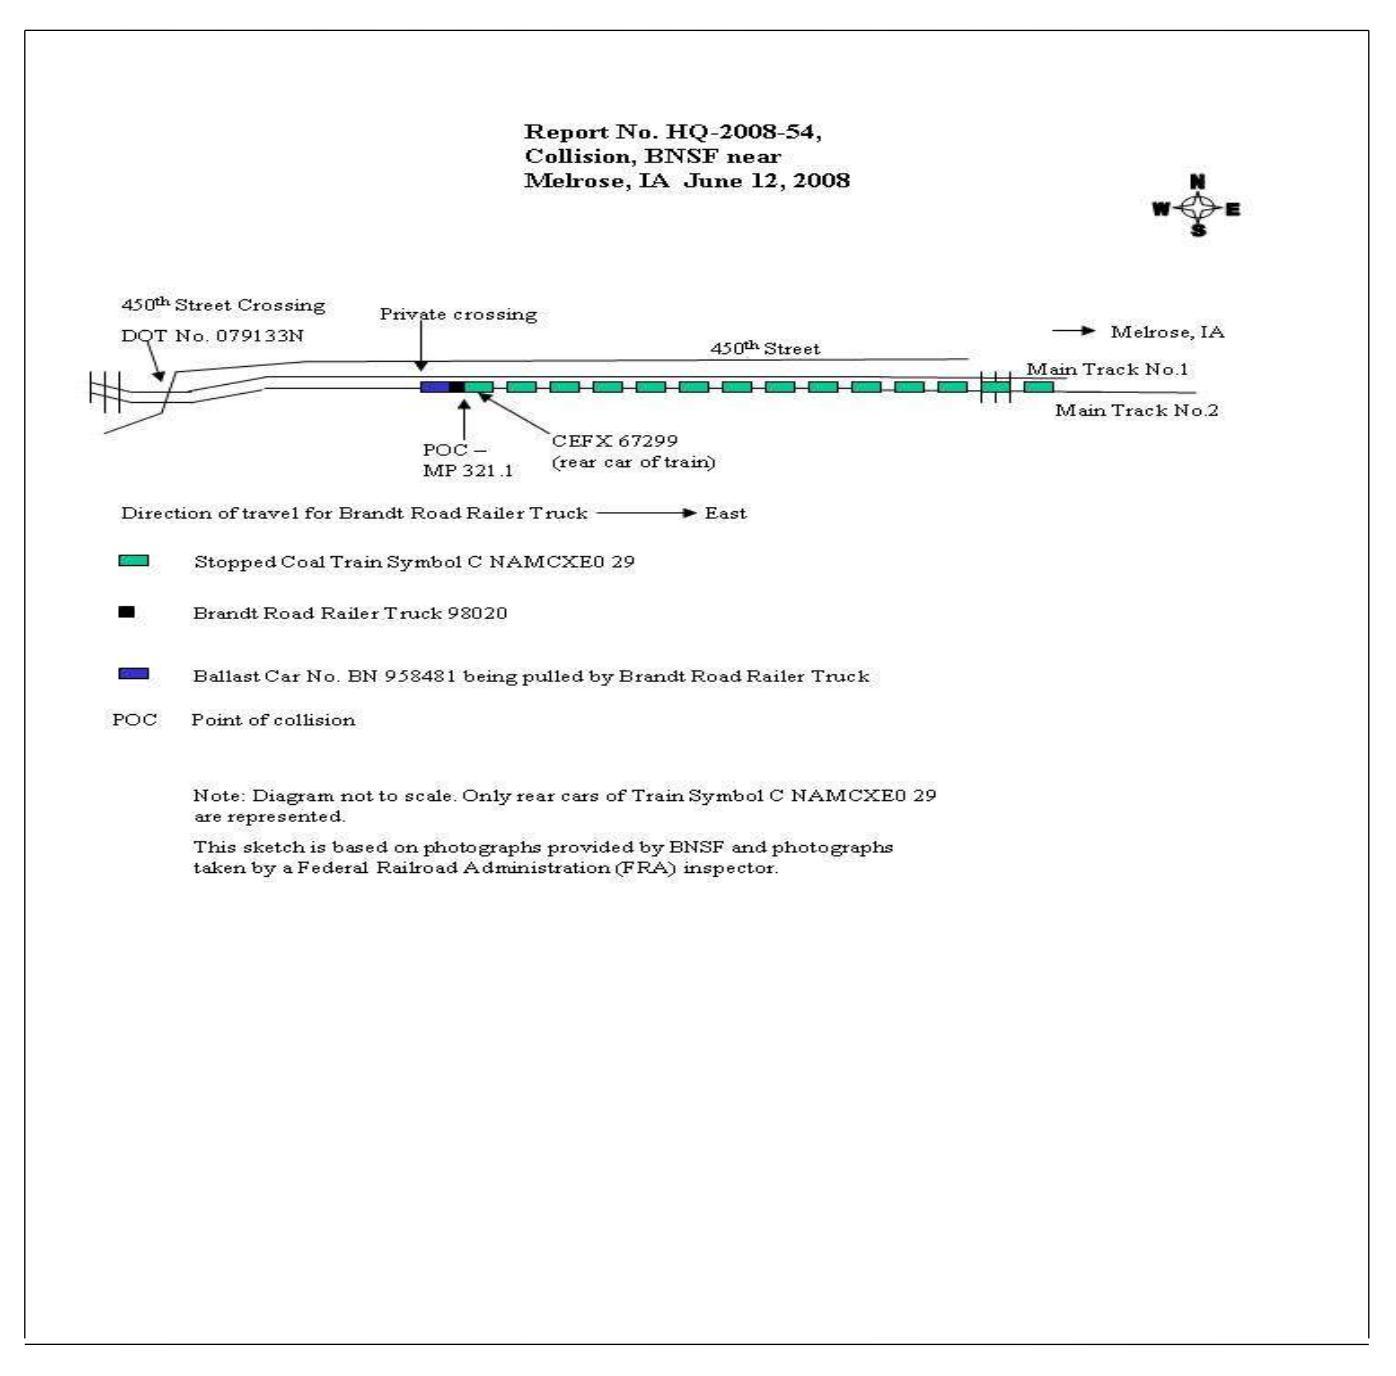
136. DRAW A SKETCH OF ACCIDENT AREA INCLUDING ALL TRACKS, SIGNALS, SWITCHES, STRUCTURES, OBJECTS, ETC., INVOLVED.

On Thursday, June 12, 2008, at 4:10 p.m., CST, an eastbound Burlington Northern Santa Fe Railway Company (BNSF) Brandt Roadrailer, Unit No. 98020, pulling one loaded car of ballast, hopper Car No. BN 958481, collided into the rear car of stopped eastbound BNSF loaded coal Train C NAMCXE0-29. The collision occurred 2.5 miles west of the town of Melrose, Iowa, at BNSF Milepost (MP) 321.1, on Main Track No. 2 of the Nebraska Division, Ottumwa Subdivision, in Monroe County. The crew of BNSF Train C NAMCXE0-29 reported an undesired emergency brake application while they were sitting still with the headend of the train located at MP 320. Inspection of the train revealed that the Brandt Roadrailer had collided with the rear car of the train. Both crewmembers of the Brandt Roadrailer were injured. No hazardous materials were involved.

The cause of the collision was determined to be cause code H607, failure to comply with restricted speed or its equivalent not in connection with a block or interlocking signal.
