Federal Railroad Administration Office of Safety Headquarters Assigned Accident Investigation Report HQ-2006-14

CSX Transportation (CSX) Laurens, South Carolina March 17, 2006

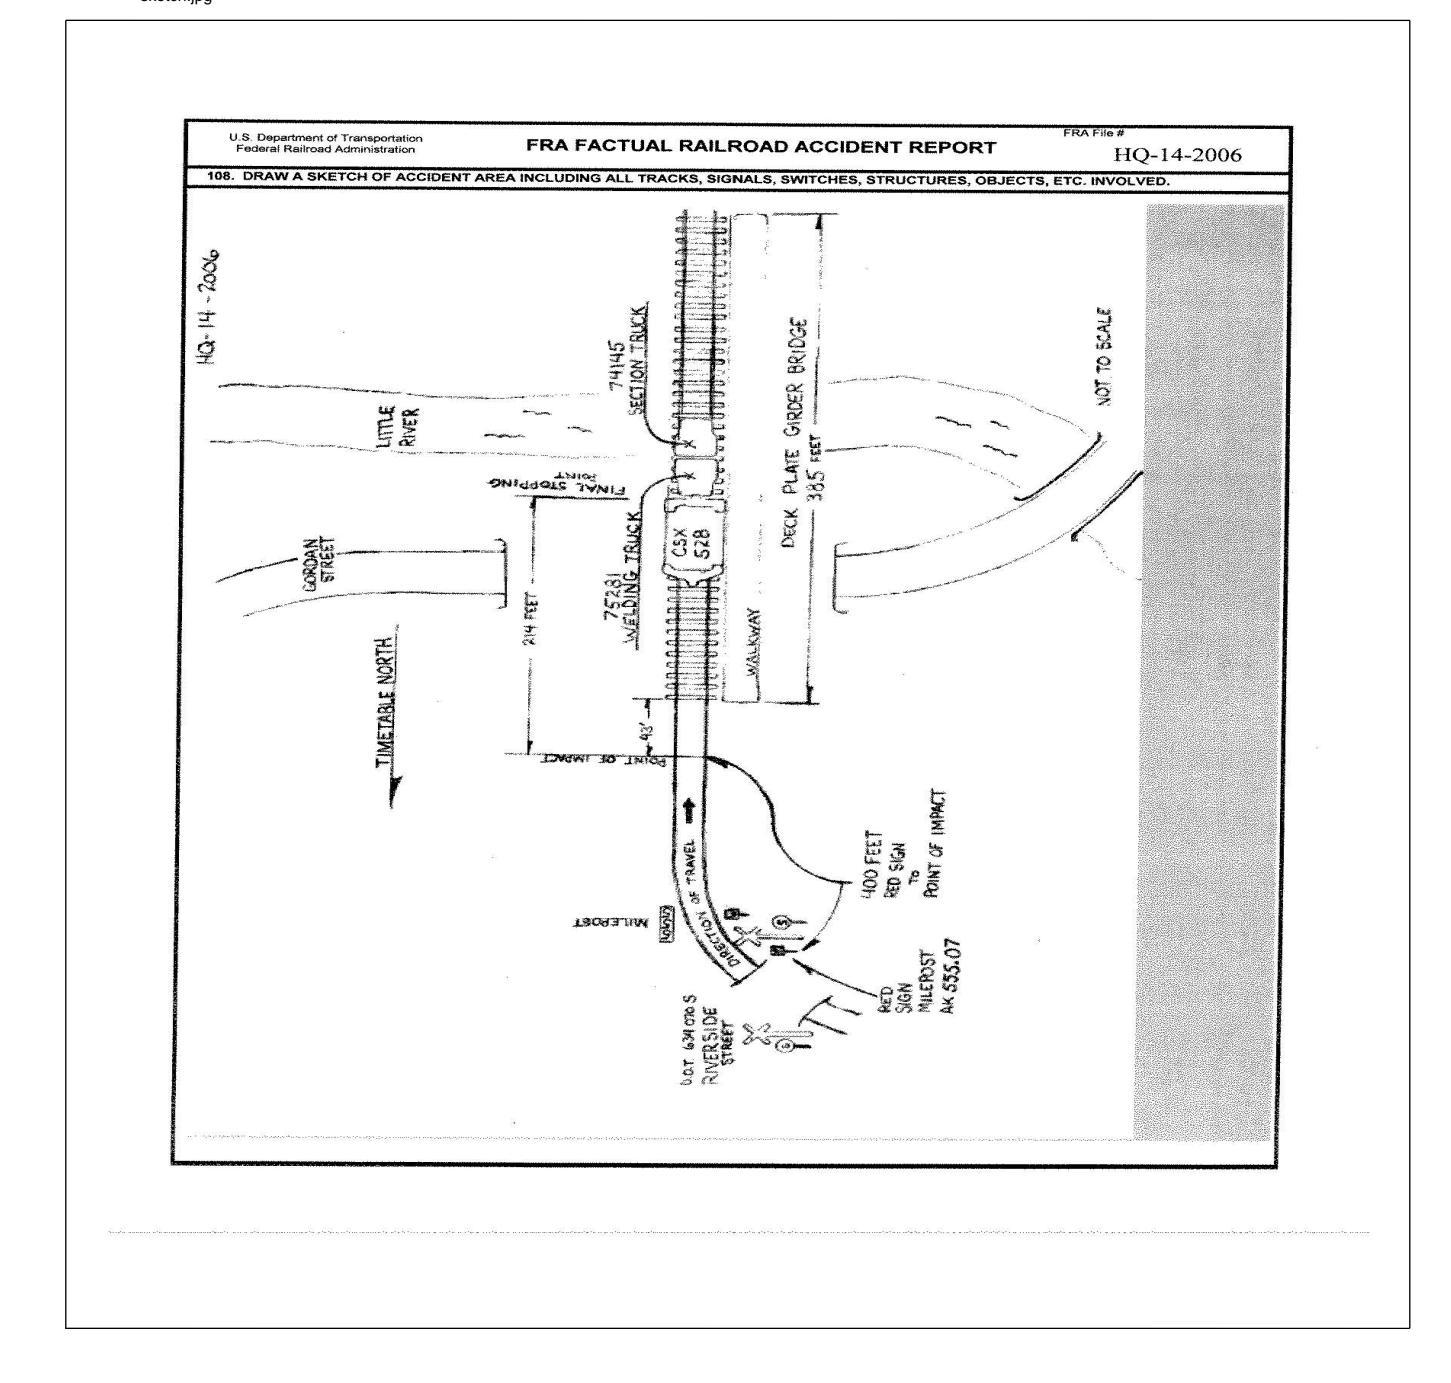
108. DRAW A SKETCH OF ACCIDENT AREA INCLUDING ALL TRACKS, SIGNALS, SWITCHES, STRUCTURES, OBJECTS, ETC., INVOLVED. HQ-14-2006 sketch.jpg

Approaching the accident site from MP AK555.4 there is tangent track for 1,000 ft., leading into a 6-degree, 22minute left hand curve. This is followed by 240 ft. of tangent track at the north end of a thru girder deck plate bridge and continues over the bridge. The grade between MP AK555.4 and AK554.9 is a 1.65-percent descending grade. The Irby Block Sign is located at MP AK555.2 on the east side of the track, 105 ft. south of the Flemming Street public road crossing. The sight distance around the curve is obscured by large trees and vegetation growing on both sides of the track; however train crew members acknowledged that excess vegetation was not an issue and did not obscure their vision in observing the advance 707 warning signs placed by the MofW employees. A second public road crossing, Riverside Street, crosses the track at MP AK555.07 and is in the curve.

CSX Train F224-17 was being operated at 26 miles per hour (mph) approaching the accident site; maximum authorized speed for light locomotives is 30 mph. The engineer said he was standing up to operate the radio, using channel # 58 as he attempted to call the dispatcher requesting authority to enter the Irby Block. He sounded the locomotive whistle for the Flemming Street crossing at MP AK555.25, and proceeded southward over the crossing into the Irby Block. The conductor and engineer stated that they did not see the Irby Block Sign as a result of operating the train locomotive with the long nose forward thereby lessoning the window of view as the train operated in the curve. As the train crossed Riverside Street, MP AK555.07, the engineer turned to sit down and observed two MofW vehicles on the track ahead of him. He then placed the locomotive into an emergency train air brake application. The train passed the red conditional stop sign placed on the west side of the track at MP AK555.07 and impacted the welding truck at MP AK554.9. As a result of the impact, the train pushed the welding truck 182 ft. which in turn impacted the section truck, pushing both vehicles an additional 32 ft. south before stopping on the bridge.
