Federal Railroad Administration Office of Safety Headquarters Assigned Accident Investigation Report HQ-2006-56

Burlington Northern Santa Fe Houston, TX June 27, 2006

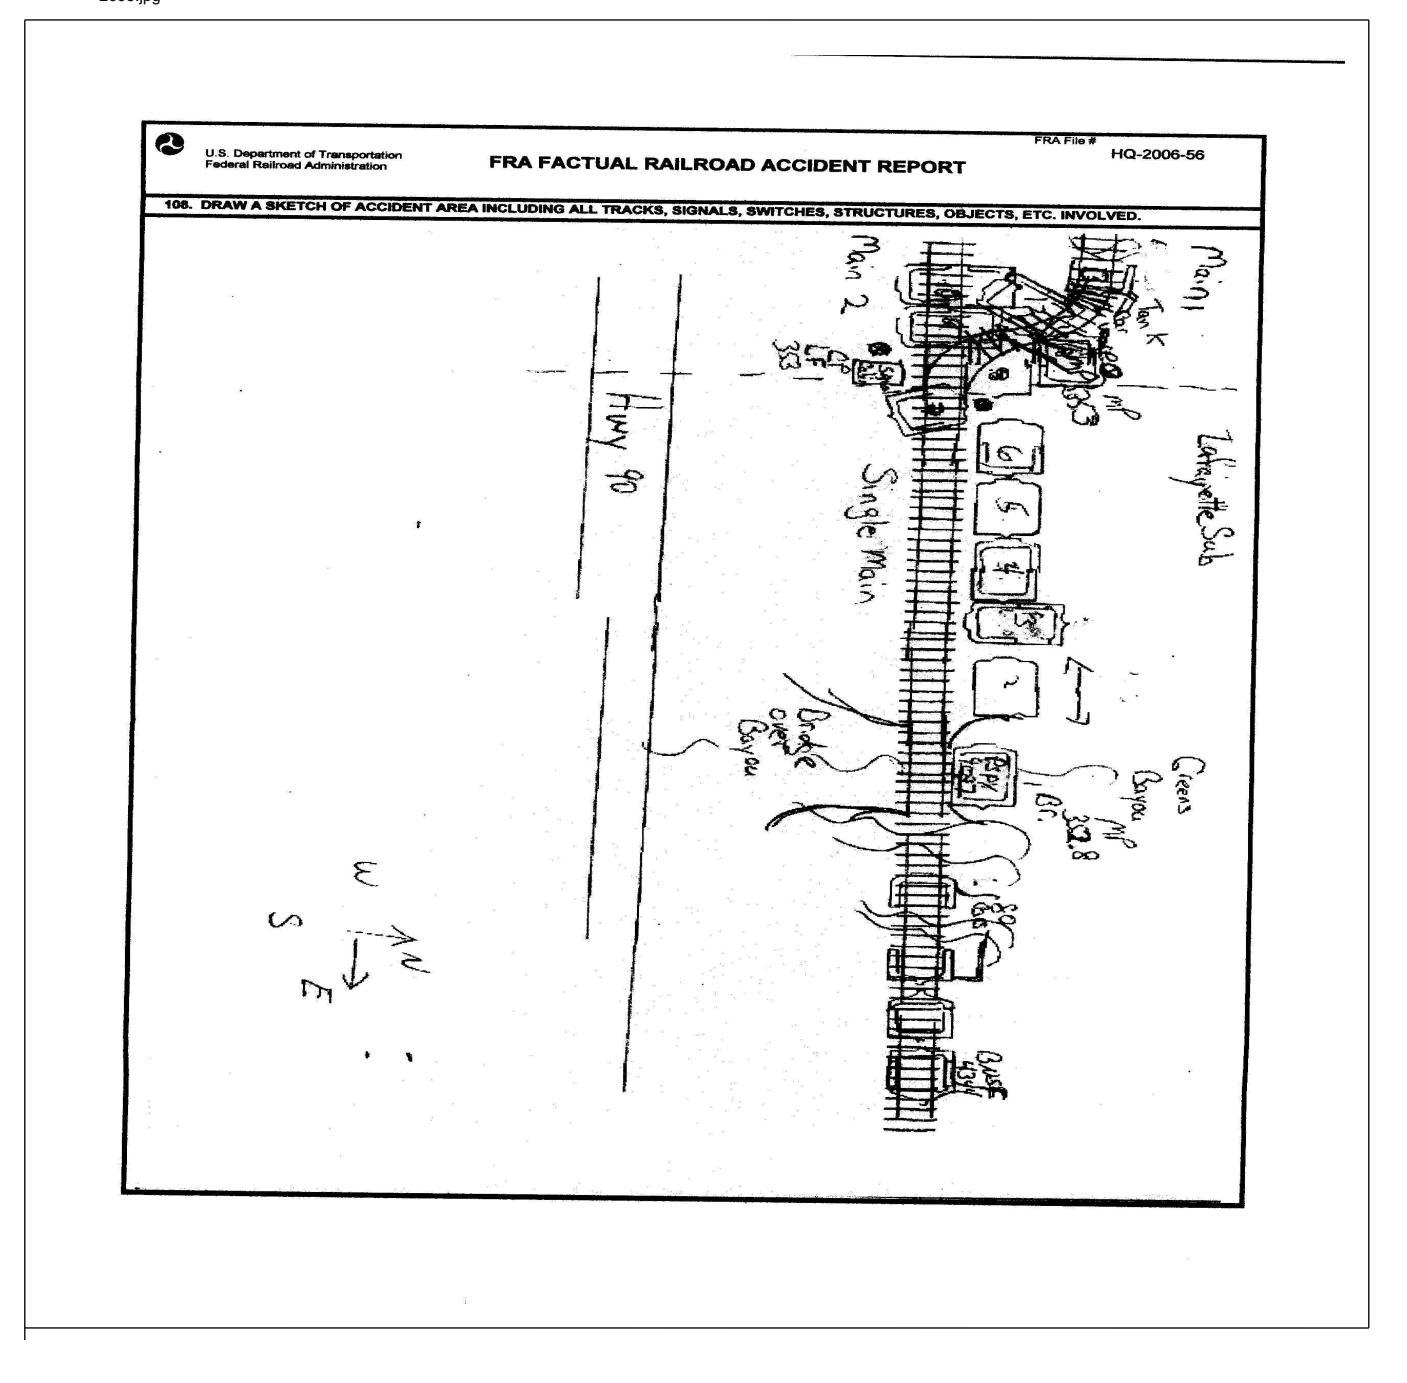
108. DRAW A SKETCH OF ACCIDENT AREA INCLUDING ALL TRACKS, SIGNALS, SWITCHES, STRUCTURES, OBJECTS, ETC., INVOLVED. HQ-56-2006.jpg

The eleven (11) cars following the PSPX 6508 crashed into the derailed car and came to rest as indicated in the drawing in this report. The rest of the train, 35 cars, came to a rest without derailing on Main 1 on the Terminal Subdivision.
