**Federal Railroad
Administration**

Trespasser Detection Systems on Railroad Rights-of-Way

1. REPORT DATE (DD-MM-YYYY) 27-01-2020		2. REPORT TYPE Technical Report		3. DATES COVERED (From - To) September 2016 – January 2020	
4. TITLE AND SUBTITLE Trespasser Detection Systems on Railroad Rights-of-Way				5a. CONTRACT NUMBER	
				5b. GRANT NUMBER	
				5c. PROGRAM ELEMENT NUMBER

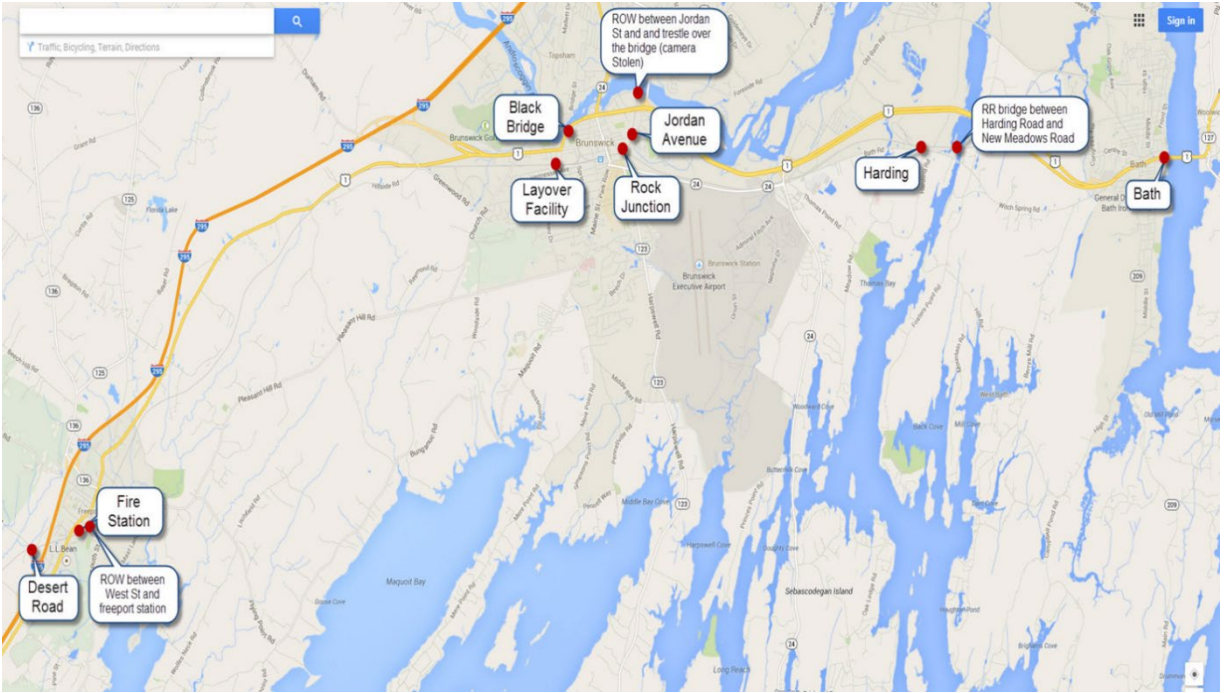
Figure 1 – Temporary Camera Locations

Volpe began this project in 2013 by discussing the problem of railroad trespassing with representatives from Pan Am Railways, Amtrak, MDOT, and Brunswick and Freeport police to target places believed to have a trespassing issue. Volpe then set up temporary video cameras for several weeks to verify that trespassing activity was actually occurring. [Figure 1](#) shows the locations of the temporary cameras installed by the Volpe research team.

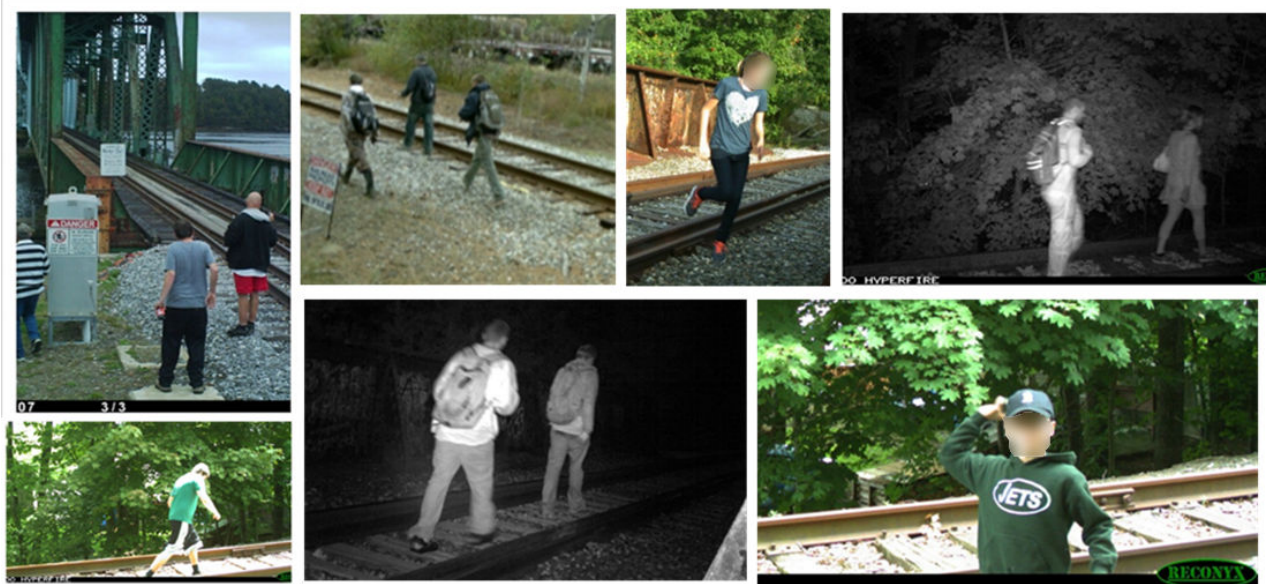
Figure 2 – Examples of Trespassing Captured by Temporary Cameras

Some locations proved to have little or no trespassing activity, while others had frequent activity. [Figure 2](#) shows examples of some of the activity captured by the temporary cameras.

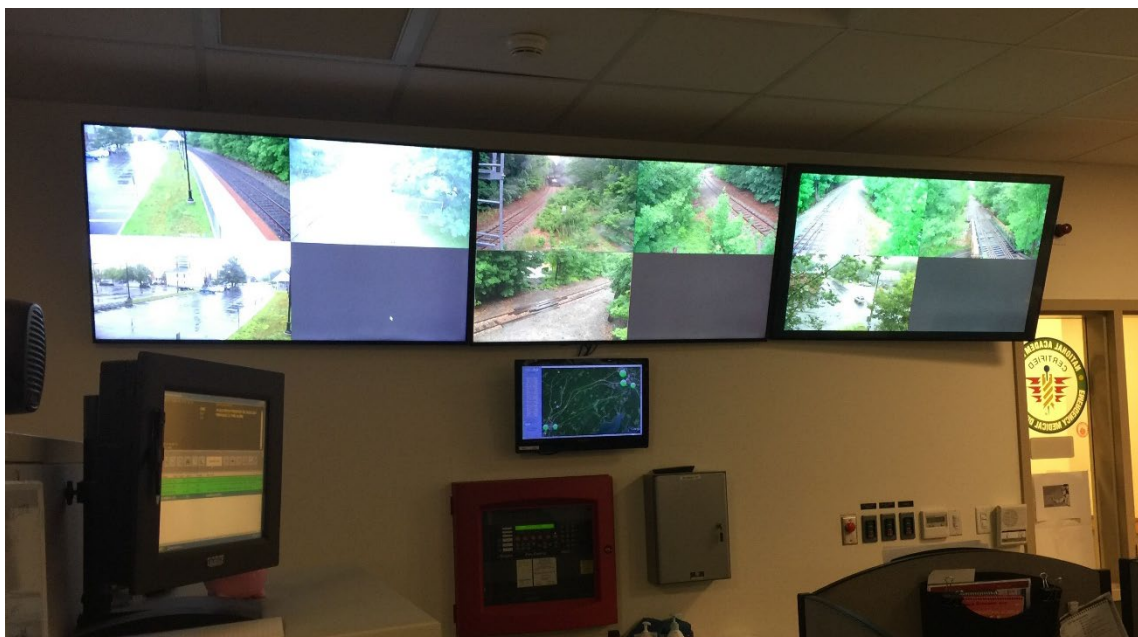
Figure 3 – Trespass Detection Monitors in the BPD Dispatch Center

The system as delivered by the contractor provided BPD with multiple video feeds from each camera site. It was based on an AXIS Camera Station enterprise video surveillance platform. Large screen monitors were set up in the BPD dispatch center, as shown in [Figure 3](#), as was a workstation from which dispatchers could control or move cameras and respond to alarms. The video was recorded on an AXIS rack mount hard drive array, with the server hosted on a Dell rack mount server, both of which were located in the BPD radio room.

Live streaming video was transmitted from the Jordan Avenue and Rock Junction sites via wireless broadband service provided by Verizon Wireless. Video from Freeport was transmitted via a Comcast broadband connection provided by the Town of Freeport. The contractor provided video motion detection as a sensor, with the ability to add external sensors later if needed. Automated vehicle location (AVL) software for patrol vehicles, shown in the screen at the bottom center of [Figure 3](#), was also purchased under this program.

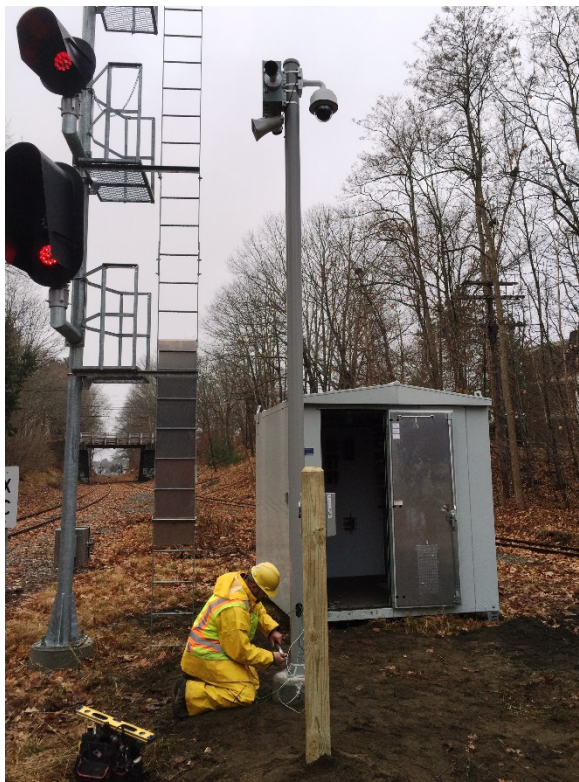
Figure 4 – Rock Junction Camera Pole

Each camera site had two fixed cameras (AXIS Q1765) and one pan-tilt-zoom camera (AXIS Q6045) on a 12-foot pole. Also, each pole had an AXIS P8221 audio control unit, along with a speaker and microphone that allowed dispatchers to speak and listen to trespassers. At Rock Junction, power was provided from the Pan Am bungalow. At Jordan Avenue, the town had power inside an adjacent flashing school zone sign that was turned off when the school was permanently closed. At Freeport, power was run from the station to the pole through existing conduit. Power and communications equipment was contained in a small enclosure near the top of each pole. The Freeport equipment was located on a light pole on the station platform. Since the internet connection was located at the nearby Chamber of Commerce building and could not be physically connected, an FM-PONTE-50 wireless bridge provided a connection to the cameras and audio devices. Each of the camera sites are shown in [Figure 4](#), [Figure 5](#), and [Figure 6](#) below.

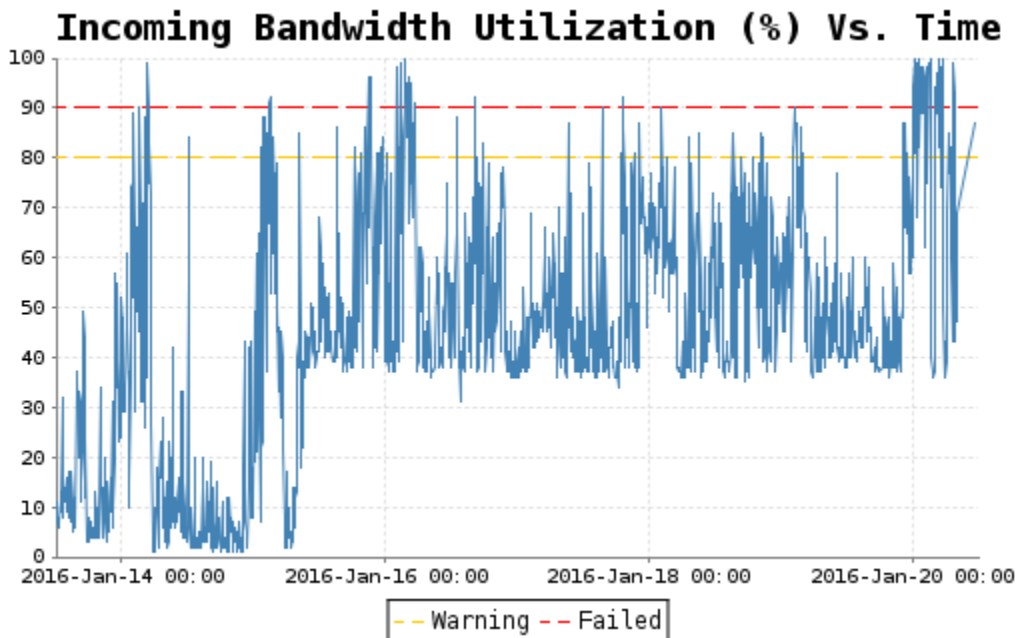
Figure 7 – BPD Network Activity Before and After System Commission

Figure 7 below shows the network utilization at BPD before and after the commissioning of the trespasser detection system on January 15, 2016. Incoming network traffic, which often runs near zero percent of capacity, suddenly never went below 35 percent, and was often above 90 percent, at which point commonly-used web services often fail to load.

At the same time, the Town of Brunswick saw the internet service at the police headquarters become heavily impacted. It turned out the town was only contracting for 10 Mbps internet service, and the new cameras were demanding nearly half of this on a constant basis.

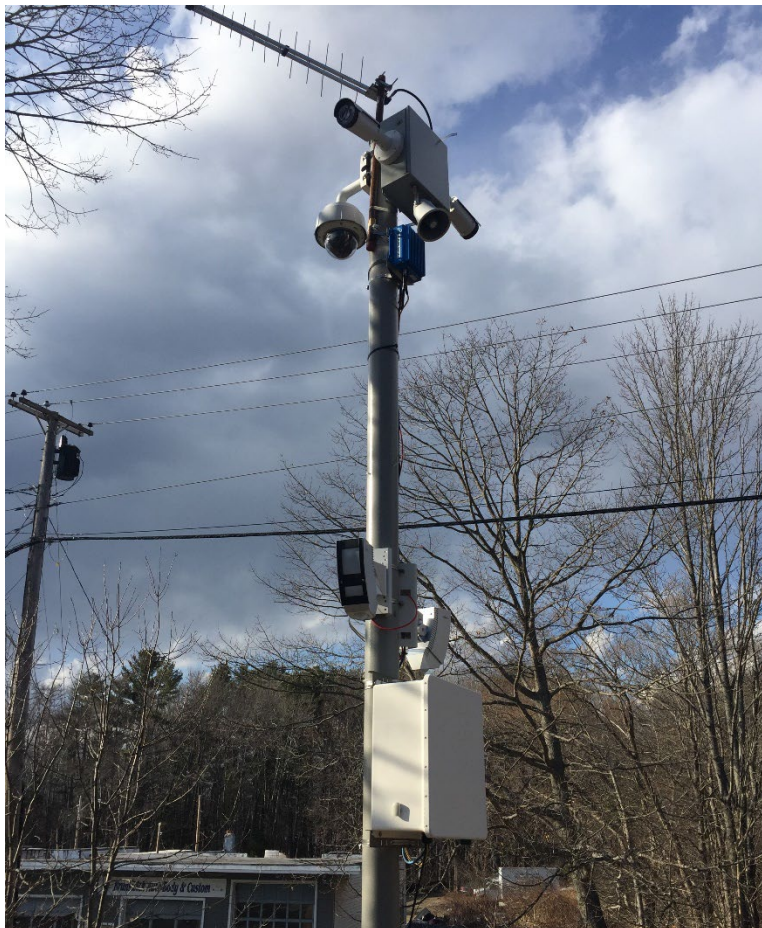
Figure 10 – Jordan Avenue Pole with Optex Sensors

At Jordan Avenue, Volpe deployed two sensors from Optex: the SIP-100 and the SIP-5030. These outdoor passive infrared sensors were essentially the same, combining a close-range sensor with a mid-range sensor. The SIP-100 also included a third, long-range sensor that could

detect objects up to 100 feet away. The long range sensor’s field of view was also only 10 feet wide. [Figure 10](#) shows the Jordan Avenue equipment pole with the Optex sensors installed.

In spite of repeated tuning and adjusting, these sensors also produced false alarms at a rate similar to the VMD sensors (at least several times per hour). Volpe then considered using a sensor similar to that used in the Pittsford project, which was shown to produce fewer false alarms. In the end, BPD expressed a disdain for any false alarms in their dispatch center, and expected they would continue to mute the alert for all sensors, so Volpe did not continue further sensor testing.
