U.S. Department
of Transportation
Federal Railroad
Administration

LED-Enhanced Sign Research to Reduce Vehicle Queuing at Highway-Rail Grade Crossings

1. REPORT DATE (DD-MM-YYYY) 31/08/2020		2. REPORT TYPE Technical Report		3. DATES COVERED (From - To) July 2016 – August 2020	
4. TITLE AND SUBTITLE LED-Enhanced Sign Research to Reduce Vehicle Queuing at Highway-Rail Grade Crossings				5a. CONTRACT NUMBER	
				5b. GRANT NUMBER	
				5c. PROGRAM ELEMENT NUMBER

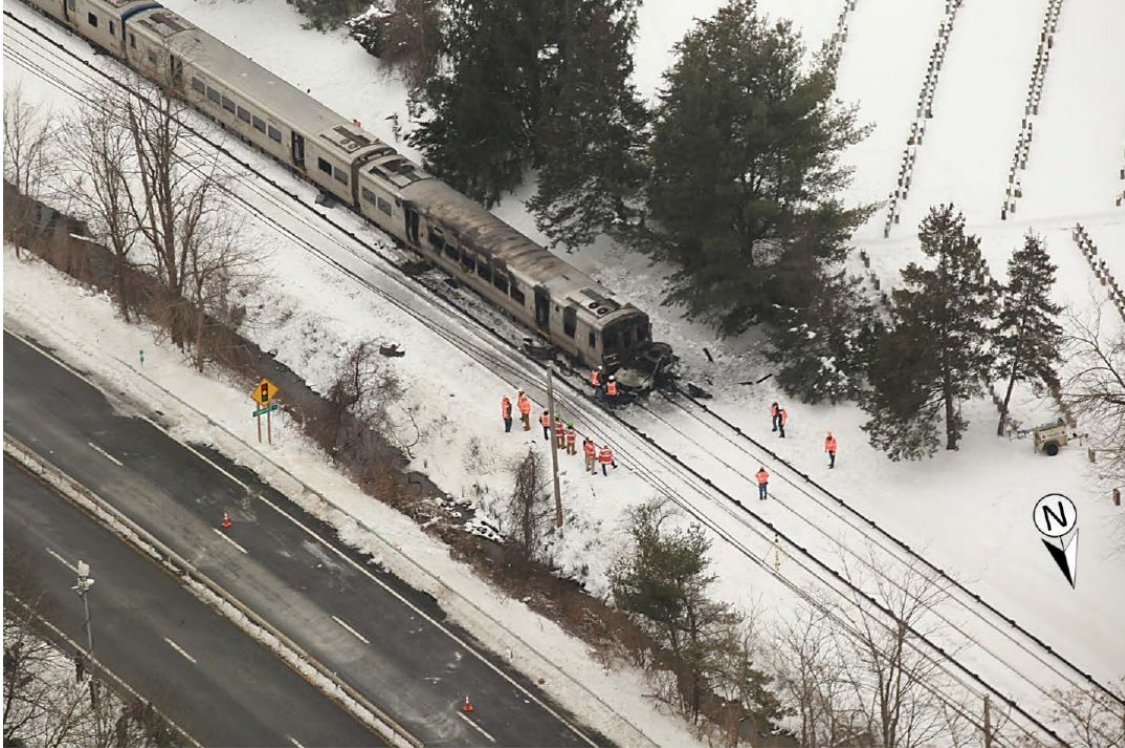
Figure 1. Aftermath of collision between Metro-North Railroad commuter train and sport-utility vehicle in Valhalla, NY, on February 3, 2015

In the early evening of February 3, 2015, a Metro-North Railroad (MNR) commuter train traveling northbound on the Harlem Subdivision (Line), collided with a 2011 Mercedes Benz ML 350 sport-utility vehicle (SUV) that was stopped on the highway-railroad grade crossing (grade crossing) located at Commerce Street in the Village of Valhalla, New York (crossing 529-902V). As a result of the collision, the SUV was pushed 665 feet north on the tracks (see [Figure 1](#)). The electrified third rail on the west side of the track was damaged and became detached from its mounting assembly. The third rail pierced the sport-utility vehicle, and an estimated 343 feet of rail penetrated the first passenger railcar (National Transportation Safety Board, 2017).

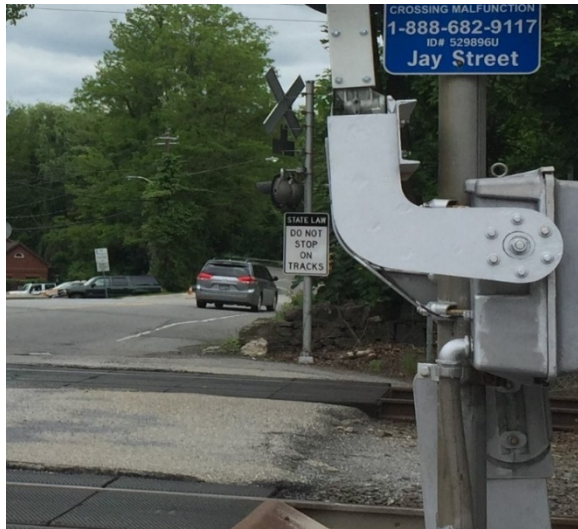
Figure 3. Existing standard NYR9-5 sign at Jay Street.

New York State law requires employment of a modified version of the R8-8, known as the NYR9-5 sign. The primary difference between the two versions is that the New York version includes text that explicitly informs motorists that it is a State law not to stop on railroad tracks. An image of the standard NYR9-5 version installed at Jay Street is found in [Figure 3](#) and a rendering of an LED-enhanced NYR9-5 is shown in [Figure 4](#).

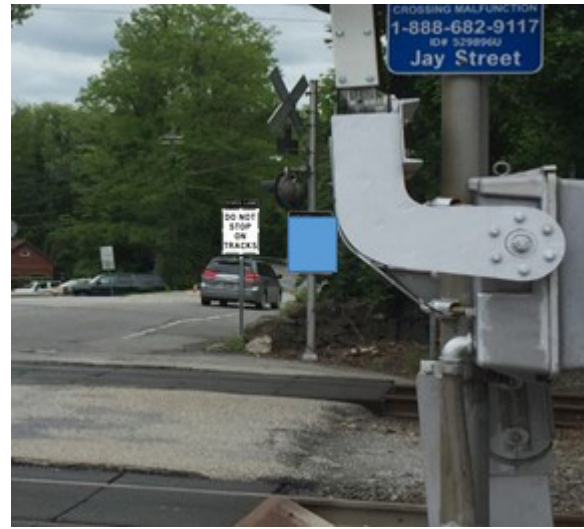
Figure 4. Rendering of an LED-enhanced version of NYR9-5 sign

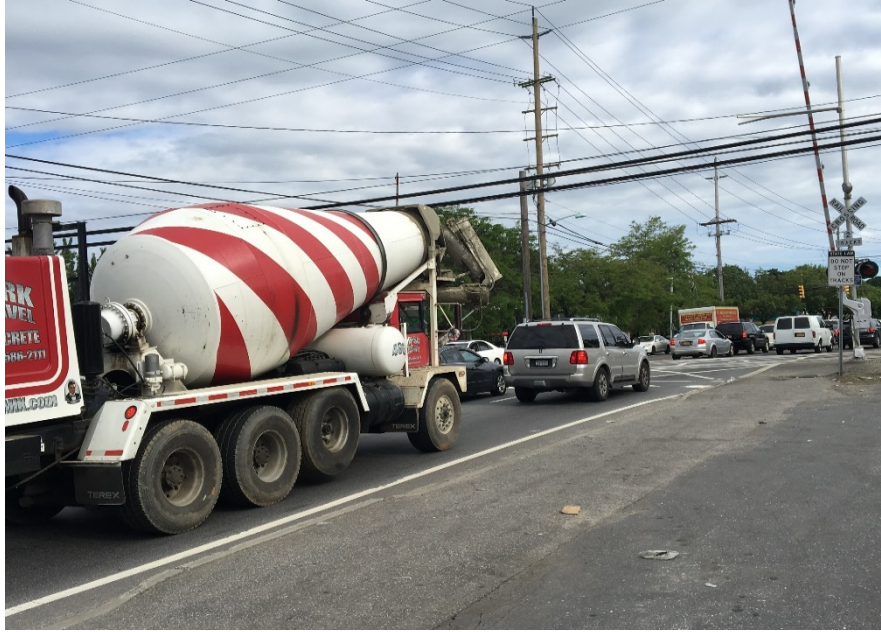
Figure 6. Southbound approach to Wicks Road grade crossing

First, Wicks Road is a multi-lane highway-rail grade crossing (see Figure 6) with significant average annual daily traffic (AADT) and commuter rail traffic. According to the latest FRA grade crossing inventory report, the crossing experiences an AADT of over 37,000 vehicles in both directions and roughly 75 daily inbound and outbound train movements on two tracks.² Second, the FRA accident history report included an accident in January 2011 in which a vehicle stopped on the grade crossing, became trapped when the gates descended, and was subsequently hit by an oncoming train.³

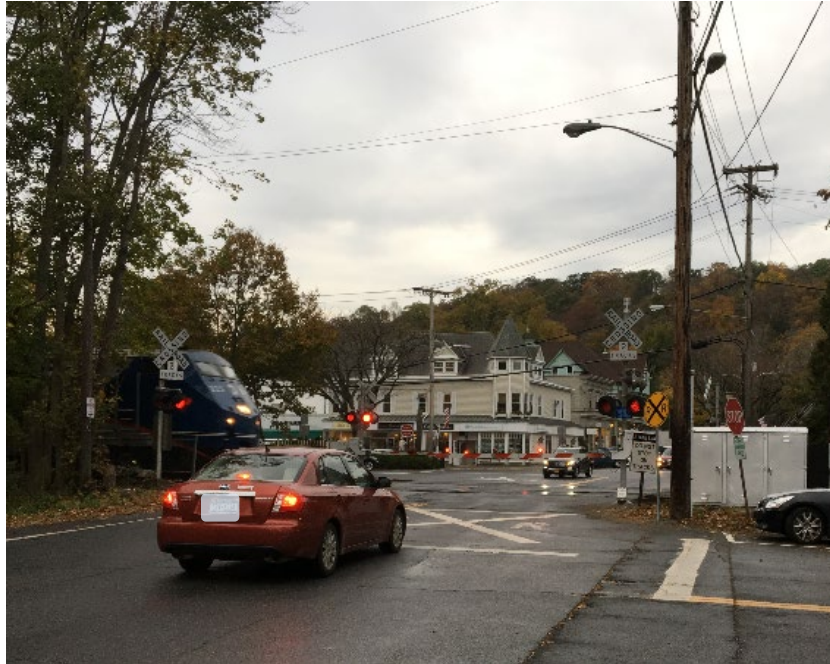
Figure 8. Approach to Jay Street grade crossing from the east

intersection of Jay Street with Katonah Avenue in the westbound traffic direction. The eastern edge line of the intersection and the farthest western rail of the intersection are separated by approximately 75 feet. This is equivalent to a storage area for nearly four passenger vehicles, using the AASHTO length of 19 feet for a typical passenger car.

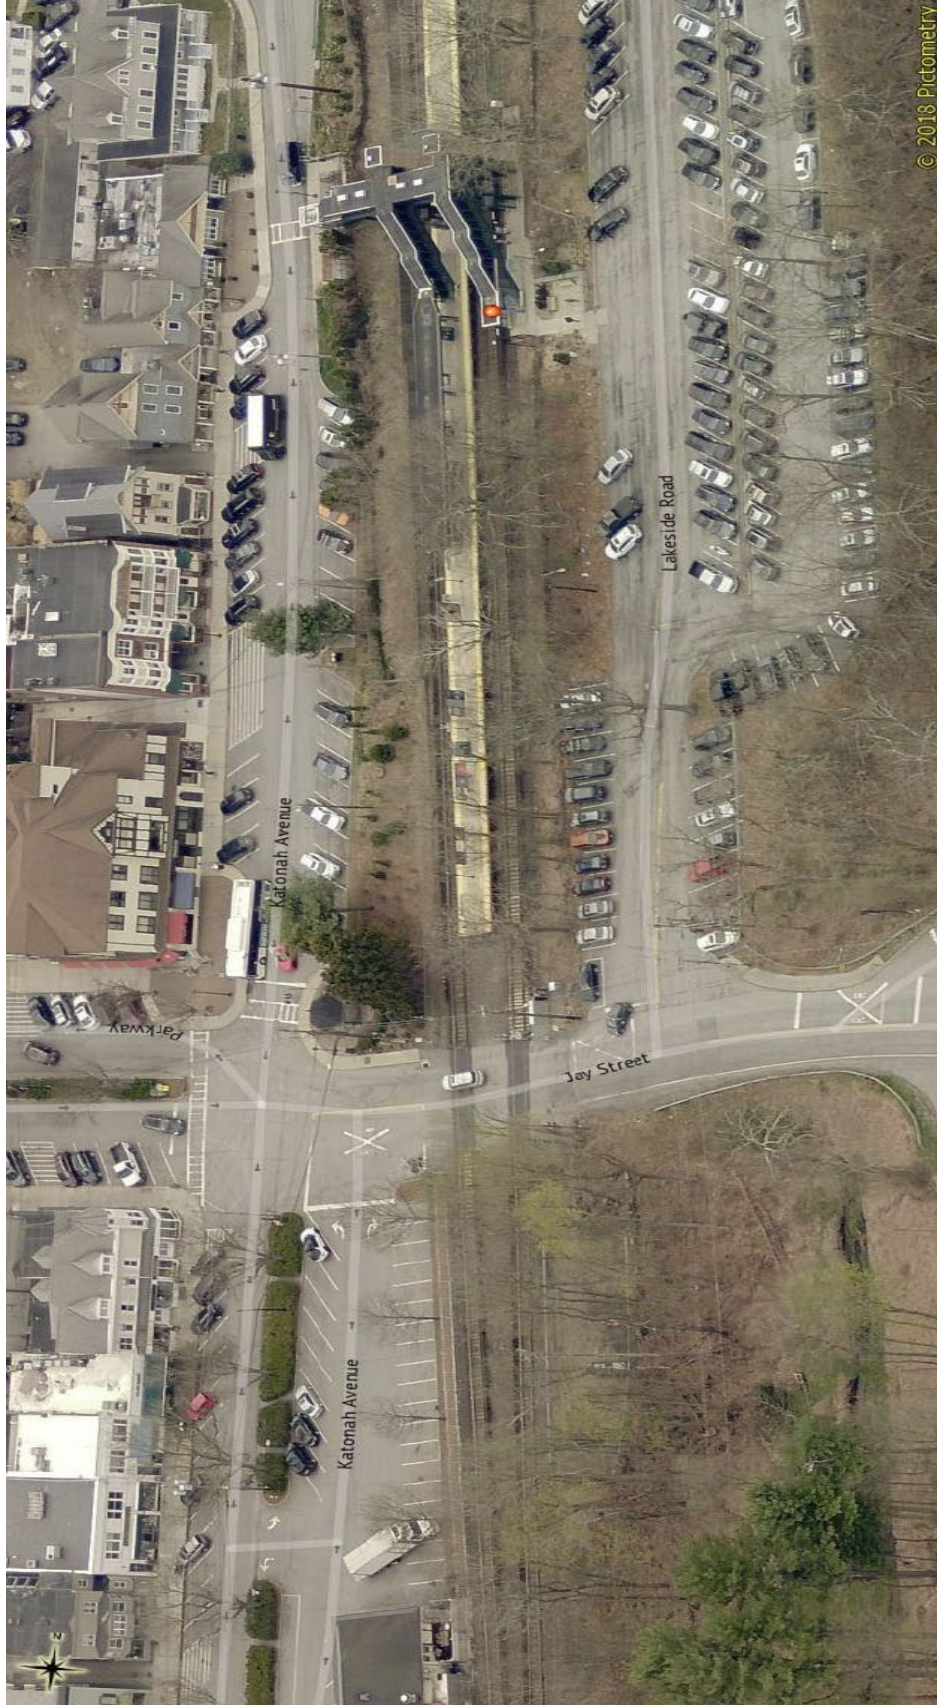
**Figure 9. Jay Street grade crossing from east (bottom) to west (top)
(Note: Lot 1 is located at the bottom of the picture.)**

There are two commuter rail parking lots within a 5-minute walk of the train station. Lot 1, shown in the bottom right quadrant of [Figure 9](#), is located at 2 Jay Street directly adjacent to the train station and has a maximum capacity of 280 vehicles. Lot 2, located at 190 Katonah Avenue,

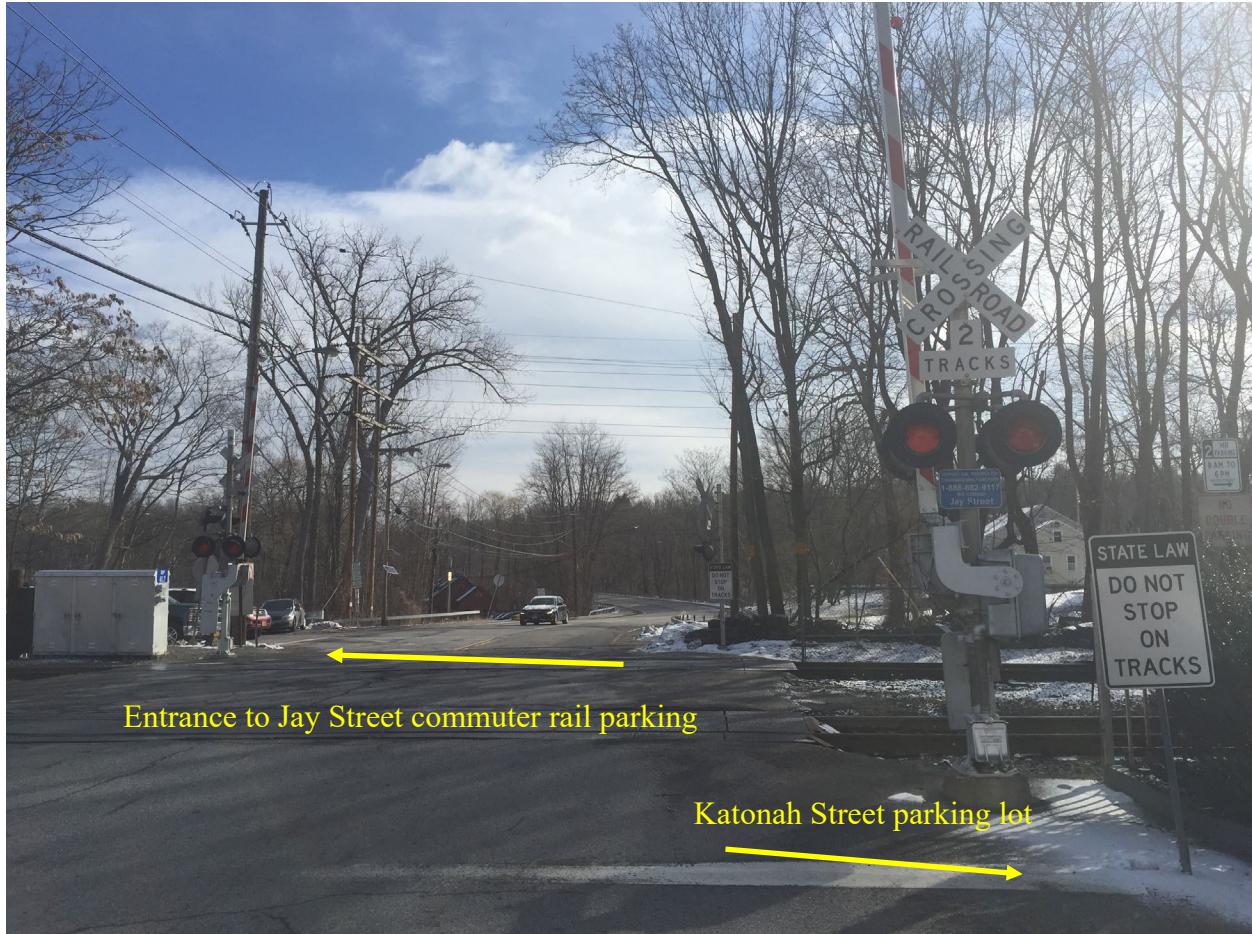
Figure 11. Eastbound approach to the Jay Street grade crossing

There is also one lane of traffic in the eastbound direction, as shown in [Figure 11](#). On the eastbound approach to the grade crossing, a stop sign is at the intersection of Jay Street and Katonah Avenue.

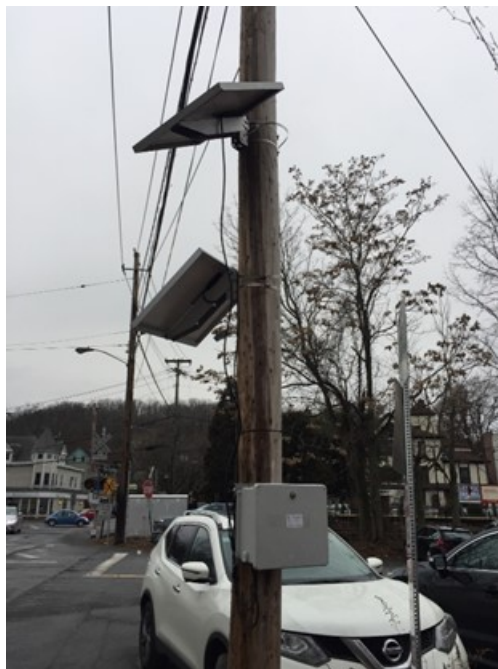
Figure 12. Baseline Volpe camera system at Jay Street

Two versions of the data acquisition system were employed during the baseline and post-installation phases. For each version, the video camera was installed on the same utility pole approximately 60 feet east of the of the westbound approach stop bar at the corner of Jay Street and Lakeside Road, as shown in [Figure 12](#). The baseline version was installed on November 1, 2017 by Volpe. Video data was collected using a 0.5 megapixel analog camera (BPRO-316VF) equipped with a 3.5–16 mm varifocal lens and recorded on a 500-gigabyte digital video recorder (DVR) (Lawmate PV-1000) set to 5 frames per second (fps). This provided for a minimum of 2 months continuous recording storage capacity.

The system was powered by two 12-volt, 12-amp-hour, sealed, lead acid batteries (Yuasa NP12-12) connected to a single solar 55-watt panel (Solartech SPM055P-N) /10-amp, 12-volt solar charge controller charging system (Morningstar SS-10-12V SunSaver). The solar panel was aimed south to optimize charging availability. After multiple failures of the battery charging system, a second solar panel was added. The panels were directed southeast and southwest, respectively, to maximize charging capability. [Figure 13](#) is a screenshot from the video collection system looking westbound toward the center of Katonah.

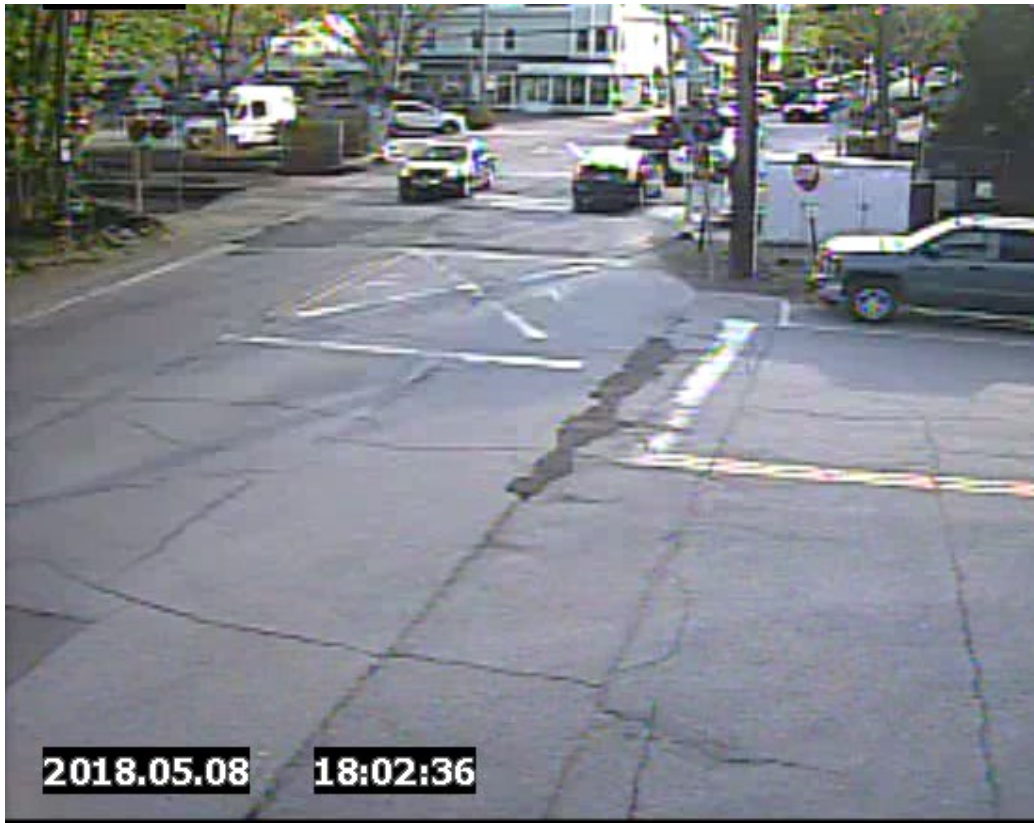
Figure 13. Westbound view from baseline Volpe camera system at Jay Street

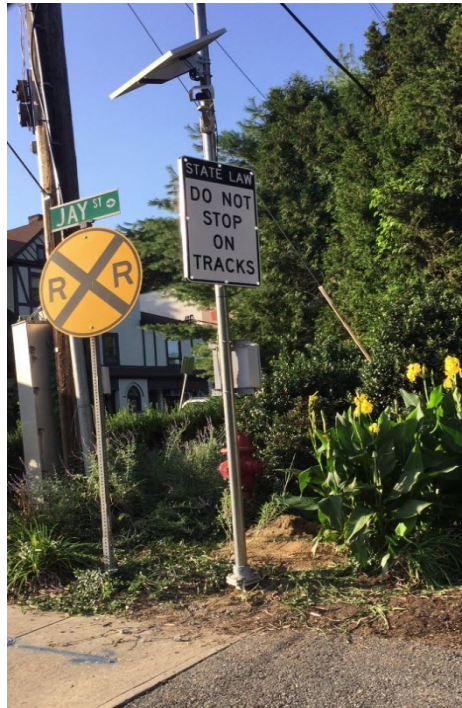
Figure 16. Laser-triggered, LED-enhanced, NYR9-5 sign

The LED-enhanced version of this sign, shown in [Figure 16](#), was purchased from Campbell Technology Corporation (CTC), a reseller of Traffic and Parking Control Co. signs. The sign is 24 inches by 30 inches in area with eight 1-watt LED lights along the perimeter that are powered by a 13-watt, 6-volt solar panel, nickel-metal hydride battery combination. The lights are programmed to flash 50 times per minute. The sign can only be disabled by disconnecting the power cable from the battery, which is enclosed inside a separate aluminum tube.

The LED-enhanced sign, which replaced the pre-existing NYR9-5 sign, was installed by the Volpe crew on the far side of the crossing in the westbound direction. The sign was mounted high enough to provide good visibility on both sides of the crossing. All other existing signs were left intact.

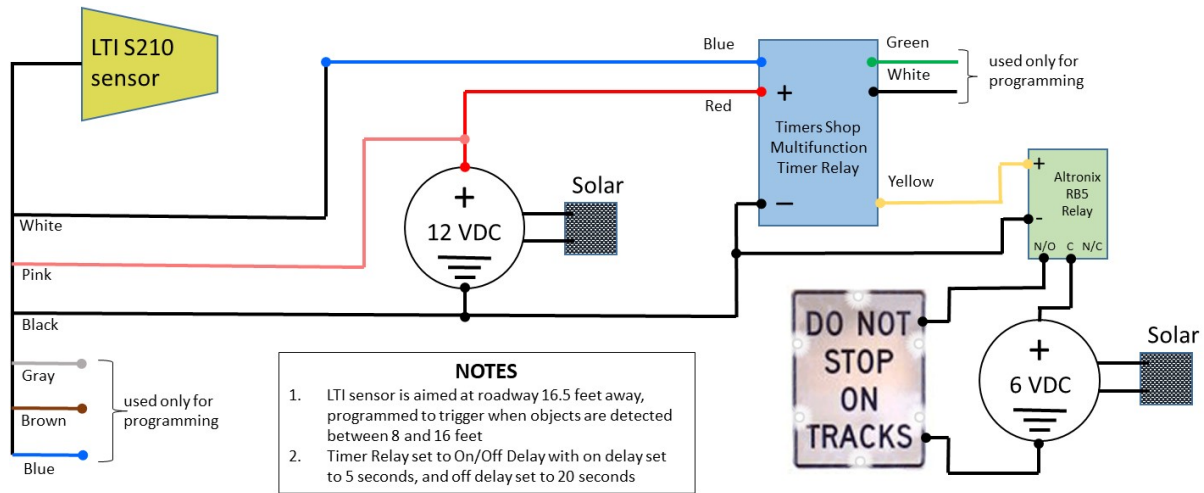
Figure 17. Circuit diagram for laser-triggered LED sign system

As seen from the schematic shown in [Figure 17](#), the laser-triggered LED-enhanced sign is composed of two subsystems: the laser sensor (Laser Technology Inc. TrueSense[®] S210), and the LED-enhanced NYR9-5 sign (CTC Inc. E*Sign). The laser is designated as a Class I emitter, the lowest hazard classification level defined by the Federal Laser Product Performance Standard published by the Food and Drug Administration's Center for Devices and Radiological Health. The S210 operates at a wavelength of 905 nanometers (nm), just outside the visible light spectrum, with a maximum transmit power of 0.39 microwatts. It transmits a continuous train of 200 pulses per second and is powered by the 12-volt solar panel and battery charging system.

The S210 is equipped with separate transmit and receive apertures and is configured to continuously monitor the power levels of the transmitted and reflected beams. The beam is aimed at a region of the road just beyond Zone 3, known as the "detection zone." Under normal operating conditions, no reflected energy would be detected at the receive aperture. When a reflective surface, such as an automobile, occupies the detection zone, the return energy will be detected at the receive aperture. The presence of the return energy activates the S210 5-volt trigger that is provided as input to the multifunction timer relay (Timers Shop multifunction relay). If the return beam is present for longer than 5 seconds, the multifunction timer outputs a 5-volt trigger to the relay (Altronix RB5) that is responsible for closing the LED sign circuit.

This sequence, shown in Figure 17, is governed by a multifunction timer relay configured for an on/off delay cycle. The timer requires a continuous trigger input for a minimum of duration of 5 seconds before its trigger output is activated. Once the timer relay is activated, it will provide an output to the RB5 relay for 20 seconds, causing the LED sign to flash for a concomitant amount of time. If, during this sequence, the S210 trigger output is again activated by a reflected signal for five continuous seconds, the cycle begins anew.

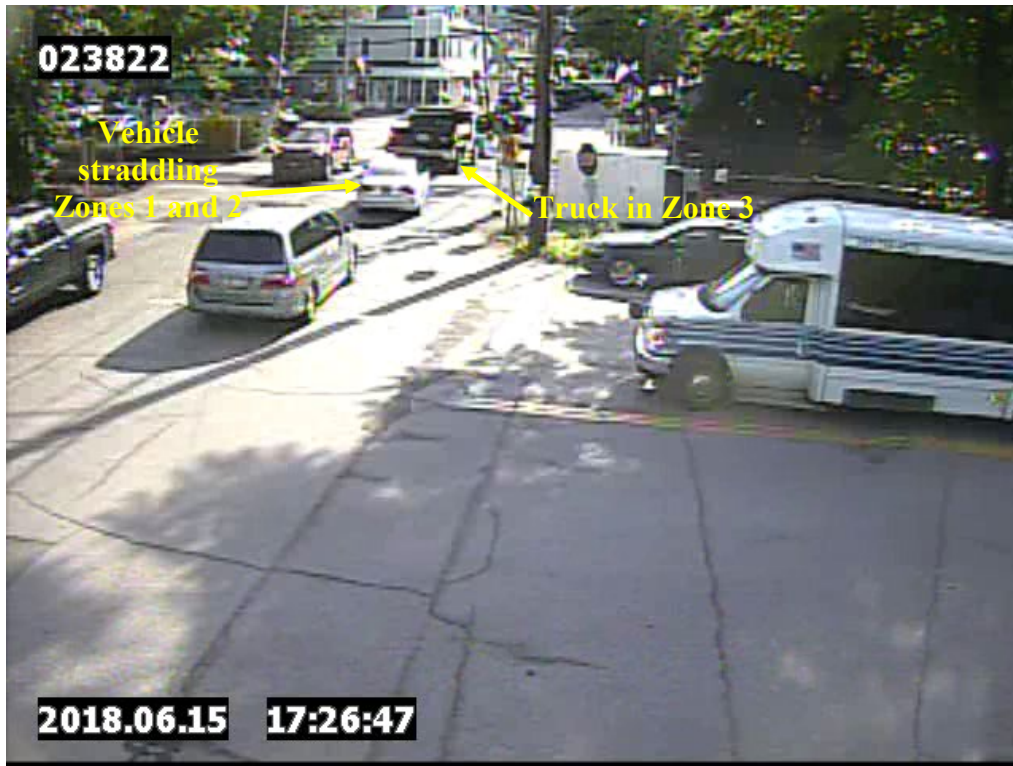
Figure 18. Vehicles queued on the Jay Street crossing during baseline data collection

A typical example of vehicle queueing is shown in [Figure 18](#), below. In the photograph, the minivan in the foreground is in the approach zone and safely outside any of the zones of interest. The white car in front of the minivan is straddling Zones 1 and 2, while the truck is stopped in Zone 3. There is also a car stopped beyond the truck in the “detection zone” that would trigger the LED-enhanced sign if it were installed.

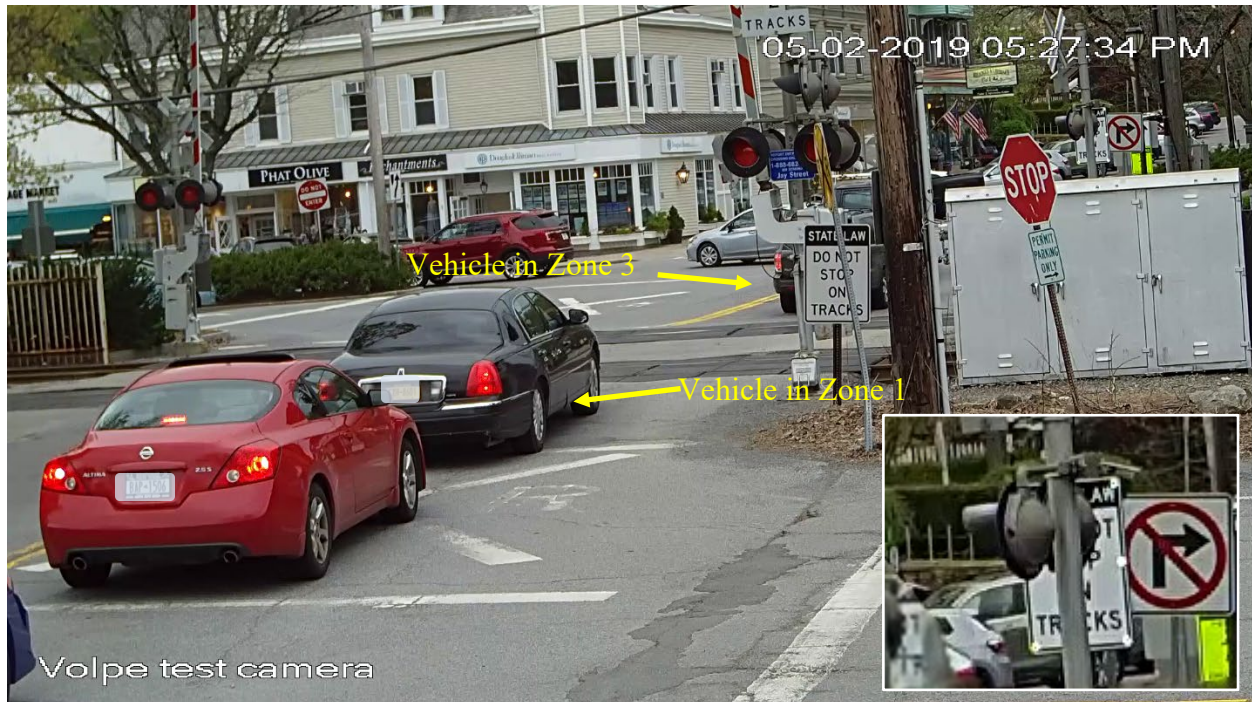
Figure 19. Vehicles queued on the westbound approach to Jay Street. Inset shows LED-enhanced NYR9-5 sign is activated.

The photograph in [Figure 19](#) is an example of the LED sign being triggered. In the photograph, a car just beyond the field of vision is stopped in the detection zone for a duration longer than 5 seconds. This has resulted in the activation of the LED-enhanced NYR9-5 as shown in the inset. In addition, there is a vehicle stopped in Zone 3 on the far side of the crossing and another vehicle stopped in Zone 1 prior to the grade crossing.
