Mechanical Properties of TC-128B Steel during Multiple Stages of Tank Car Fabrication

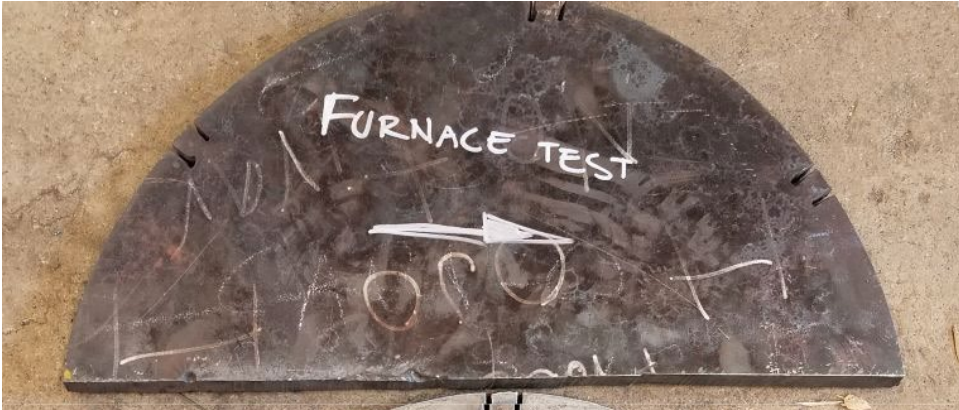
Figure 4. Samples of Material A1 in Four Conditions

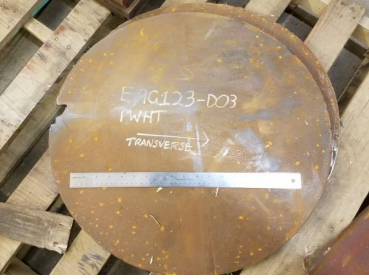
Figure 5. Samples of Material B1 in Four Conditions

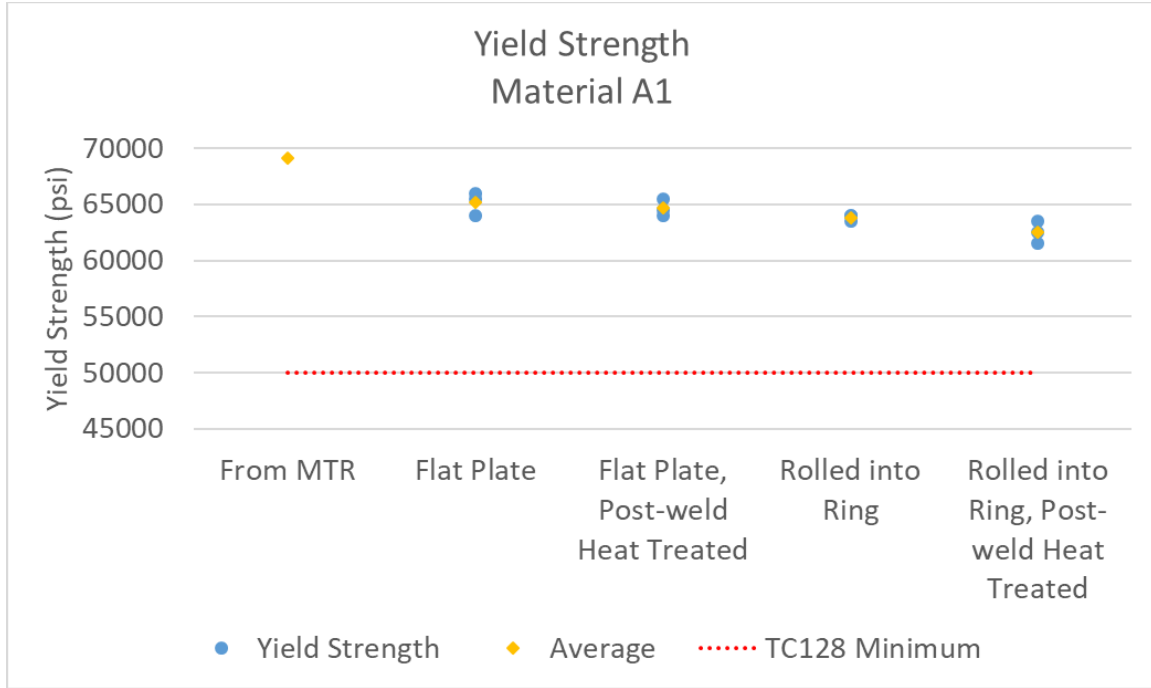
Figure 7. Material A1 – Yield Strength at Each Material Condition

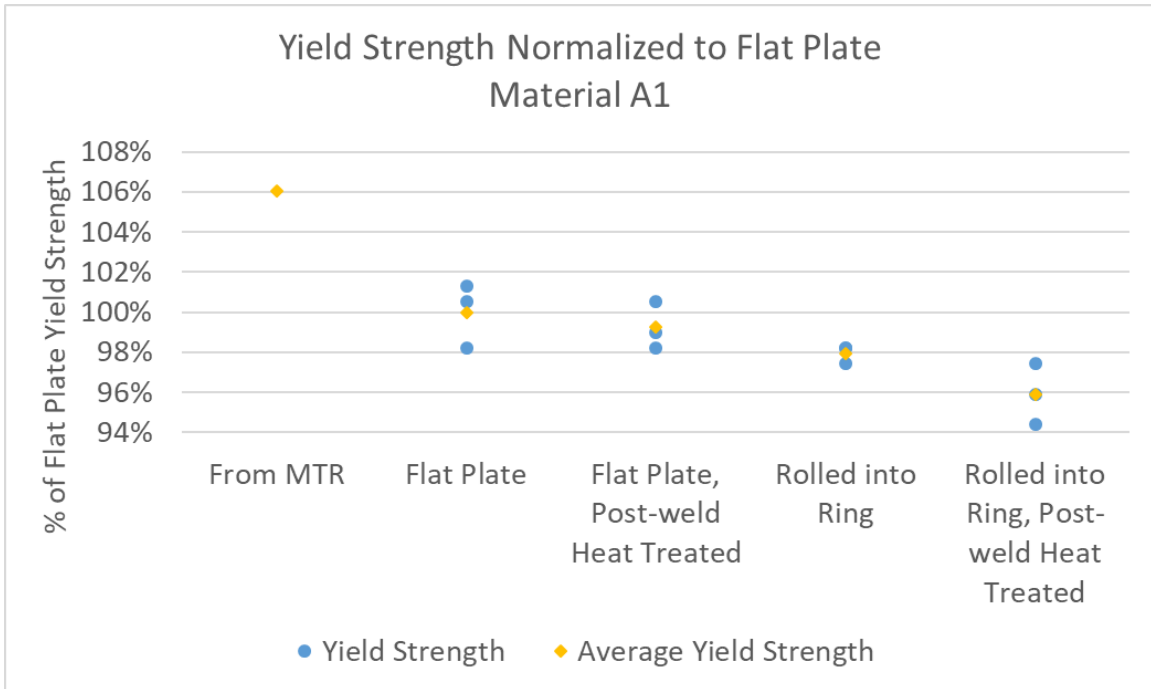
Figure 12. Material A1 – Yield Strength at Each Material Condition Normalized to Average Flat Plate Yield Strength

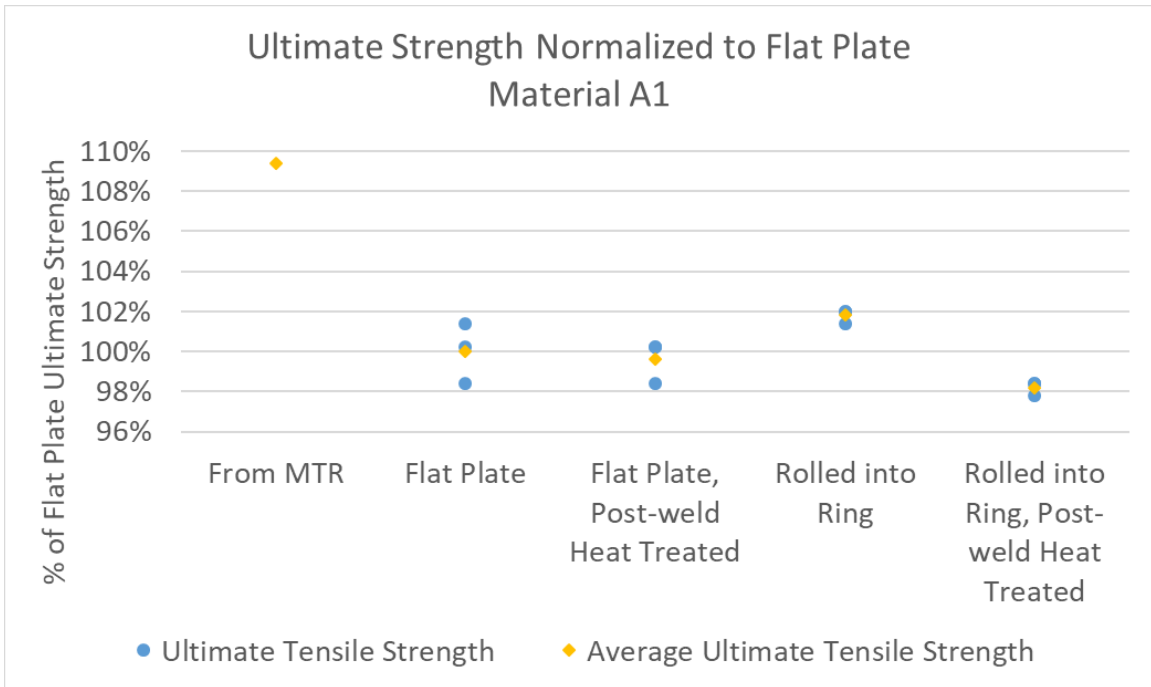
Figure 13. Material A1 – Ultimate Tensile Strength at Each Material Condition Normalized to Average Flat Plate Ultimate Tensile Strength

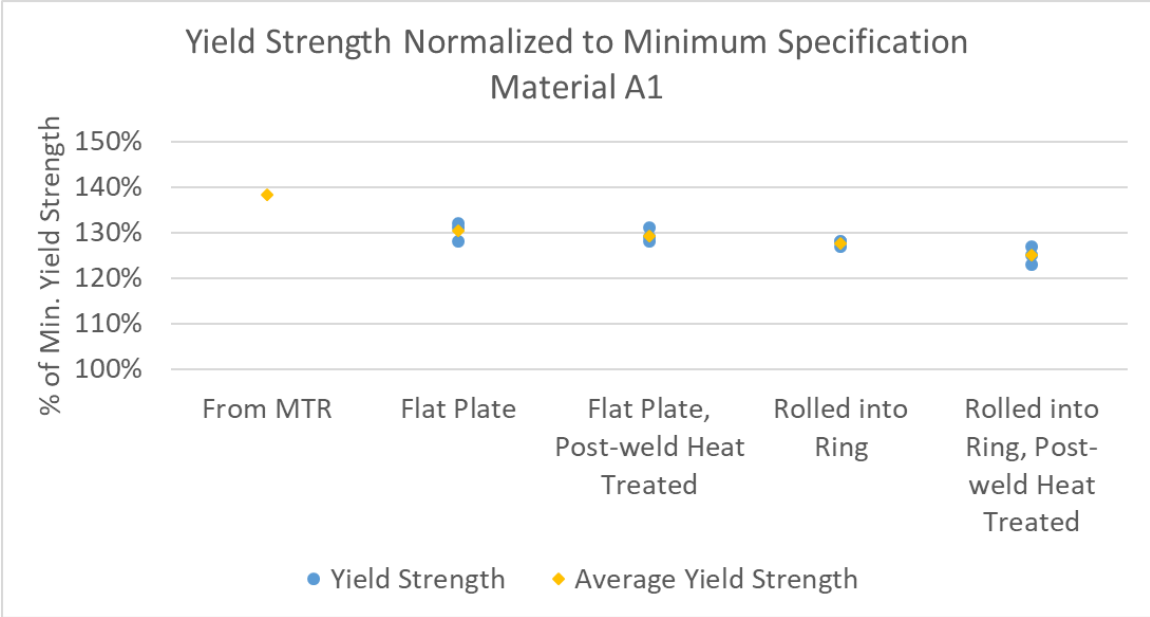
Figure 15. Material A1 – Yield Strength at Each Material Condition Normalized to Minimum Yield Strength in TC-128B Specification

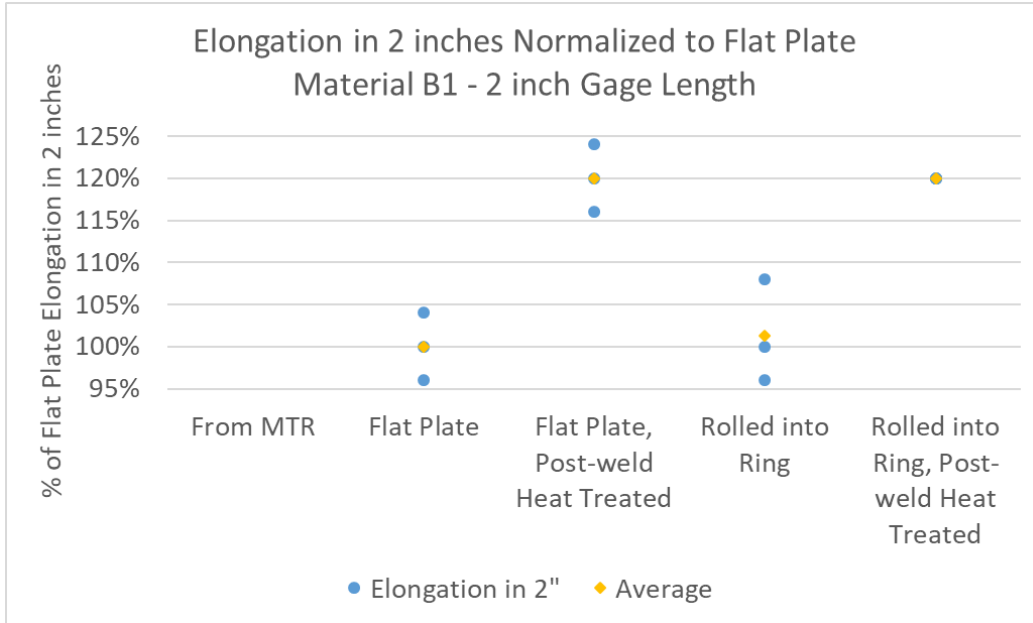
Figure 35. Material B1 – Elongation in 2 inches at Each Material Condition Normalized to Average Flat Plate Elongation in 2 inches

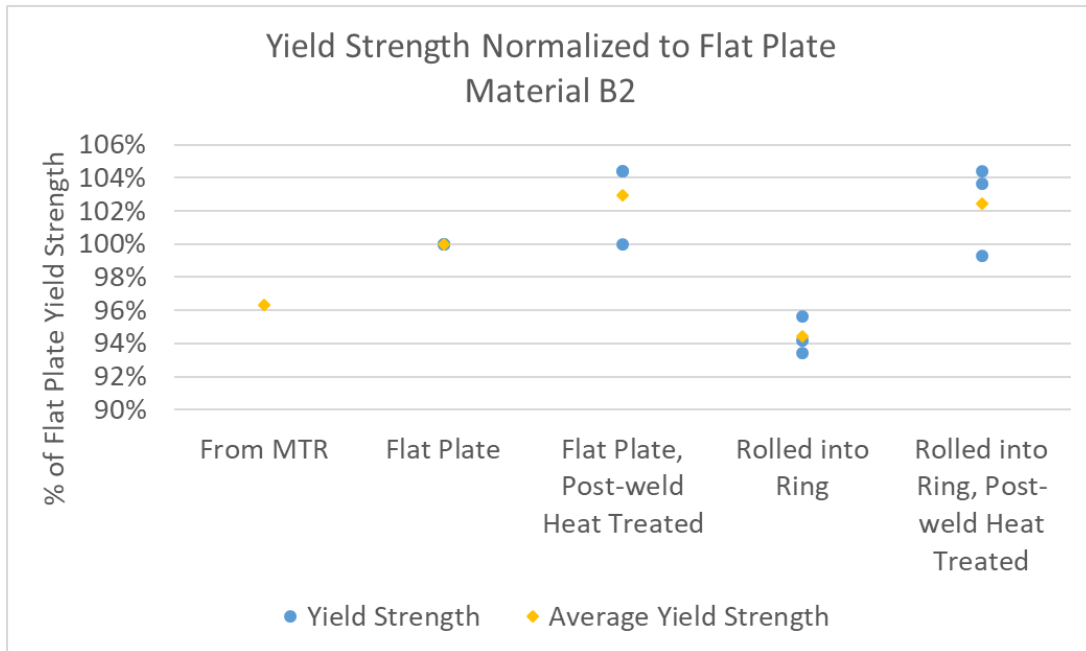
Figure 51. Material B2 – Yield Strength at Each Material Condition Normalized to Average Flat Plate Yield Strength
