Livingston Avenue Railroad Bridge
 P.I.N. 1935.49.101, BIN 7092890

Cities of Albany and Rensselaer - Albany and Rensselaer Counties

APPENDIX C
PHOTOGRAPHS

**P.I.N. 1935.49.101, BIN 7092890
Livingston Avenue Railroad Bridge
Cities of Albany and Rensselaer
Albany and Rensselaer Counties, NY**

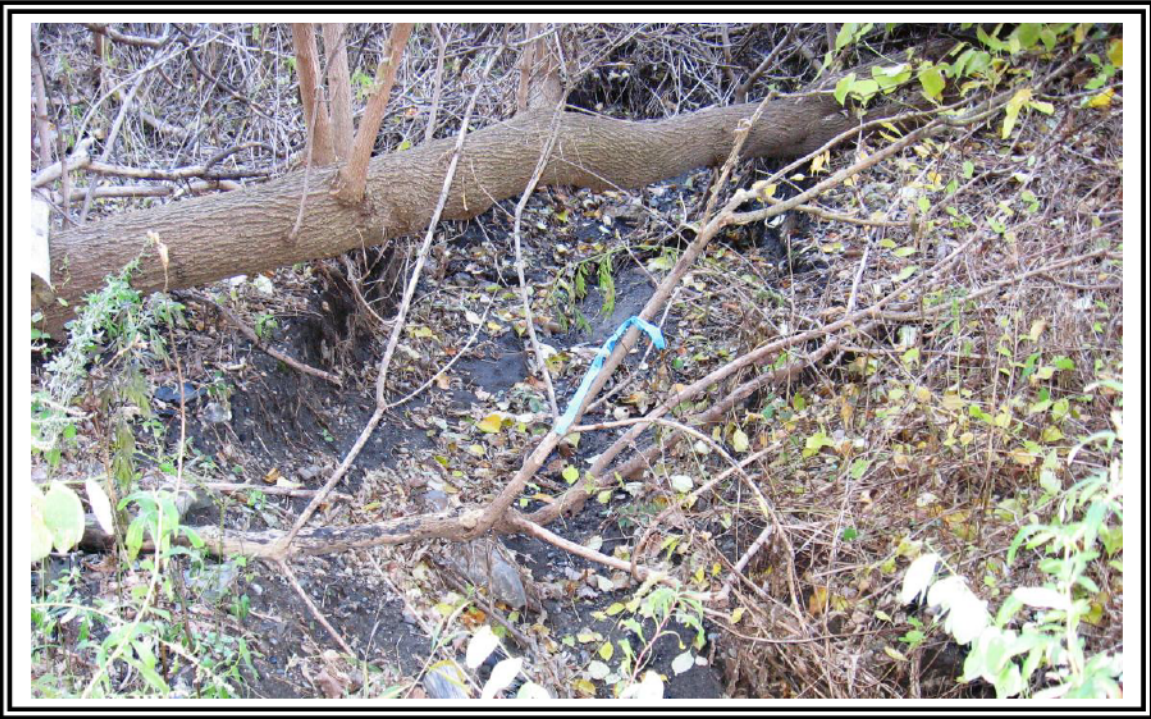
Photo 1- Delineated feature A, an ephemeral stream (R4UB1).

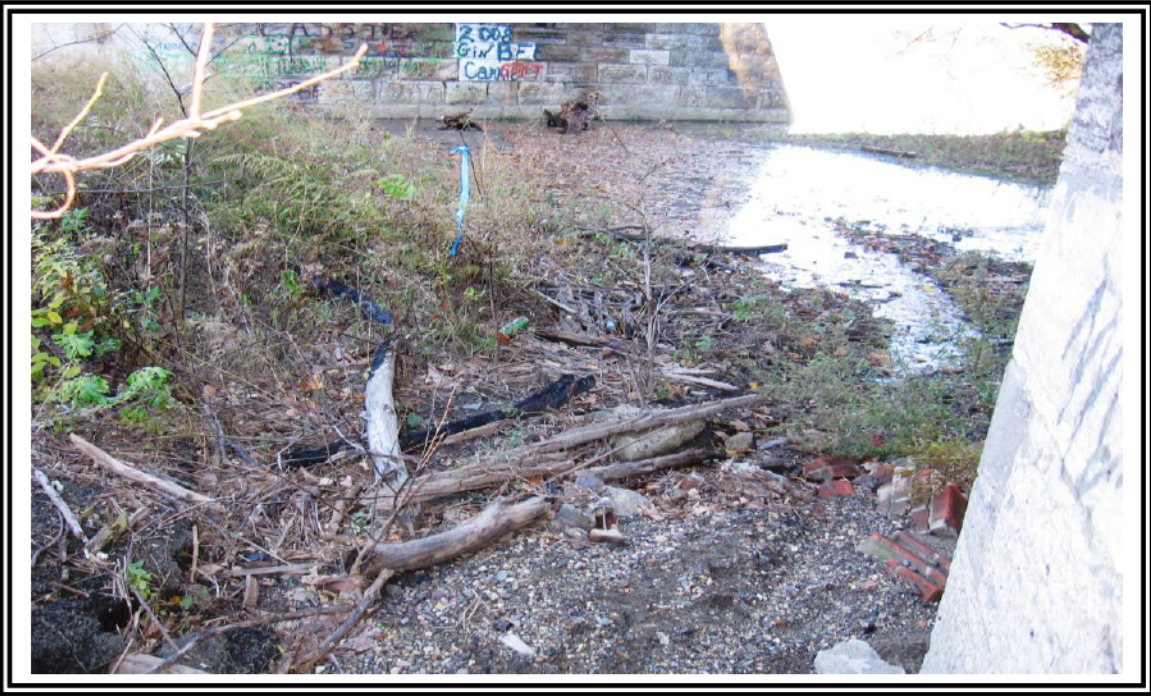
Photo 2 – Delineated feature A, the ephemeral stream (gravel in the foreground), where it meets the Hudson River (beyond the pillar in the background). Water in the picture is a rain puddle.

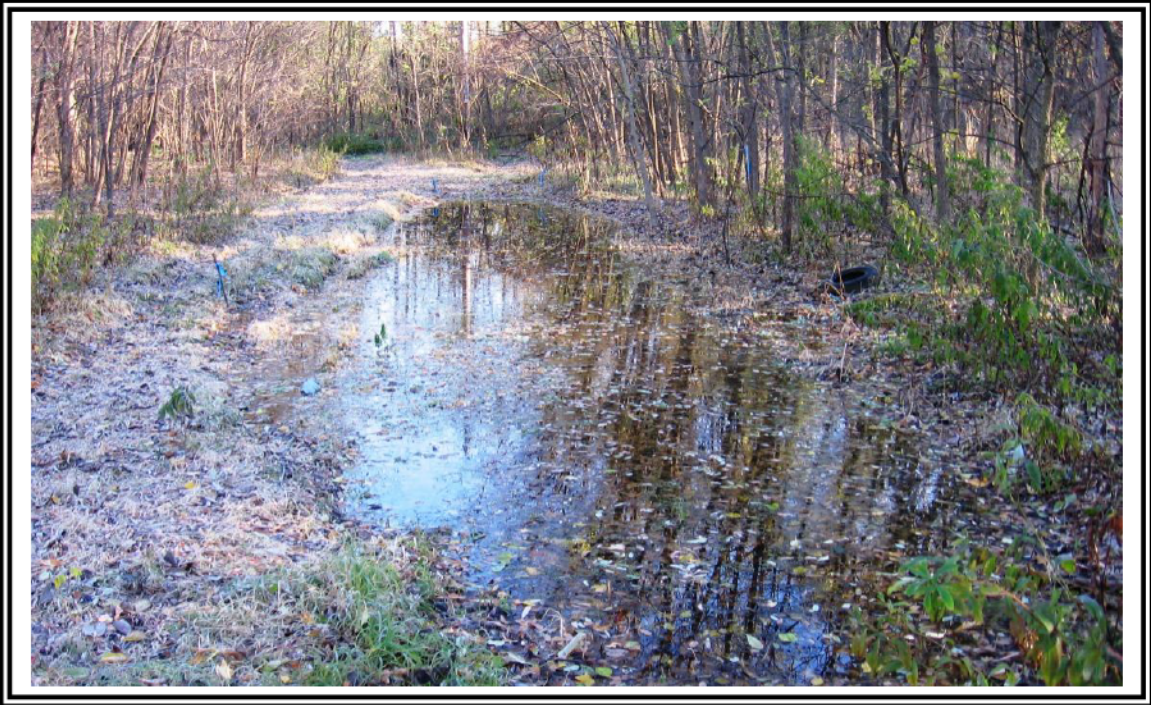
Photo 3 – Delineated feature B (Wetland B), a vernal pool (PEMC).

Hydrophytic Vegetation Present? Yes <input checked="" type="checkbox"/> No _____ Hydric Soil Present? Yes <input checked="" type="checkbox"/> No _____ Wetland Hydrology Present? Yes <input checked="" type="checkbox"/> No _____	Is the Sampled Area within a Wetland? Yes <input checked="" type="checkbox"/> No _____ If yes, optional Wetland Site ID: <u>Wetland B</u>
Remarks: (Explain alternative procedures here or in a separate report.) <u>Vernal Pool</u>

These are problematic hydric soils. This is a Recently Developed Wetland with Seasonally Ponded Soils (as described in Chapter 5 of the Regional Supplement). Sufficient indicators of wetland hydrology and hydrophytic vegetation were present at the time of survey. This "vernal pool" occurs in a depression within a flat floodplain of the Hudson River. Surrounding areas were upland, but this depression was wetland. This depression may have been deepened by ATV or truck traffic.

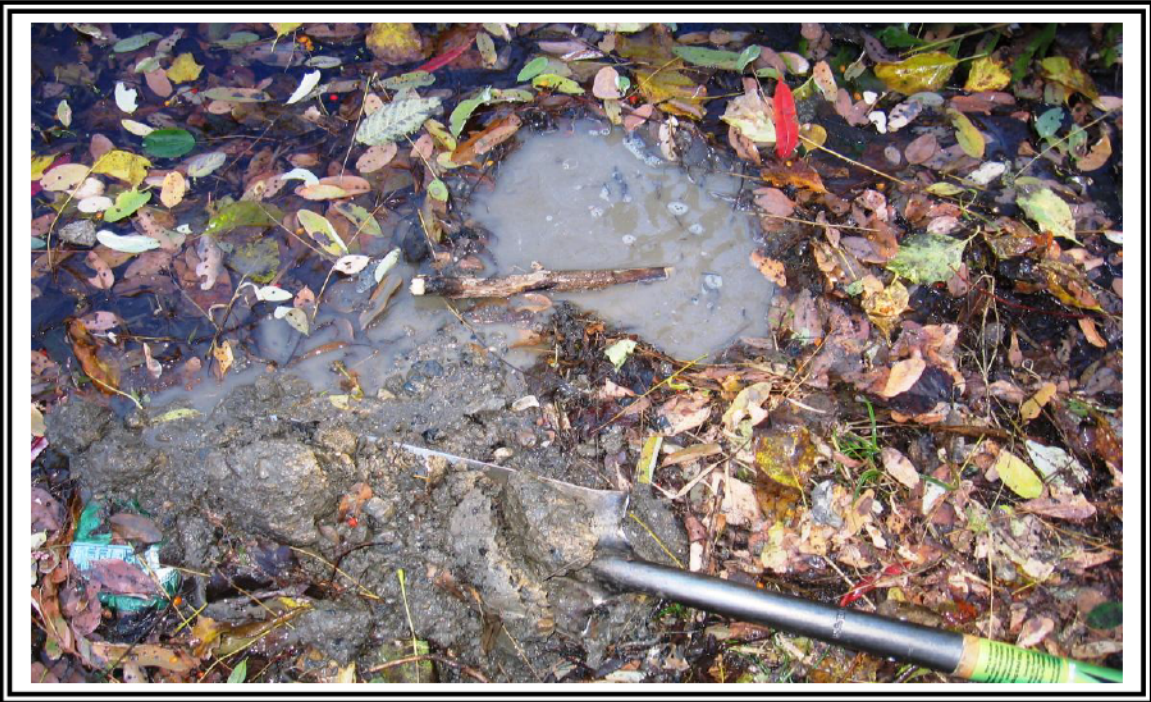
Photo 4 –Shovel pit of Wetland B's soils.

Profile Description: (Describe to the depth needed to document the indicator or confirm the absence of indicators.)								
Depth (inches)	Matrix		Redox Features			Texture	Remarks	
	Color (moist)	%	Color (moist)	%	Type ¹			
0-16+	2..5Y 3/1	100				Gravelly clay

Can't get past 16" due to rock.

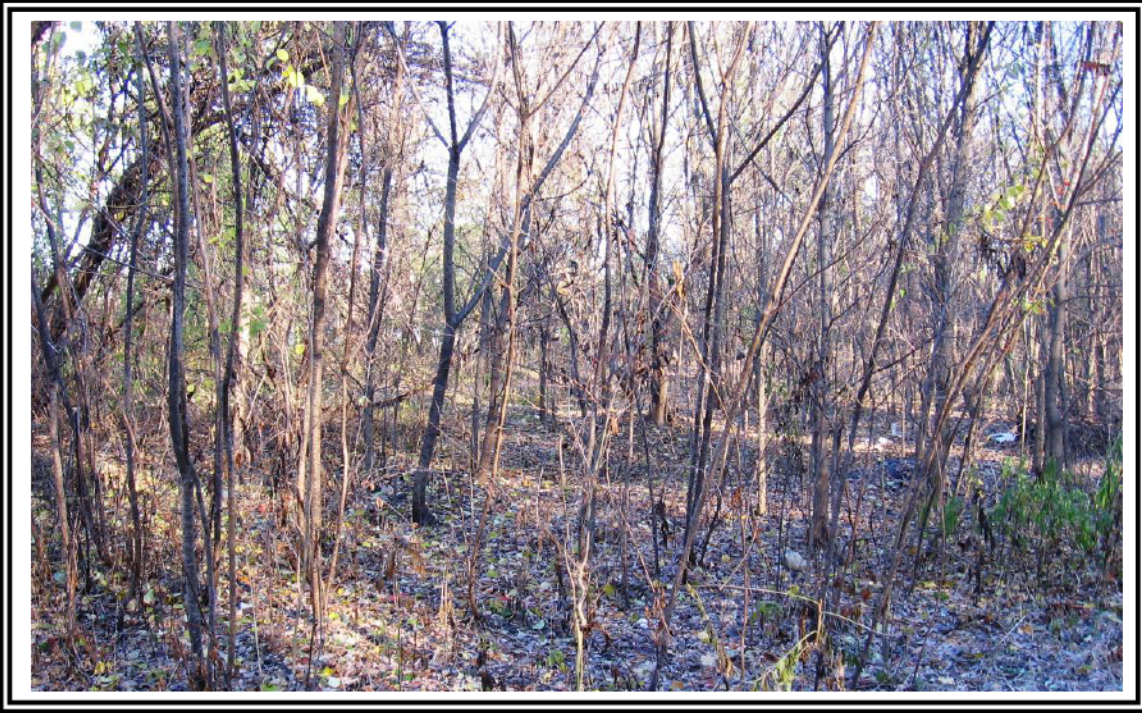
Photo 5 – Successional northern hardwoods that surround Wetland B.

Hydrophytic Vegetation Present? Yes _____ No <input checked="" type="checkbox"/> Hydric Soil Present? Yes _____ No <input checked="" type="checkbox"/> Wetland Hydrology Present? Yes _____ No <input checked="" type="checkbox"/>	Is the Sampled Area within a Wetland? Yes _____ No <input checked="" type="checkbox"/> If yes, optional Wetland Site ID: <u>Upland B</u>
Remarks: (Explain alternative procedures here or in a separate report.) Successional Southern Hardwoods

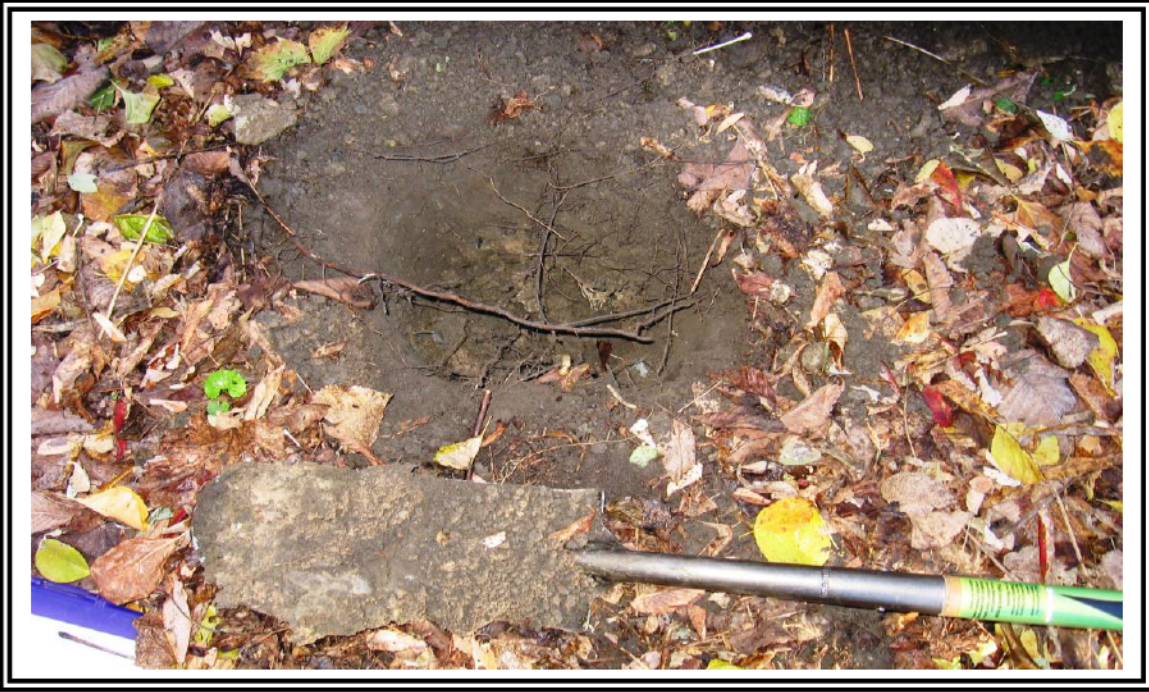
Photo 6 – Shovel pit to document the soils of the successional northern hardwoods surrounding Wetland B

Depth (inches)	Matrix		Redox Features				Texture	Remarks
	Color (moist)	%	Color (moist)	%	Type ¹	Loc ²		
0-8	2.5Y 3/2	100					loamy sand	
9-16+	10YR 4/3	95	10YR 3/1	5			clay with rocks

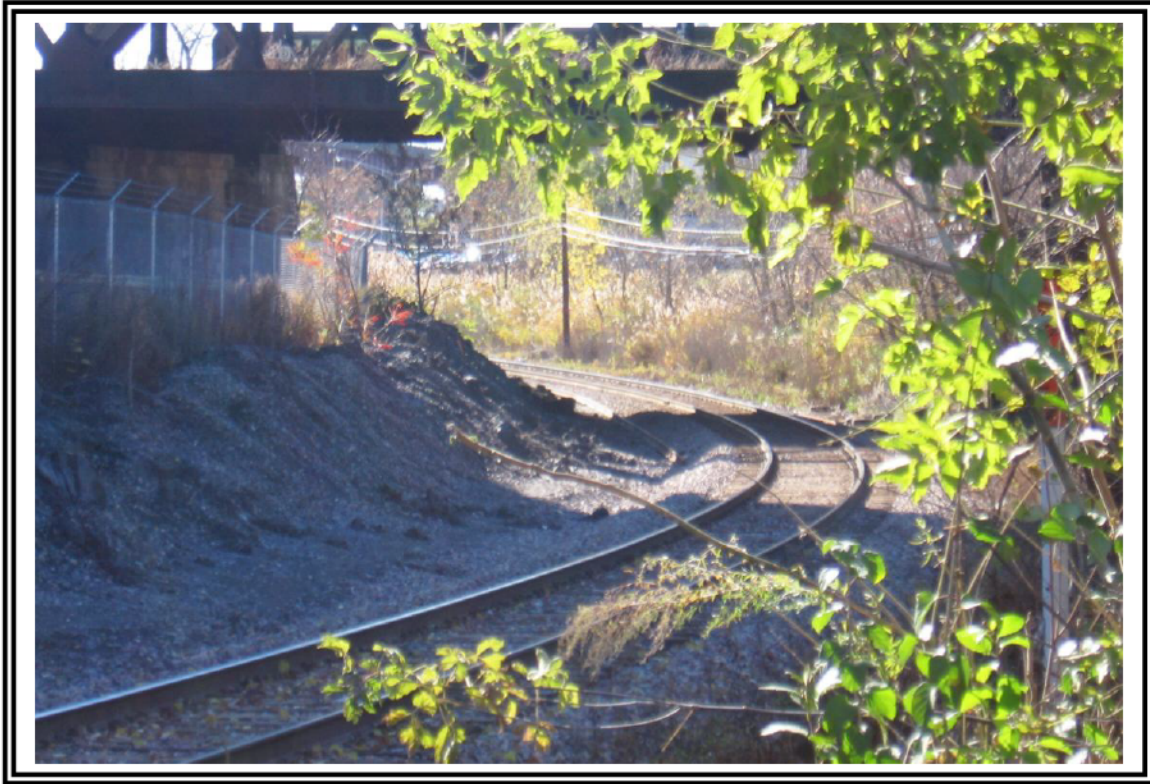
Photo 9 – View of the undelineated reedgrass/purple loosestrife linear wetland ditch (next to the telephone pole in the background).
