U.S. Department  
of Transportation  
Federal Railroad  
Administration

## Sled Tests Using the THOR-50M ATD and Quasi-Static Tests of Workstation Tables for Passenger Trains

<b>1. REPORT DATE (DD-MM-YYYY)</b> 06/01/2022		<b>2. REPORT TYPE</b> Technical Report		<b>3. DATES COVERED (From - To)</b> 6/4/2020 to 3/25/2022	
<b>4. TITLE AND SUBTITLE</b> Sled Tests Using the THOR-50M ATD and Quasi-static Tests of Workstation Tables for Passenger Trains				<b>5a. CONTRACT NUMBER</b> 693JJ620C000008	
				<b>5b. GRANT NUMBER</b>	
				<b>5c. PROGRAM ELEMENT NUMBER</b>	
<b>6. AUTHOR(S)</b> Ryan Zika - Test Engineer (0000-0002-9558-6811) Greg Shively - Test Engineer (0000-0002-9875-5967) Jeremy Wood - Project Manager (0000-0002-7825-8787) Shaun Eshraghi - Mechanical Engineer (0000-0002-8152-0838)* Kristine Severson - Mechanical Engineer (0000-0002-1039-554X)* Jennifer Young - Quality Manager (0000-0003-4302-1541)				<b>5d. PROJECT NUMBER</b>	
				<b>5e. TASK NUMBER</b>	
				<b>5f. WORK UNIT NUMBER</b>	
<b>7. PERFORMING ORGANIZATION NAME(S) AND ADDRESS(ES)</b> MGA Research Corporation *Volpe National Transportation Systems Center 820 Suburban Park Drive 55 Broadway Greer, SC 29651 Cambridge, M

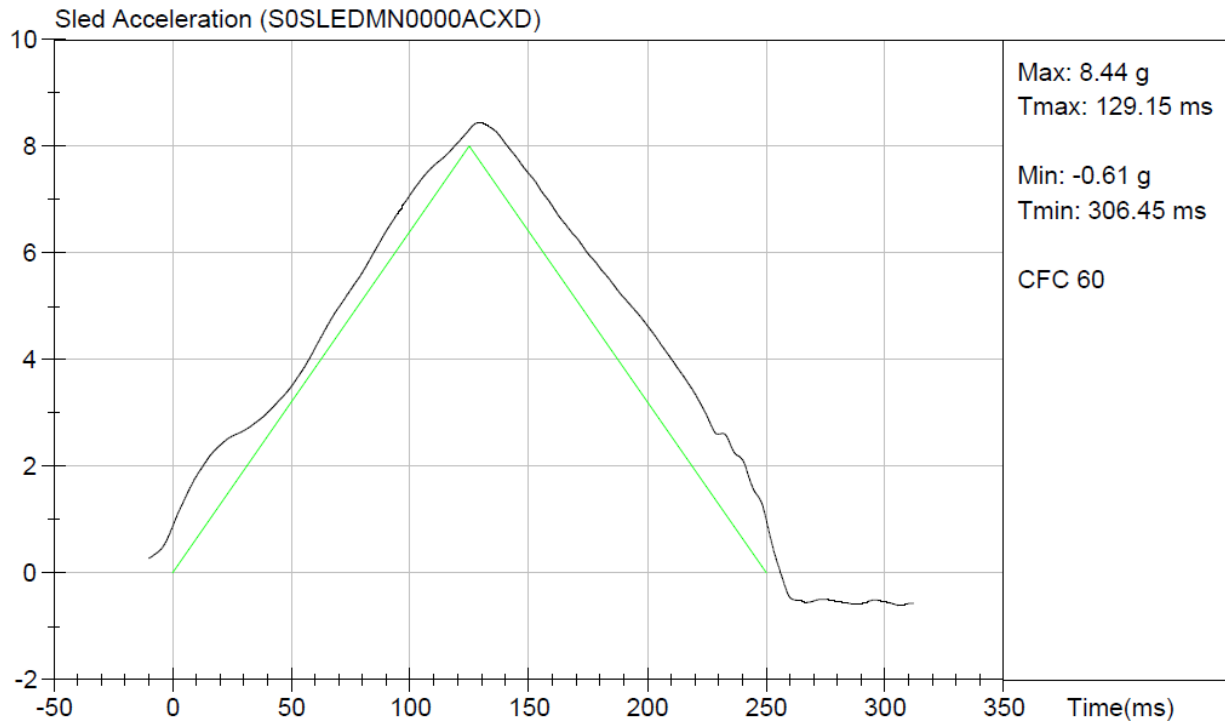
Figure 1. Pre-test Calibration Acceleration Curve

A calibration test was conducted by attaching ballast weight to the sled to simulate the weight of the ATDs and the seats. To help offset the effect of the ATD and seat kinematics during the actual test, additional ballast weight was also used to effectively increase the mass of the sled carriage. [Figure 1](#) is the pre-test calibration pulse, and its corresponding velocity curve shown in [Figure 2](#).

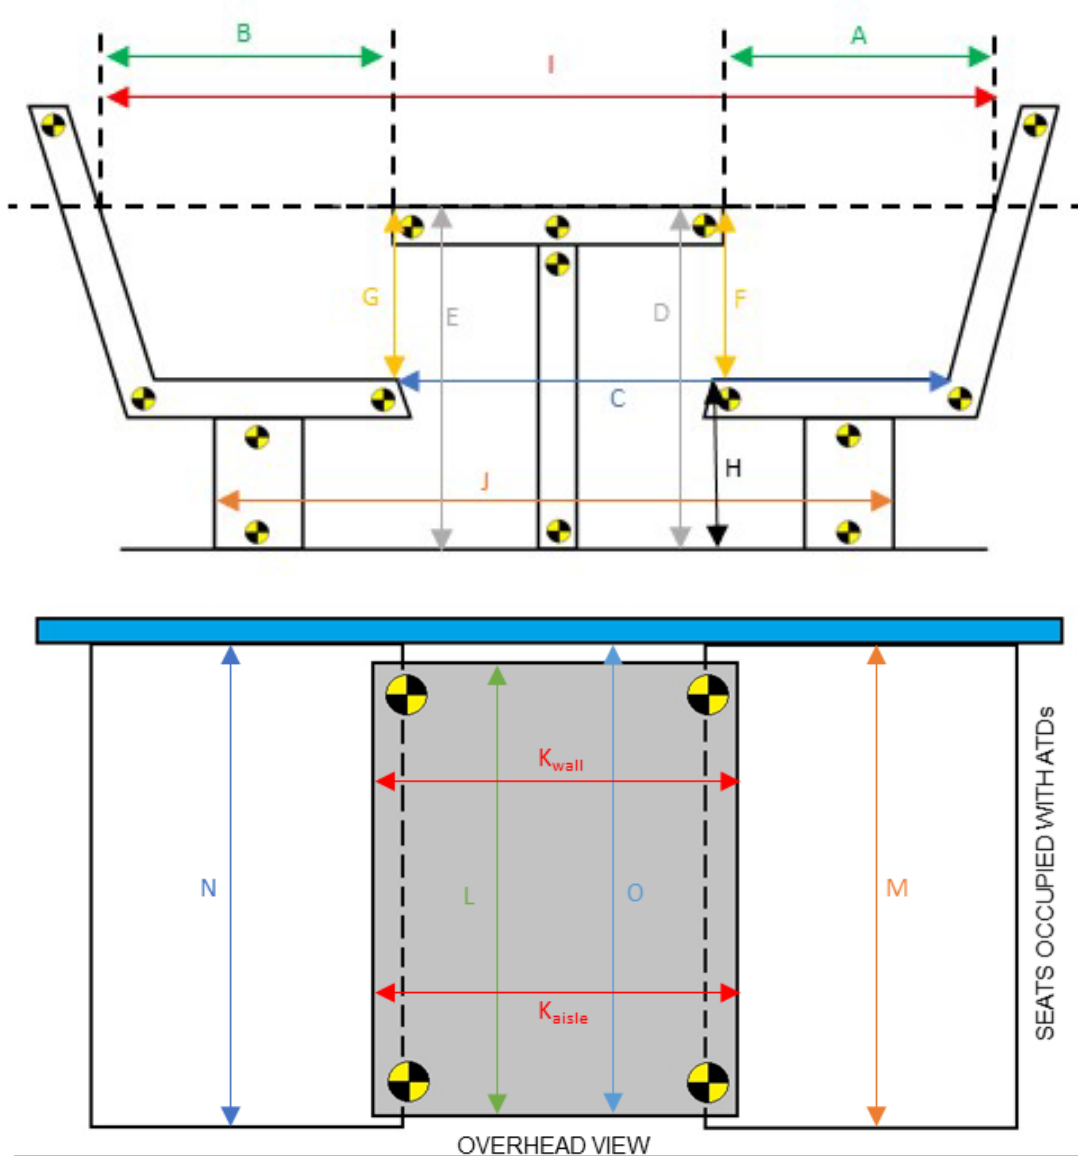
**Figure 3. Schematic of Pre- and Post-test Measurements to Be Recorded**

A facing pair of two-person seats and a workstation table were installed in the simulated carbody in the nominal location for their intended rail service. This setup information, provided by each of the donating parties, was documented prior to the execution of the test using calibrated measuring devices. For documentation and verification purposes, photographs were taken of each measurement pre- and post-test. A simulated floor covering was included in the test setup to best replicate the railcar floor covering. Detailed pre- and post-test photographs were taken of the seats and tables to document the seat and table mounting locations and conditions to evaluate any post-test damage. The pre and post-test measurements that were taken are detailed in [Figure 3](#) and [Table 2](#) below. All measurements were taken at the center of each ATD position.

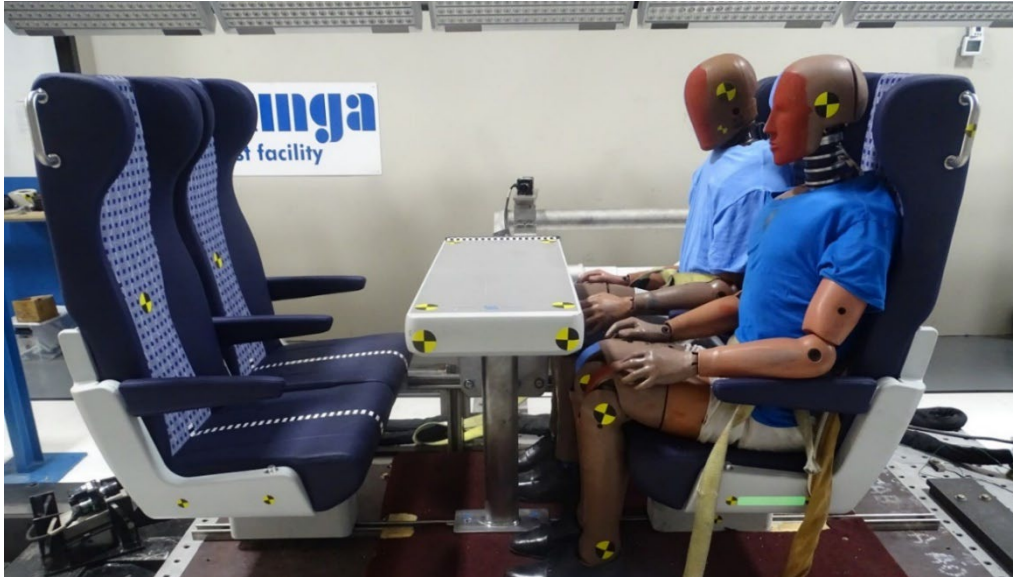
**Figure 5. Test 1A Lateral Pre-test Photo**

A two-person passenger seat was mounted to the test sled. A facing seat was mounted to the test sled on the opposite side of the table at the nominal seat pitch for the intended installation. A fixed workstation table was installed in the middle of the two facing seats. Instrumented ATDs, representative of 50<sup>th</sup> percentile adult males, were positioned to face the direction of travel. The aisle-side (left passenger) ATD was a H3-50M and the wall-side (right passenger) ATD was a THOR-50M, as specified in Option A of APTA S-018.

Figure 5 shows the setup and Figure 6 shows the post-test outcome for Test 1A.

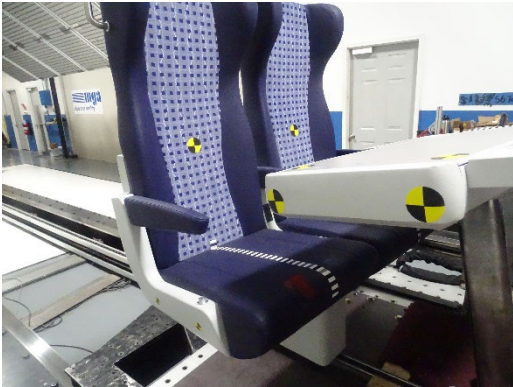
**Figure 7. Test 1A Impact Seat**

The impact seat pedestal rotated and the seat slid on the track during the event once impacted by the two ATDS.

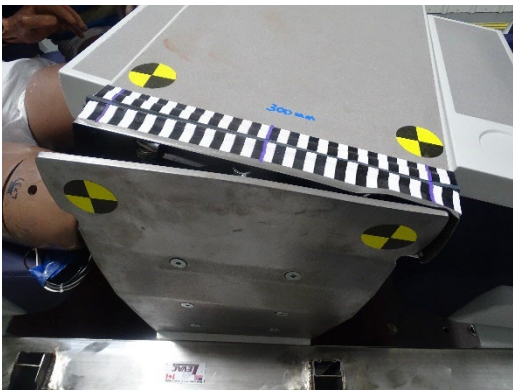
**Figure 9. Test 1A Workstation Table Wall Mount**

The workstation table translated 3 mm, as observed on the inch tape, and then deformed. The workstation table partially pulled off the wall mount during the event.

In Test 1A, the workstation table failed to translate the length of its intended stroke and instead rotated around the wall mount. This likely influenced the injury results. The table partially separated from the simulated wall mount during the event. There was mild deformation to the pedestal mount. No components separated from the workstation table during the test. The injury criteria were not met due to the THOR-50M lower right chest deflection criteria exceeding the limit. The chest rotary potentiometer in the H3-50M dislodged from the base resulting in an invalid reading. The minimum survival space was preserved during the event.

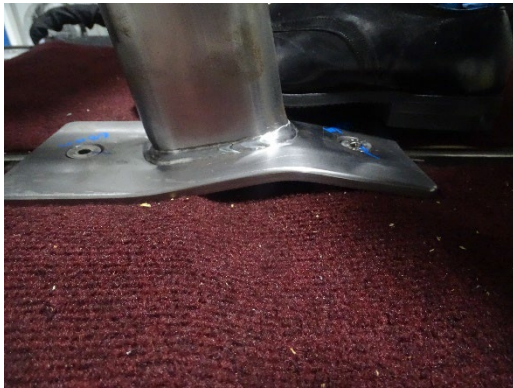
**Figure 10. Test 1A Workstation Table Floor Mount**

The workstation table mount deformed along the track mount during the event.

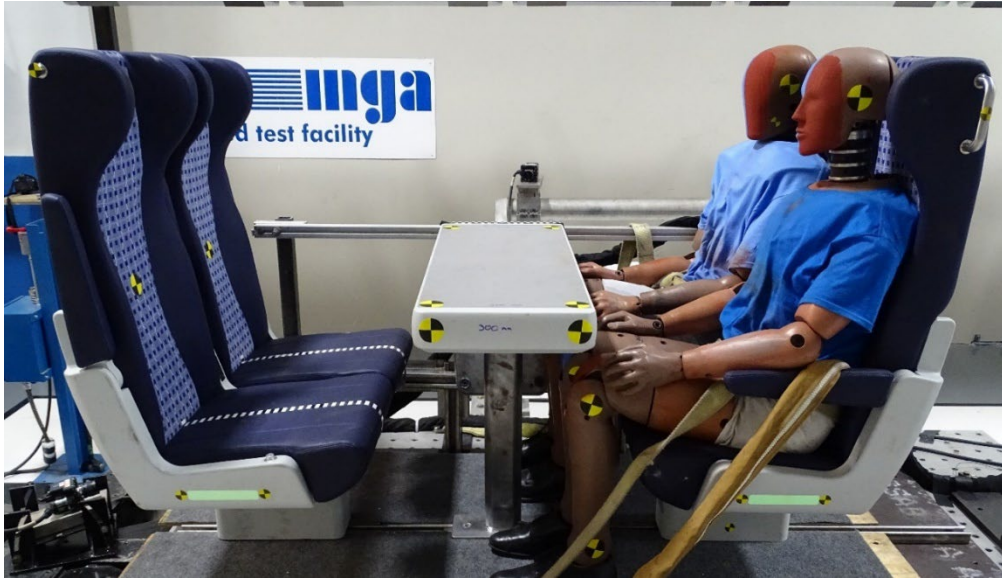
Figure 11. Test 1A\* Lateral Pre-test Photo

A two-person passenger seat was mounted to the test sled. A facing seat was mounted to the test sled on the opposite side of the table at the nominal seat pitch of the intended installation. A fixed workstation table was installed in the middle of the two facing seats. Instrumented ATDs, representative of 50<sup>th</sup> percentile adult males were positioned to face the direction of travel. The aisle-side (left passenger) ATD was an H3-50M, and the wall-side (right passenger) ATD was a THOR-50M as specified in Option A of APTA S-018.

Figure 11 shows the setup and Figure 12 shows the post-test outcome for Test 1A\*.

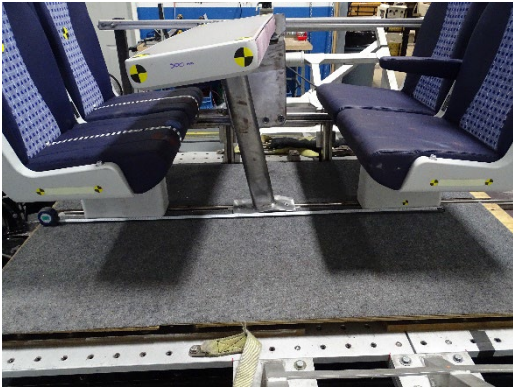
**Figure 13. Test 1A\* Impact Seat**

The workstation table deformed toward the impact seat during the event.

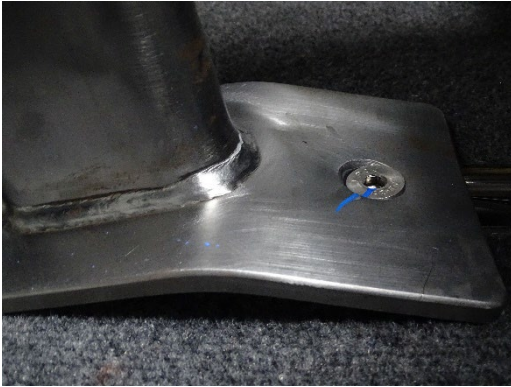
**Figure 16. Test 1A\* Workstation Table Floor Mount**

The workstation table floor mount deformed upwards during the event. The table mount remained connected to the simulated floor mount.

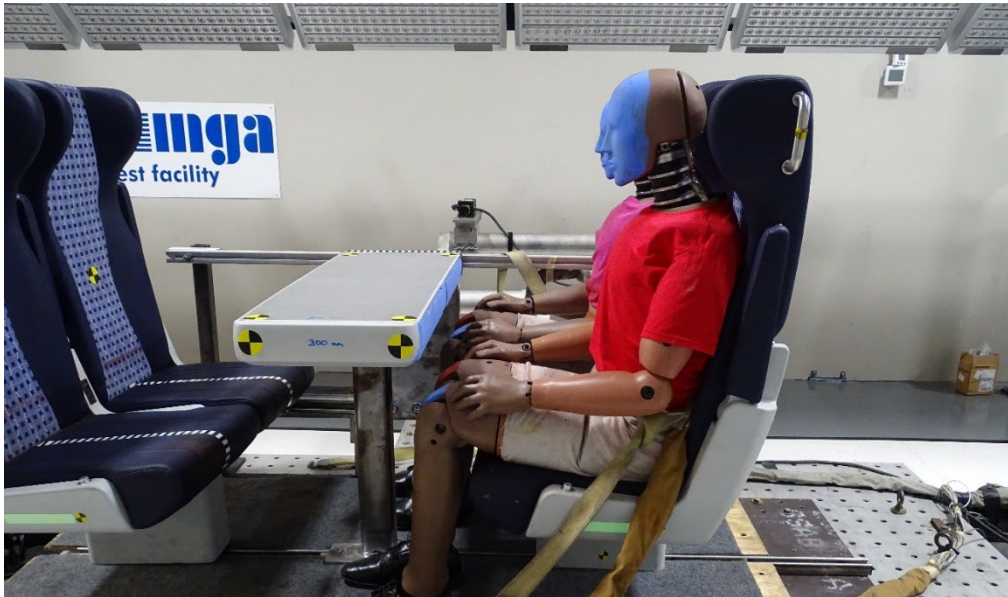
Figure 17. Test 1BD Lateral Pre-test Photo

A two-person passenger seat was mounted to the test sled. A facing seat was mounted to the test sled on the opposite side of the table at the nominal seat pitch for the intended installation. A fixed workstation table was installed in the middle of the two facing seats. Instrumented ATDs, representative of 50<sup>th</sup> percentile adult males, were positioned to face the direction of travel. Both ATDs were H3-50Ms, as specified in Option B of APTA S-018.

Figure 17 shows the setup and Figure 18 shows the post-test outcome for Test 1BD.

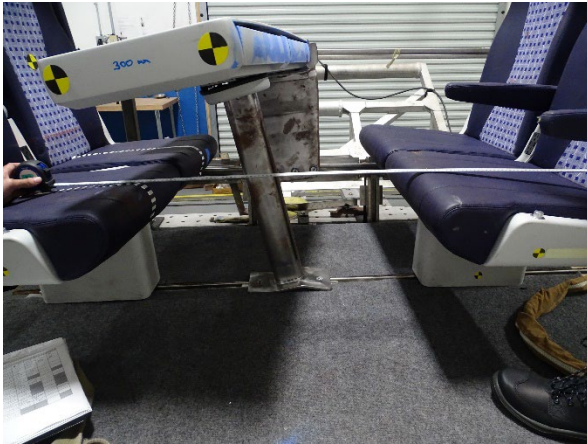
**Figure 19. Test 1BD Workstation Table**

The workstation table deformed toward the impact seats upon contact during the event.

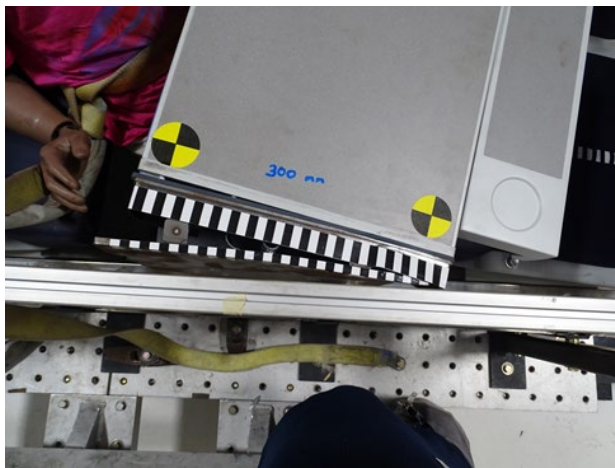
**Figure 20. Test 1BD Workstation Table Wall Mount**

The workstation table translated approximately 10 mm, as observed on the inch tape, and then deformed. The workstation table partially pulled off the simulated wall mount during the event.

The workstation table in Test 1BD was designed to translate along the wall mount and absorb energy during impact. In Test 1A, the table failed to translate and instead rotated in a clockwise direction during the event. For Tests 1BD, 1BDQ, and 1A\*, an additional longitudinal sidewall frame member was constructed to simulate an interior sheathing and provide additional transverse support to the table bracket. The table partially translated along the simulated carbody, then separated slightly from the wall mount, failing to translate for the full stroke. The table also deformed toward the rear-facing seat upon impact. There was partial separation observed along the impact seat pedestal. The aisle-side H3-50M chest compression criterion was not met. The wall-side H3-50M chest rotary potentiometer dislodged from the base, resulting in an invalid reading. The minimum survival space was preserved during the event.

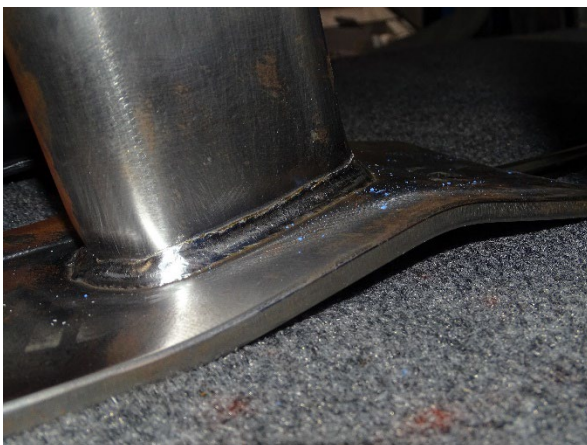
**Figure 21. Test 1BD Workstation Table Floor Mount**

The workstation table mount deformed during the event, causing slight separation from the floor track.

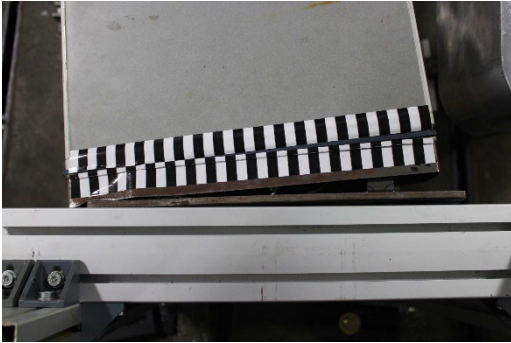
**Figure 24. Test 1BQ Workstation Table Overhead**

The workstation table translated approximately 25 mm, as observed on the inch tape, along the simulated wall structure. The full stroke of the energy absorbing mechanism was not utilized.

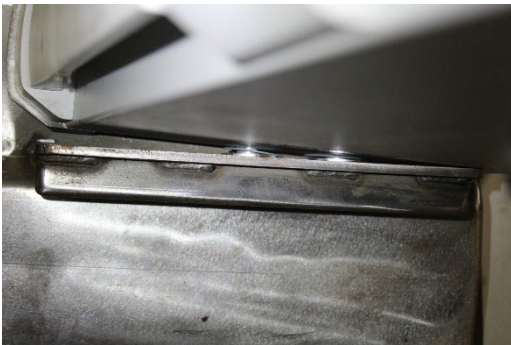
**Figure 25. Test 1BQ Workstation Table Wall**

The workstation table partially lifted vertically at the wall mount of the structure.

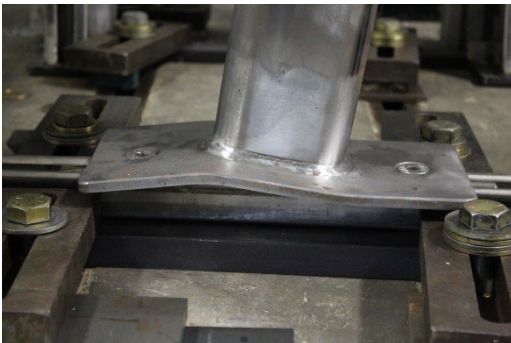
**Figure 26. Test 1BQ Pedestal Floor Mount**

The pedestal floor mount deformed during the event, causing slight separation from the floor track.

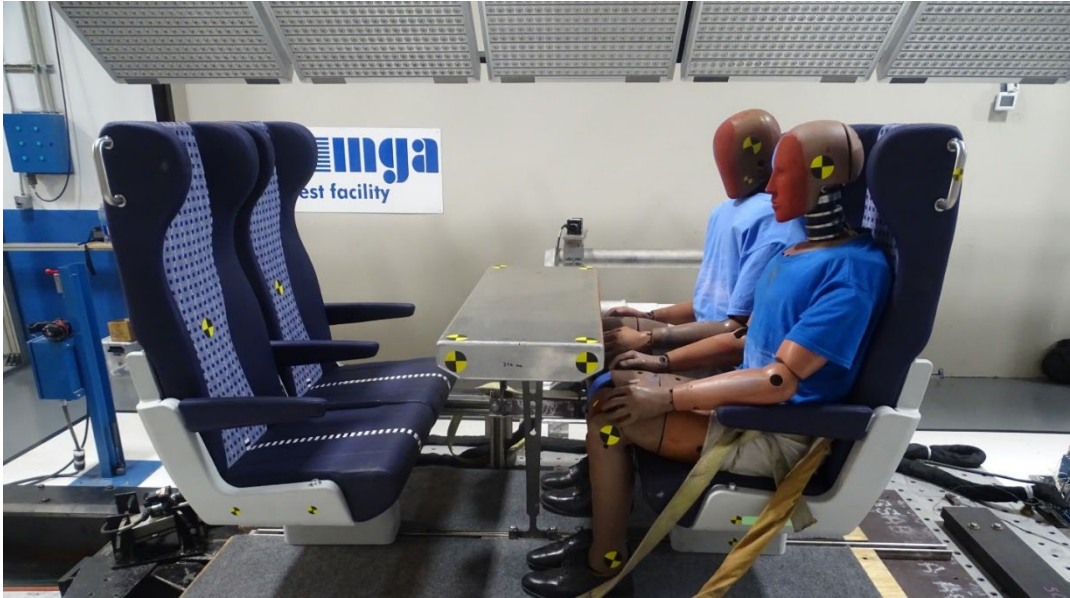
Figure 27. Test 2A Lateral Pre-test Photo

A two-person passenger seat was mounted to the test sled. A facing seat was mounted to the test sled on the opposite side of the table at the nominal seat pitch for the intended installation. A fixed workstation table was installed in the middle of the two facing seats. Instrumented ATDs, representative of 50<sup>th</sup> percentile adult males, were positioned to face the direction of travel. The aisle-side (left passenger) ATD was an H3-50M, and the wall-side (right passenger) ATD was a THOR, as specified in Option A of APTA S-018.

Figure 27 shows the setup and Figure 28 shows the post-test outcome for Test 2A.

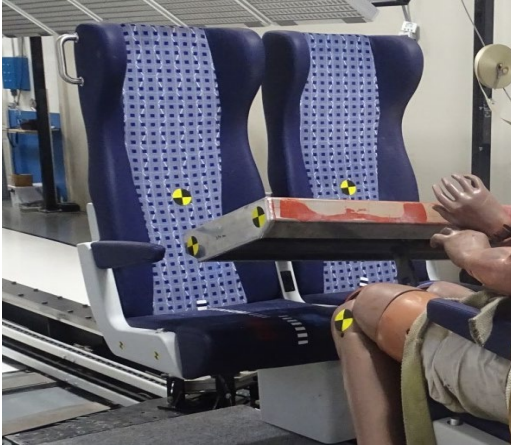
**Figure 29. Test 2A Impact Seat**

The ATDs' knees impacted the opposite seat during the event. No structural issues were observed.

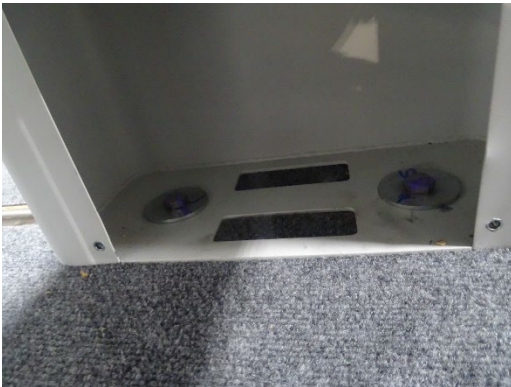
**Figure 30. Test 2A Impact Seat Pedestal**

The impact seat pedestal mount experienced no deformation. Slight movement was witnessed along the floor track.

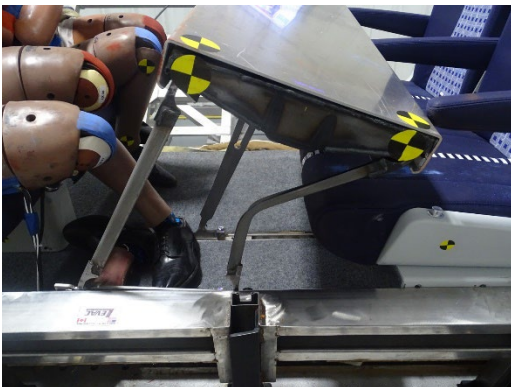
**Figure 31. Test 2A Workstation Table Wall Mount**

During the event, the THOR-50M tibia was broken.

The workstation table deformed toward the impact seat during impact and remained attached to wall mount.

The workstation table in Test 2A was designed to bend at the floor mounts and absorb energy through material deformation. After MGA received the table, modifications were made to the table to reduce the bending moment along the wall mount in order to limit contact forces with the ATDs. The pedestal and table mount deformed toward the impact seat during the event. No components separated from the table during the event. Both tibias on the THOR-50M ATD fractured upon impact, and the injury criteria for the lower right chest peak deflection were not met. The minimum survival space was preserved throughout the event.

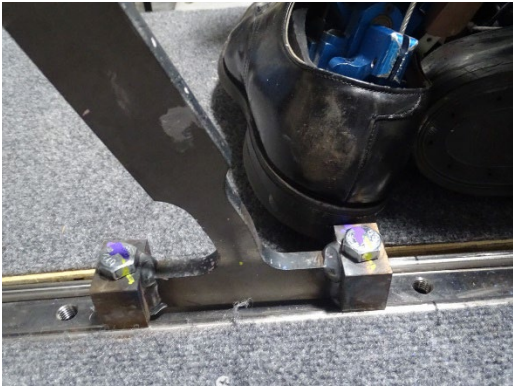
**Figure 32. Test 2A Workstation Table Floor Mount**

The workstation table floor mount remained attached to the floor track during the event.

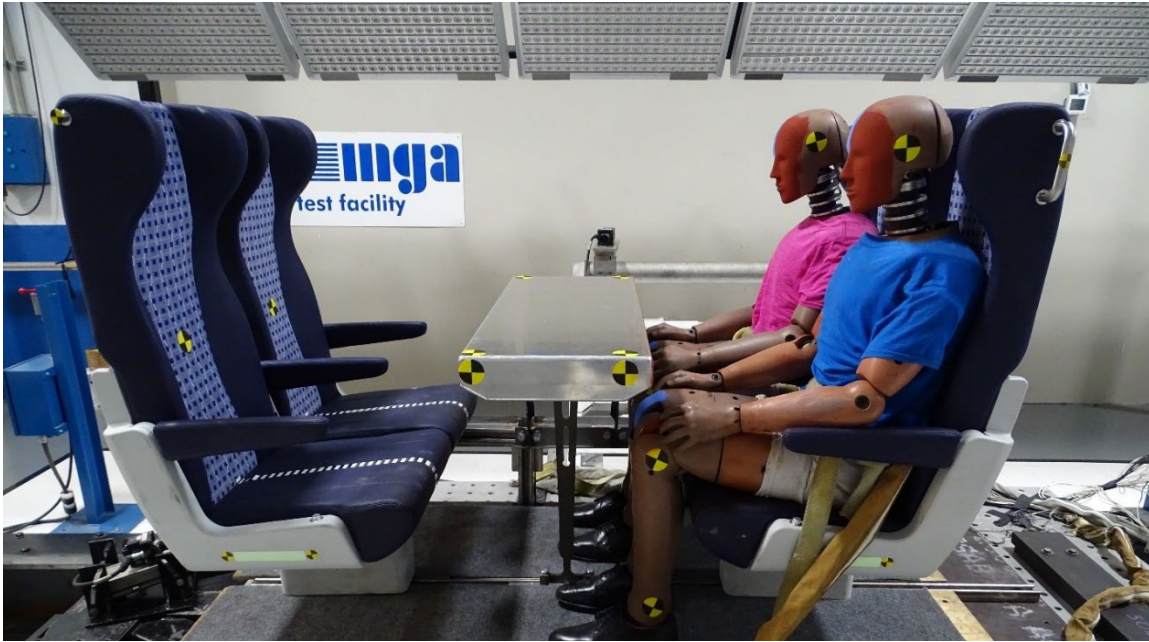
Figure 33. Test 2BD Lateral Pre-test Photo

A two-person passenger seat was mounted to the test sled. A facing seat was mounted to the test sled on the opposite side of the table at the nominal seat pitch for the intended installation. A fixed workstation table was installed in the middle of the two facing seats. Instrumented ATDs, representative of 50<sup>th</sup> percentile adult males, were positioned to face the direction of travel. Both ATDs were H3-50Ms, as specified in Option B of APTA S-018.

Figure 33 shows the setup and Figure 34 shows the post-test outcome for Test 2BD.

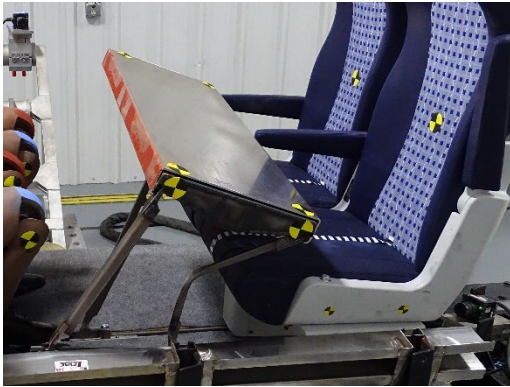
**Figure 35. Test 2BD Workstation Table**

The workstation table deformed toward the impact seats and remained attached to the wall and floor mount.

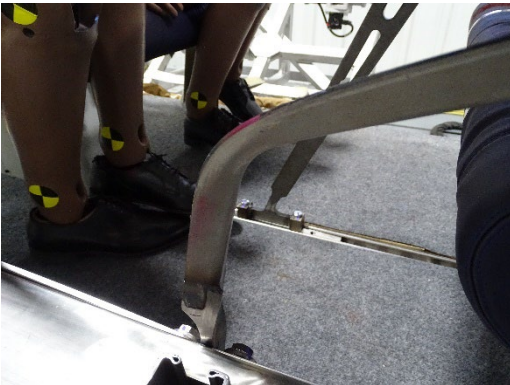
**Figure 36. Test 2BD Workstation Table Front Wall Mount**

The workstation table deformed at simulated front wall mount along the table leg frame.

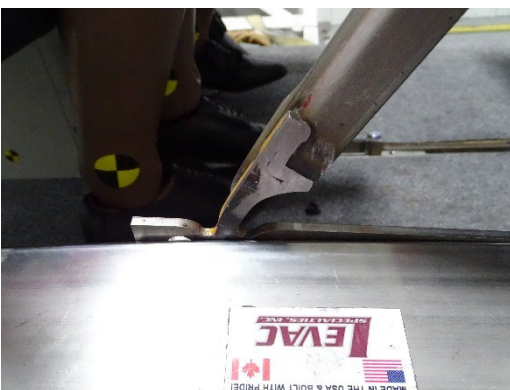
**Figure 37. Test 2BD Workstation Table Rear Wall Mount**

The workstation table deformed at the rear wall mount near the impact seats.

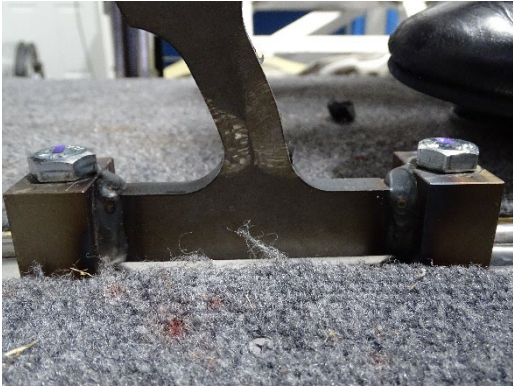
**Figure 38. Test 5 Workstation Table Floor Mount**

The workstation table floor mount deformed during the event and remained secured to the floor. No separation was observed.

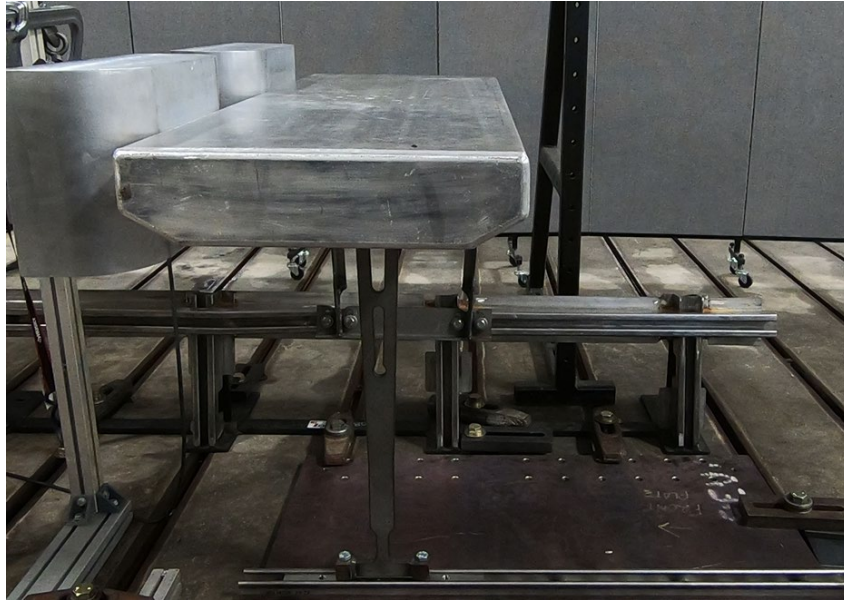
**Figure 39. Test 2BQ Lateral Pre-test Photo**

A fixed workstation table and provided simulated car structure was mounted to the rigid t-slot floor plates. The fixed workstation table was attached to the simulated car structure using the same fasteners and attachment mechanisms as intended for service. The hydraulic cylinders and rigid body blocks were aligned laterally at the center of each seating position and centered vertically on the table edge. The table was quasi-statically tested according to the Option B test requirements in Section 5.2.2 of the table standard at a load-controlled rate of 350 lbf/min.

Figure 39 shows the pre-test setup and Figure 40 shows the post-test outcome for Test 2BQ.

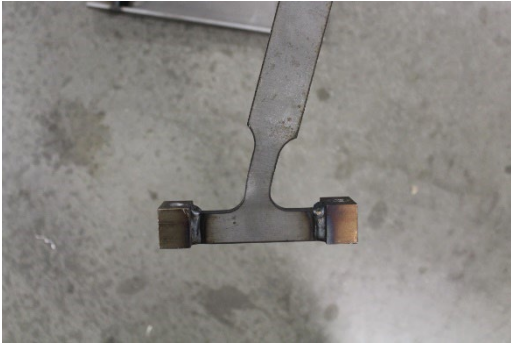
**Figure 41. Test 2BQ Workstation Pedestal Floor**

Deformation to the pedestal where mounted to the floor rail.

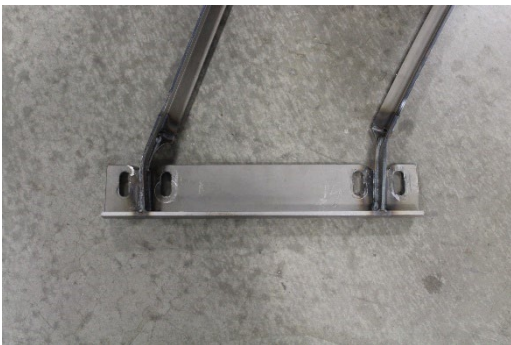
**Figure 43. Test 2BQ Workstation Table Wall Mount**

Deformation to the workstation table where mounted to the simulated wall structure.

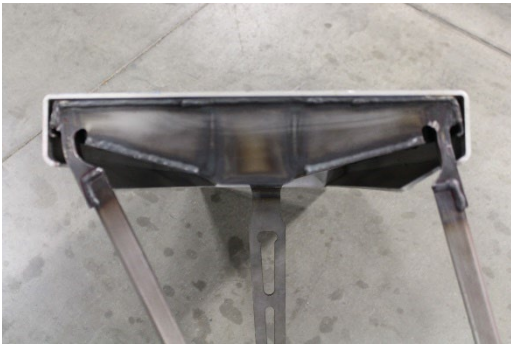
**Figure 44. Test 2BQ Workstation Table Wall**

Deformation to the workstation table where wall mount legs connect to the workstation table base.

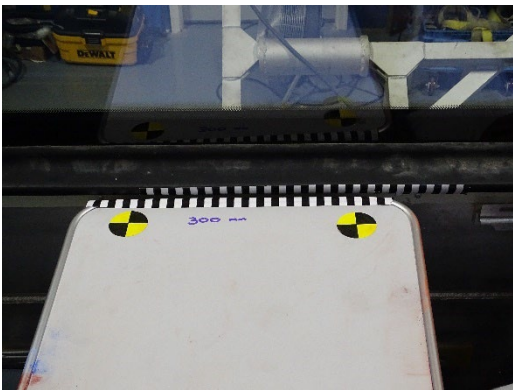
**Figure 48. Test 3A Workstation Table Top**

The workstation table translated approximately 100 mm, as was observed on the inch tape, along the simulated wall mount.

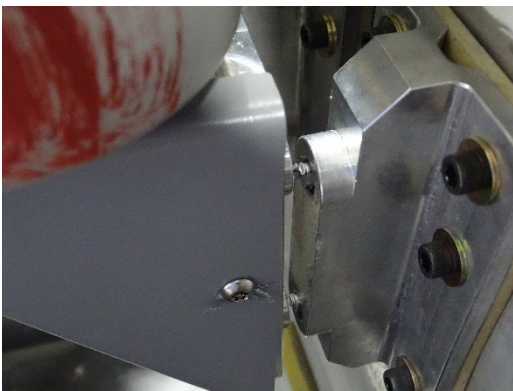
**Figure 49. Test 3A Workstation Table Wall Mount**

The workstation table separated from the simulated wall mount at two separate locations. The wall mount bolts broke off the table mounting locations during the event.

The workstation table in Test 3A was designed to translate while supported by a cantilever attached to a side-wall cutout. A steel bracket was bolted to the simulated carbody wall to hold the wall mounts in position after the rivets failed during Test 3BD. The table translated along the wall mounts during the event. The bolts in two locations along the wall mount broke off from the simulated carbody. No components separated from the workstation table during the event. The THOR-50M left abdominal peak deflection criterion was not met. The THOR-50M sensor for the right abdomen was damaged during the event, resulting in an invalid reading. The minimum survival space remained intact during the event.

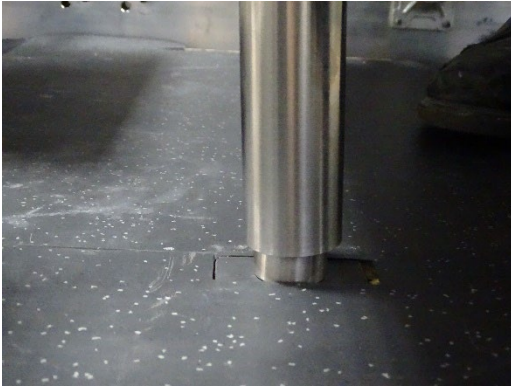
**Figure 50. Test 3A Workstation Table Floor Mount**

The workstation table floor mount remained attached to the floor mounting position. The workstation table post bent slightly toward the impact seat during the event.

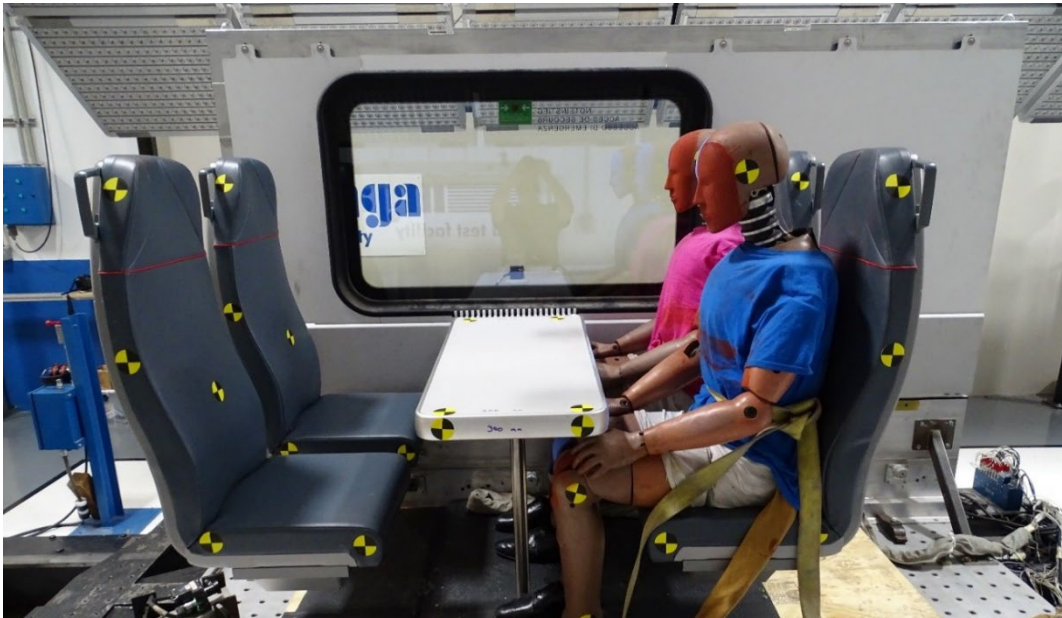
Figure 51. Test 3BD Lateral Pre-test Photo

A two-person passenger seat was mounted to the test sled. A facing seat was mounted to the test sled on the opposite side of the table, at the nominal seat pitch for the intended installation. A fixed workstation table was installed in the middle of the two facing seats. Instrumented ATDs, representative of 50<sup>th</sup> percentile adult males, were positioned to face the direction of travel. Both ATDs were H3-50Ms, as specified in Option B of APTA S-018.

Figure 51 shows the pre-test setup and Figure 52 shows the post-test outcome for Test 3BD.

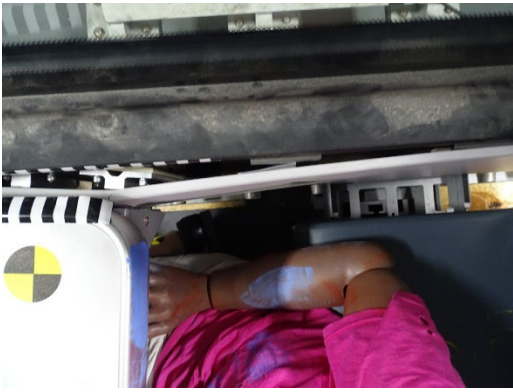
**Figure 53. Test 3BD Workstation Table Wall Mount Brackets**

The wall mount bracket rivets were pulled from the simulated wall mount during the event on the two rearmost brackets. The workstation table translated approximately 90 mm, as was observed on the inch tape, along the simulated wall mount.

The workstation table in Test 3BD was designed to translate along the simulated carbody at the wall mount position. Upon impact, the rivets used for the wall mounting brackets failed. Each wall mounting bracket was intended to have six rivets but were installed only using four – which resulted in two brackets pulling off the wall mount. This caused the workstation table to slide underneath the ribs of both H3-50Ms. The injury criteria were met, but there was limited contact with the chest sensors due to the table sliding lower than expected with respect to the ribs. The minimum survival space was not preserved during the test. The table edge on the aisle-side came within 7.8 inches of the opposing seatback during the test.

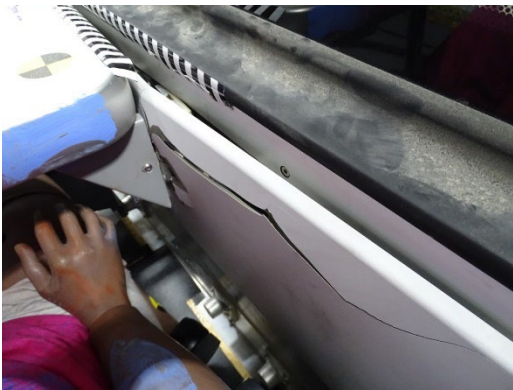
**Figure 54. Test 3BD Wall Panel**

The wall panel cracked due to the wall mount brackets being disconnected from the wall.

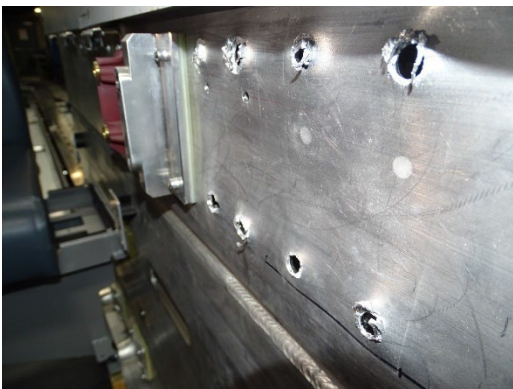
**Figure 55. Test 3BD Rivet Holes**

The wall panel was removed to show the deformation around the rivet holes of the table mount rivets.

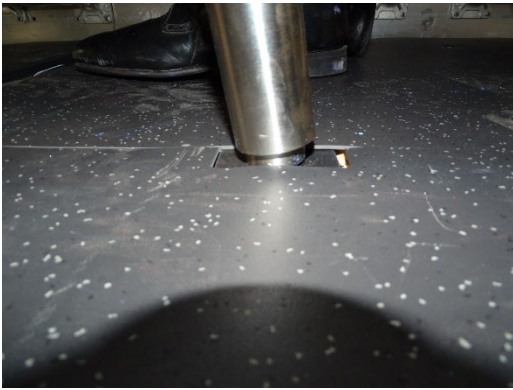
**Figure 56. Test 3BD Workstation Table Floor Mount**

The workstation table floor mount deformed slightly during the event and remained secured to the floor. No separation was observed.

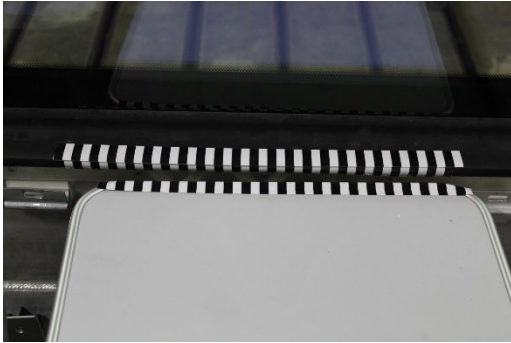
**Figure 59. Test 3BQ Workstation Table Overhead**

The workstation table translated approximately 20 mm, as was observed on the inch tape, along the simulated wall structure.

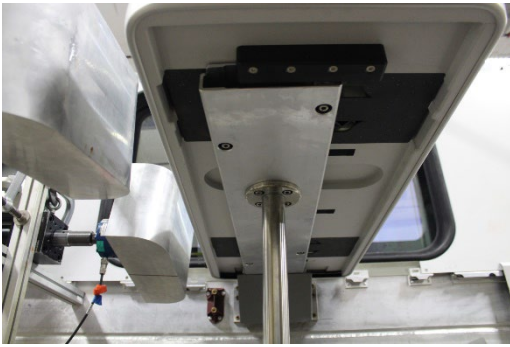
**Figure 60. Test 3BQ Workstation Table Below**

The workstation table translated as designed in the direction of loading.

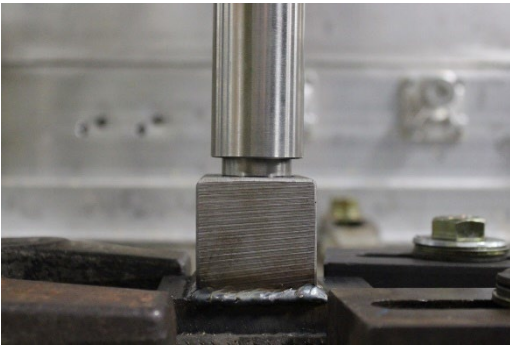
**Figure 61. Test 3BQ Pedestal Floor Mount**

The pedestal floor mount had minimal deformation following loading.

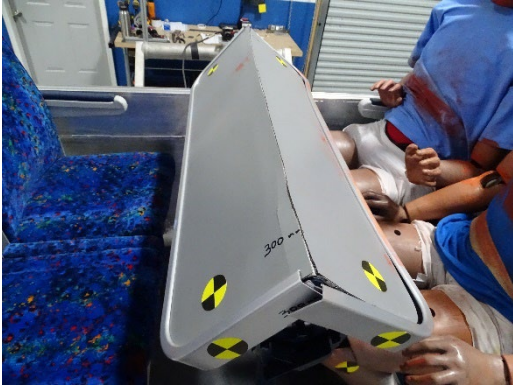
**Figure 64. Test 4A Workstation Table**

The workstation table folded upwards along the mid-table line upon impact during the event. Fractures were observed in tabletop post-test.

The table developed for Test 10 was designed to fold along the length of the table to absorb the impact of the passengers. The table folded on impact as designed. No structural issues were observed. All injury criteria requirements were met for both occupants. The wire for the H3-50M rotary chest potentiometer was pinched during the event and that portion of the test data was excluded from the evaluation because it did not occur during peak compression.

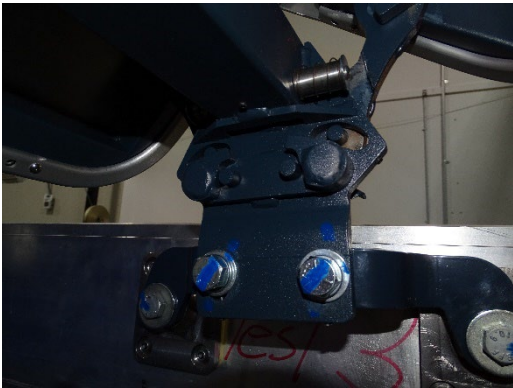
**Figure 65. Test 4A Workstation Table Floor Mount**

The bolts that attached the workstation table to the wall mounting bracket rotated partially during event.

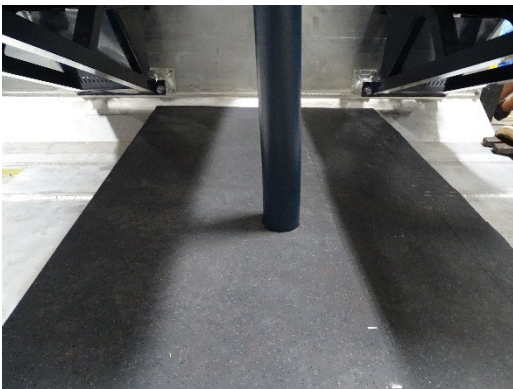
**Figure 66. Test 4A Workstation Table Floor Mount**

There were no structural issues observed with the workstation table floor mount.

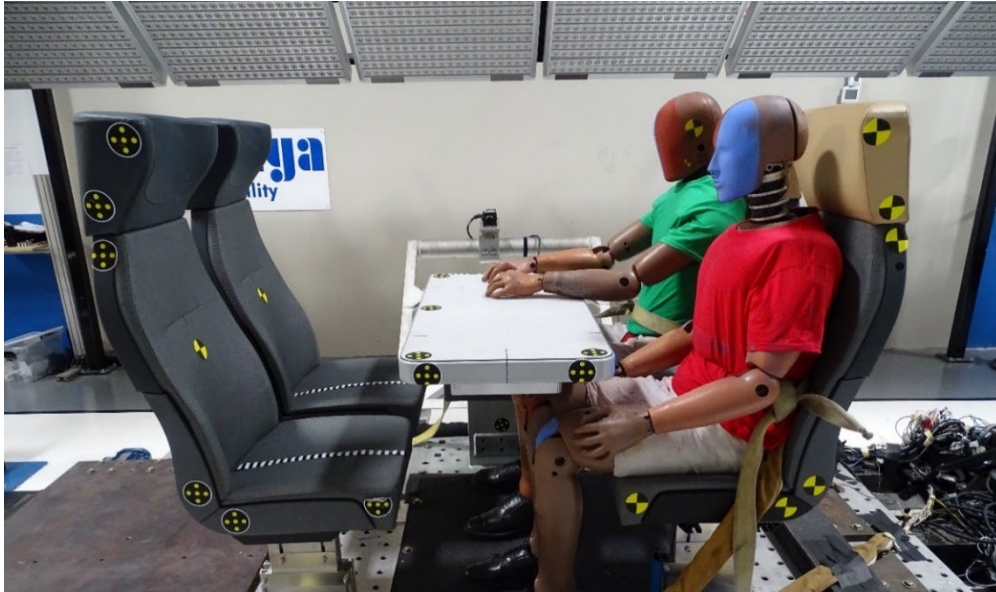
Figure 67. Test 5A Lateral Pre-test Photo

A two-person passenger seat was mounted to the test sled. A facing seat was mounted to the test sled on the opposite side of the table, at the nominal seat pitch for the intended installation. A fixed workstation table was installed in the middle of the two facing seats. Instrumented ATDs, representative of 50<sup>th</sup> percentile adult males, were positioned to face the direction of travel. The aisle-side (left passenger) ATD was an H3-50M, and the wall-side (right passenger) ATD was a THOR-50M, as specified in Option A of APTA S-018.

Figure 67 shows the pre-test setup and Figure 68 shows the post-test outcome for Test 5A.

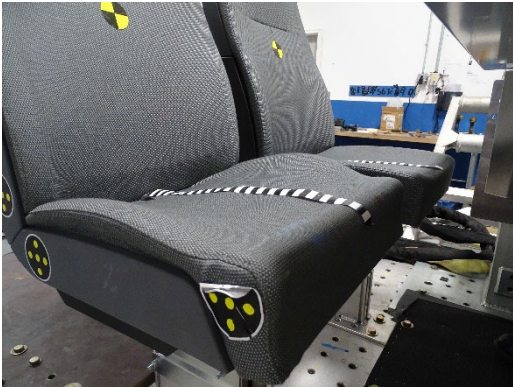
**Figure 69. Test 5A Impact Seat**

Only the aisle-side ATD's knees contacted the impact seat during the event. No structural issues were observed.

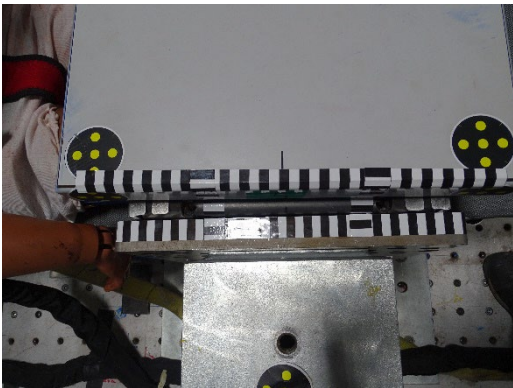
**Figure 70. Test 5A Workstation Table Wall Mount**

No structural issues were observed along the simulated wall mount of the workstation table.

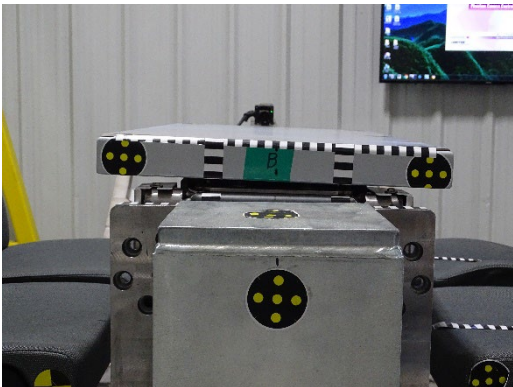
**Figure 71. Test 5A Workstation Table**

The workstation table became slightly deformed during the event. The table was angled slightly toward the impact seat post-test.

The workstation table developed for Test 11 was designed to translate along the simulated carbody at the wall mount position. The table translated as designed upon impact by the ATDs. As the ATDs rebounded, the table returned to its original position. No structural issues were observed during the event. The human injury criteria were met for the THOR-50M and H3-50M,

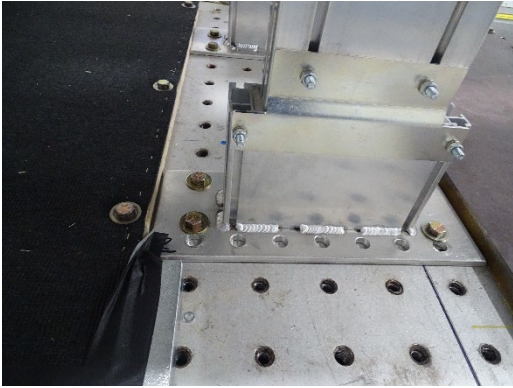
**Figure 72. Test 5A Impact Seat Pedestal**

No structural issues were observed along the impact seat pedestal.
