U.S. Department
of Transportation
Federal Railroad
Administration

Torsional Strength and Stiffness of a Passenger Car Coupling System

1. REPORT DATE (DD-MM-YYYY) 29-06-2022		2. REPORT TYPE Technical Report		3. DATES COVERED (From - To) 9/30/2019 – 6/30/22	
4. TITLE AND SUBTITLE Torsional Strength and Stiffness of a Passenger Car Coupling System				5a. CONTRACT NUMBER 693JJ618D000006 / 693JJ619F000113	
				5b. GRANT NUMBER	
				5c. PROGRAM ELEMENT NUMBER

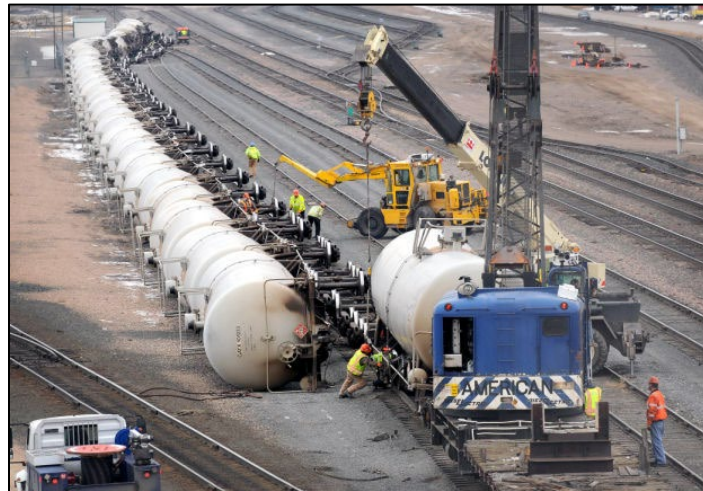
noting, “It is possible that for every ‘domino’ effect multicar rollover, there are also some potential rollovers that are eliminated because of the shelf-type coupler.”

Figure 1. Domino Derailment of Tank Cars

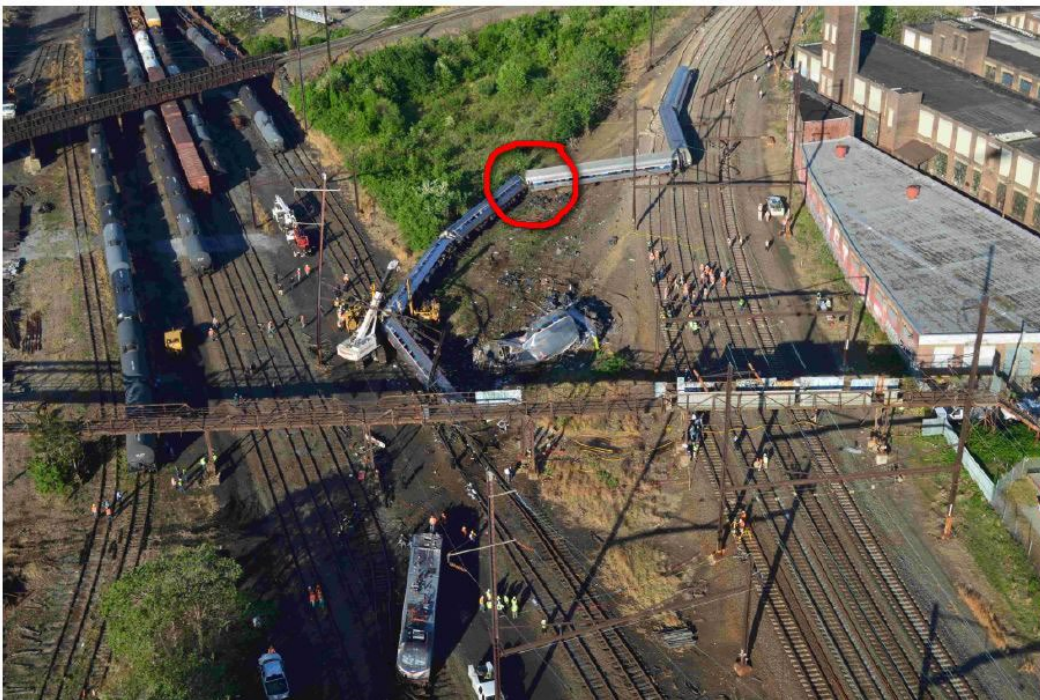
Figure 4. Aerial View of Philadelphia Accident [3]

Some useful information on coupler performance was found in NTSB’s report on the December 8, 2015, Amtrak derailment near Philadelphia, PA [3]. In this accident, a passenger train entered a 50 mph speed-restricted curve at 103 mph and subsequently derailed. [Figure 4](#) shows an aerial view of the derailment. The red circle indicates the connection between the fourth car, which rolled onto its side, and the fifth car, which remained more upright.

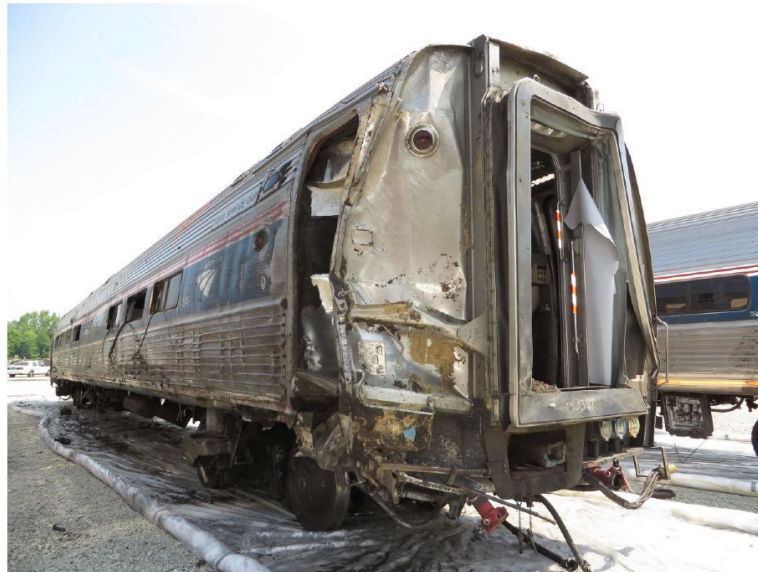
Figure 5 shows the end of the fourth car in the train that was coupled to the fifth car. The coupler shank casting failed across its transverse section. The draft sill remained intact without any extreme deformation.

Figure 5. Fourth Car Coupler Shank Failure

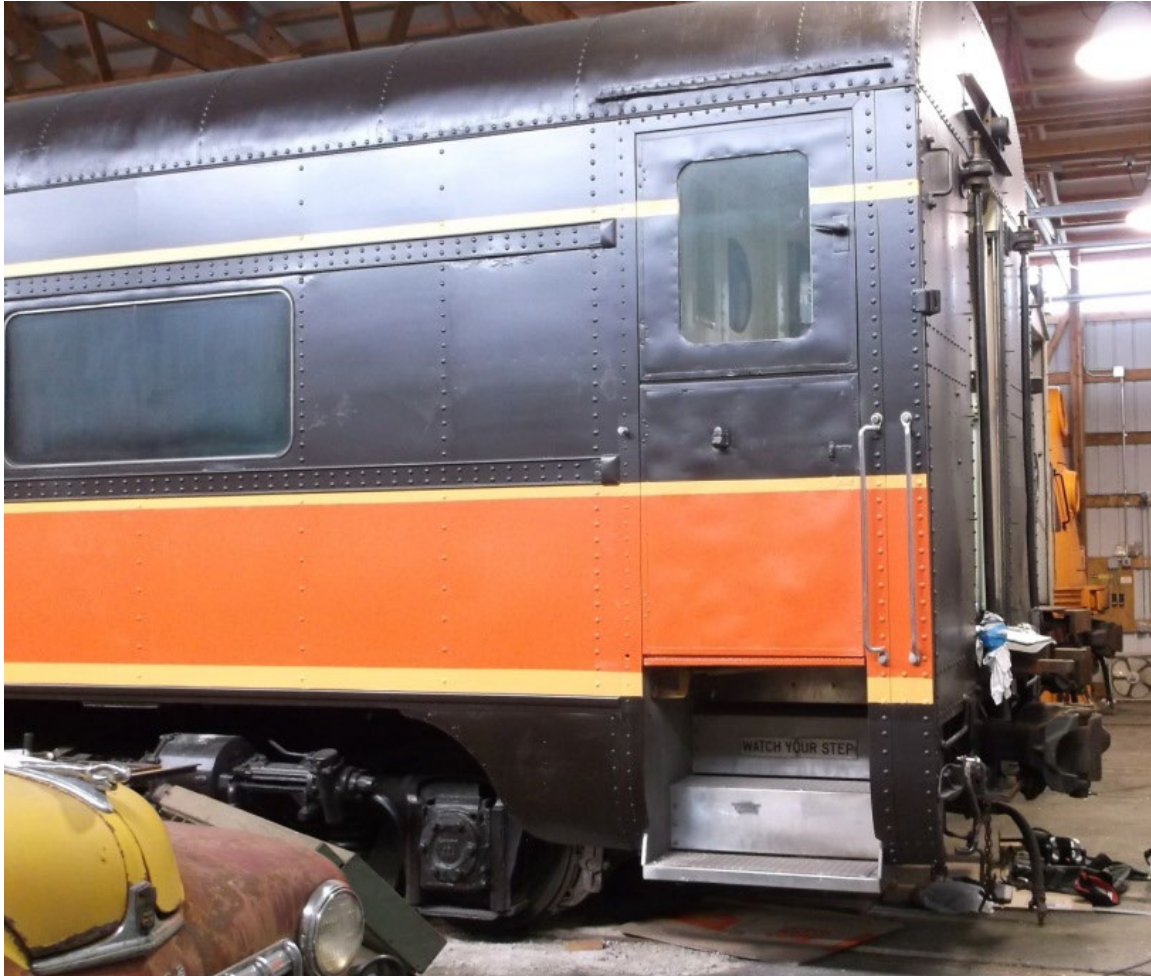
Figure 10. Illinois Central Grill-Coach #3345

Measurements on an Illinois Central (IC) Grill-Coach #3345 (former Missouri Pacific 568) built by American Car and Foundry (lot # 2905) were used to design the draft sill for the full-scale tests. This car had an H-type coupler arrangement like that of the CH81E. Some original manufacturer's drawings of this car were also obtained to aid in the design. [Figure 10](#) shows the end of the coach and [Figure 11](#) is an example of the original drawings.

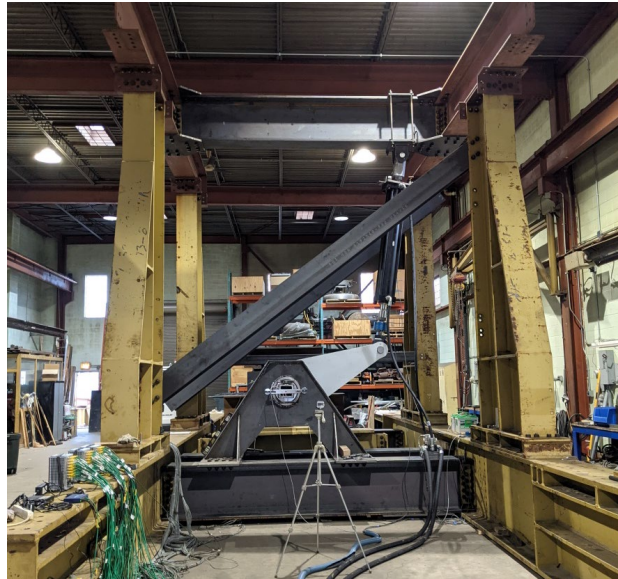
Figure 14. Test Fixture – End View

Figure 14 shows the end of the finished test fixture with the hydraulic actuator. The diagonal beams were included to increase the torsional stiffness of the test fixture.

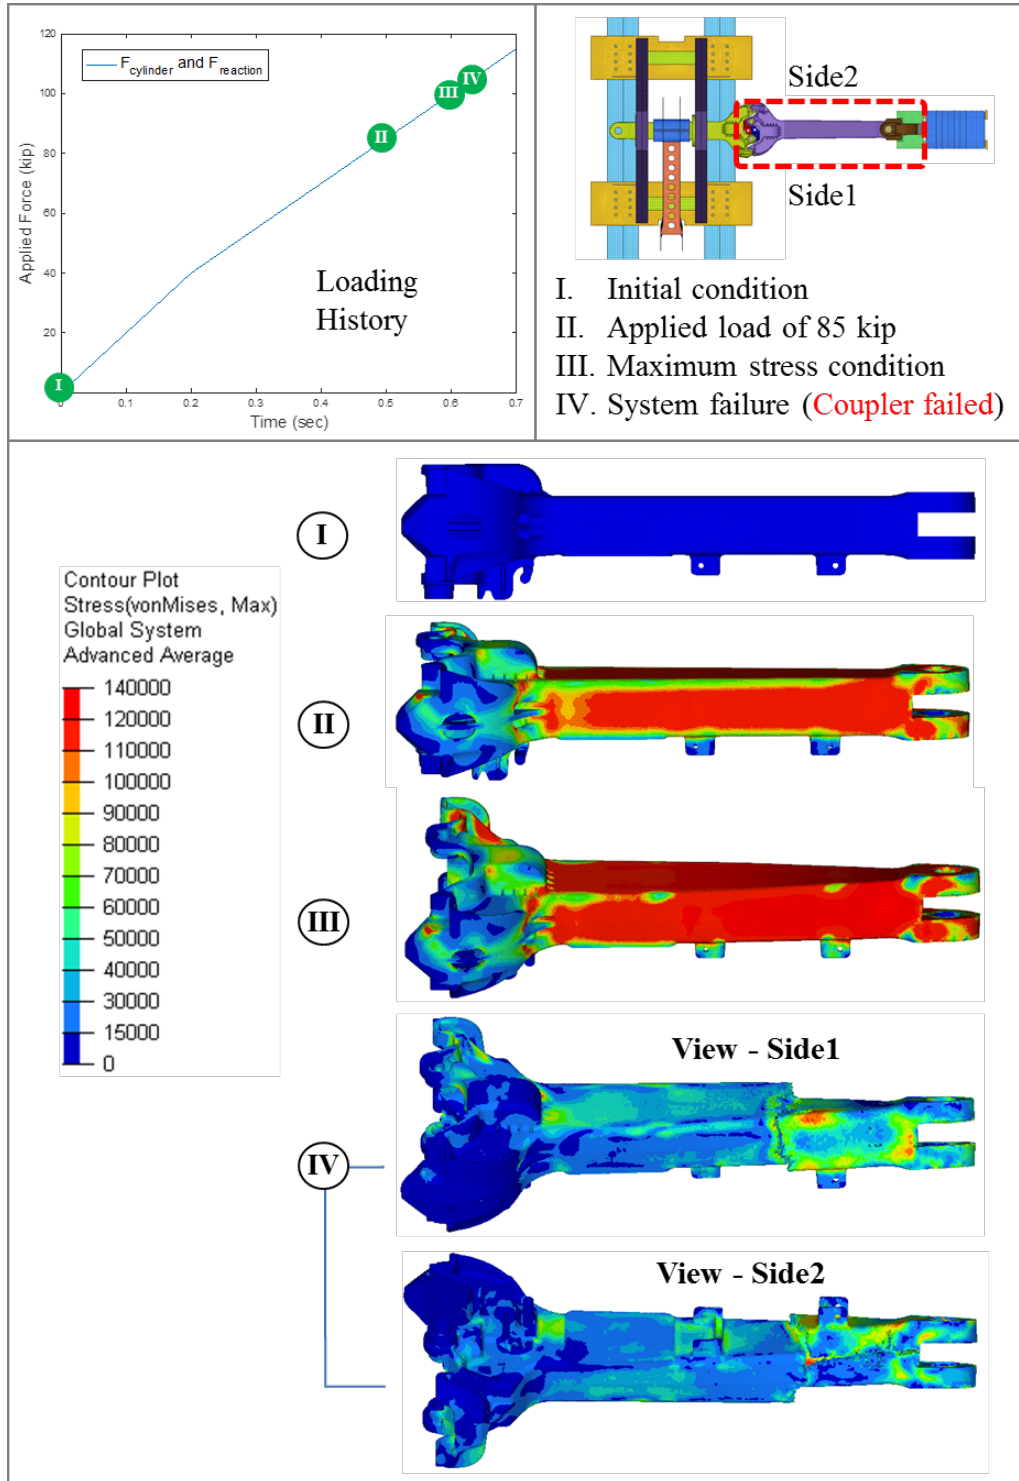
Figure 30 shows the von-Mises stress contours for the test coupler at progressive levels of twist. The maximum coupler stress can be observed at point III, directly before the failure. The coupler shank fracture can be seen in the last image (at point IV in the loading history) where the fracture is shown from two side views.

Figure 30. von-Mises Stress Contours - Coupler Failure Model

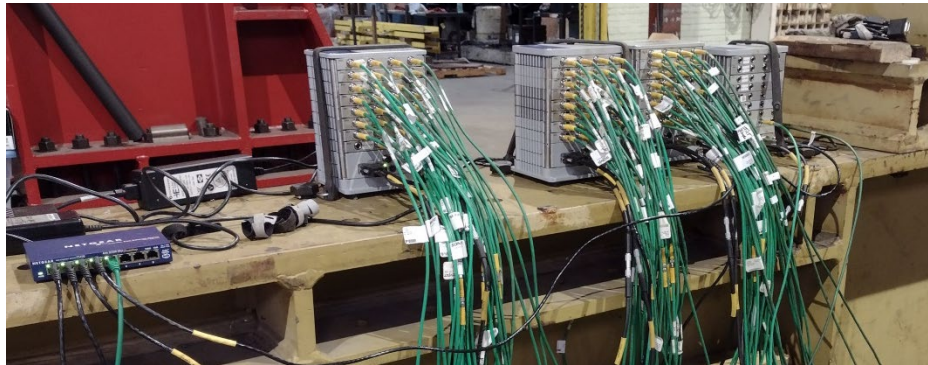
Figure 31. Data Acquisition System

Figure 31 shows the Somat e-DAQ lite data acquisition system used in the testing. The sample rate was 100 samples/second with a 33 Hz filter on the strain and displacement channels and a 15 Hz filter on the force and tilt channels.

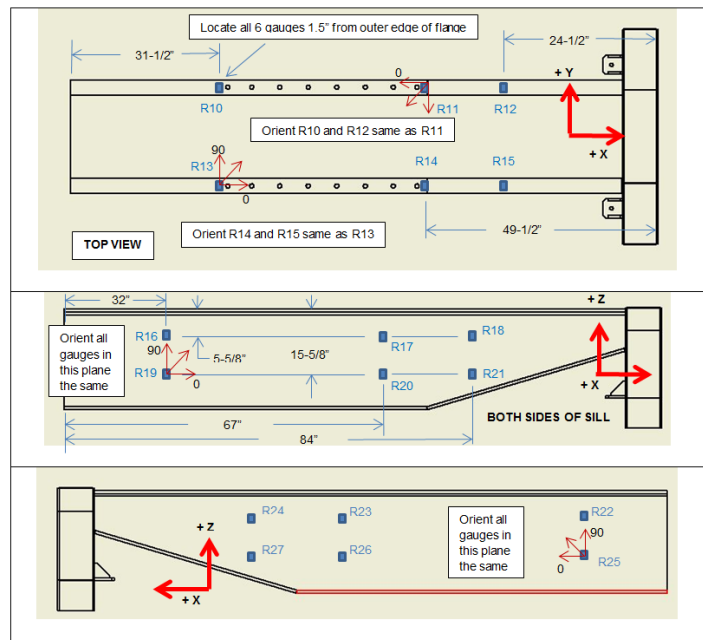
Figure 34 shows the locations of the strain gauges on the draft sill for the Coupler/Draft Sill System Test.

Figure 34. Strain Gage locations on Draft Sill

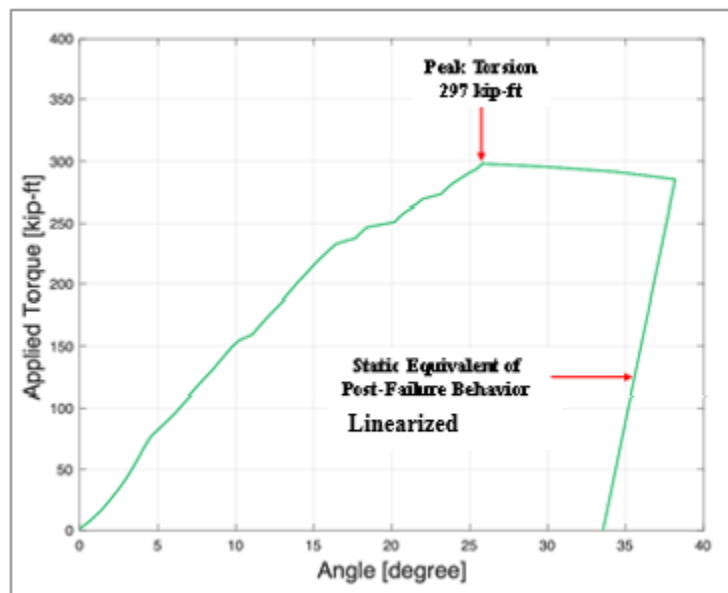
Researchers measured the cylinder force data and lever arm angle at each load step. Figure 40 shows the relationship between applied cylinder force and actuating coupler rotation in the Coupler/Draft Sill System Test. The resulting torque values were calculated and plotted against the angle of rotation, as shown in Figure 41.

Figure 41. Applied Torque vs. Actuating Coupler Rotation – Coupler/Draft Sill System Test

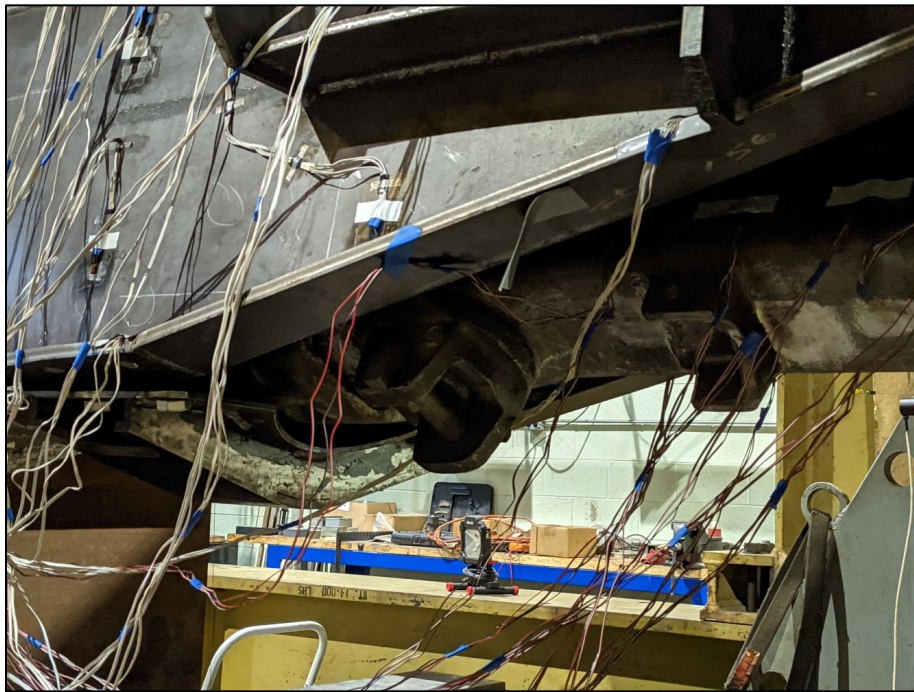
Figure 43. Draft Sill and Bolt Failure – View 2

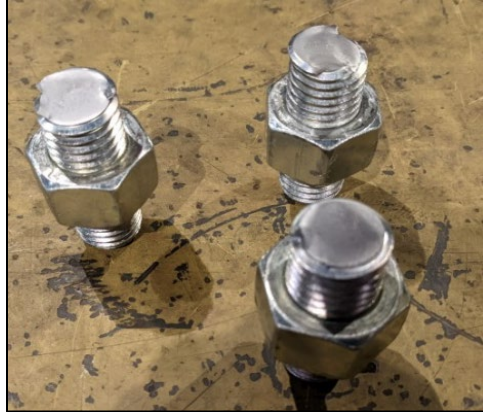
Figure 44. Shear Failure of Bolts

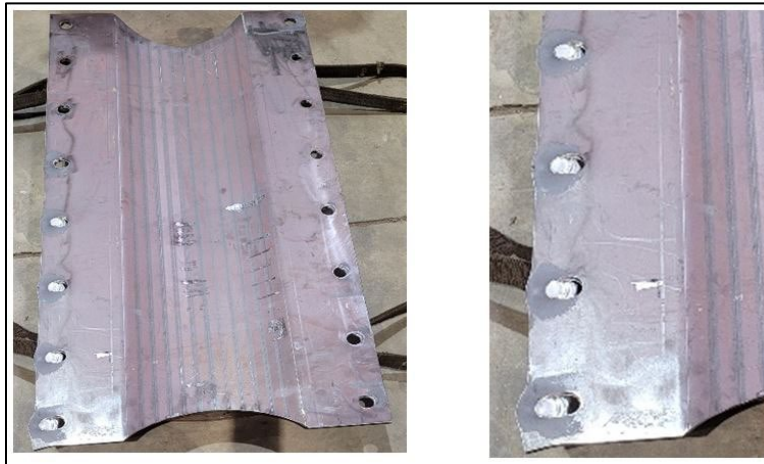
Figure 45. Hole Elongation on Retainer Plate

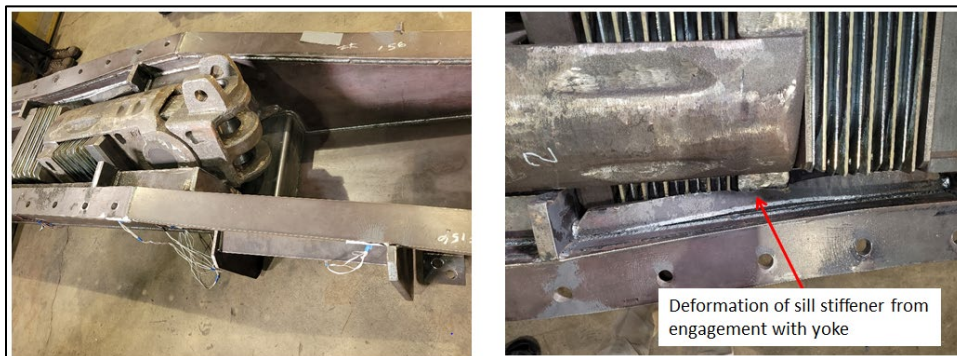
Figure 46. Post Test After Disassembly – View 1

Figure 46 and Figure 47 show the contacts made between the draft gear, radial connector, and follower block and the draft sill after failure. The yoke had grabbed on to one of the draft sill's longitudinal stiffeners and deformed it. The radial connector had also dug into the draft stops of the draft sill.

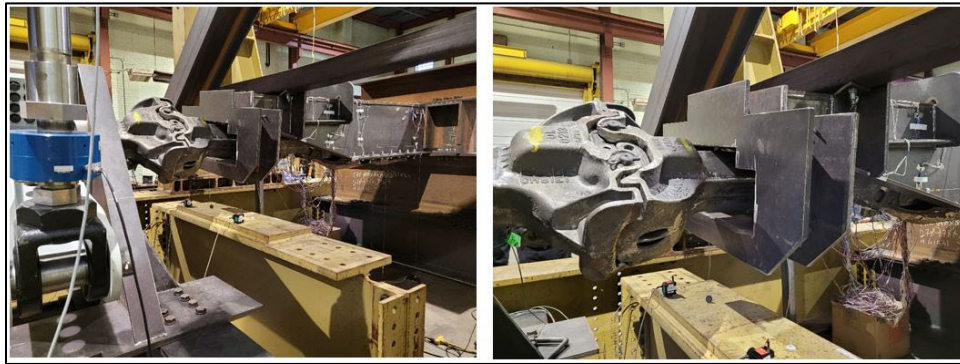
Figure 48. Rotation of Couplers – Post Test

Figure 48 is a post-test view of the test coupler engagement and rotation. A 1-degree permanent twist of the test coupler was measured after removal from the test fixture.

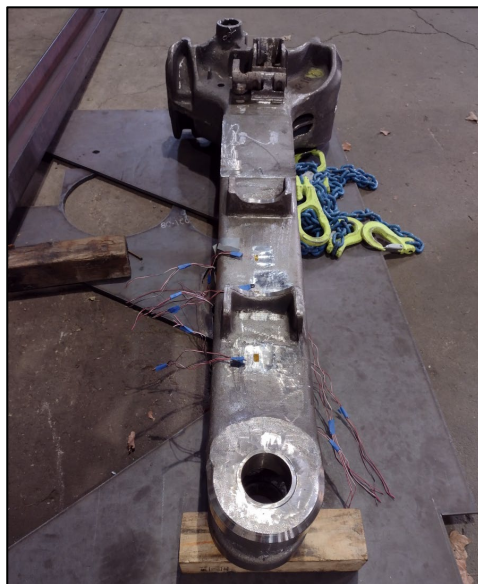
Figure 49. Test Coupler Underside - Post Test

Figure 49 shows the underside of the coupler after the test. The strains from the gauges on the coupler indicated stresses would be at or (in some small local areas) beyond yield. No measurable deformation occurred to the radial connector or yoke.

From these results, the team estimated that the stress state at peak load on the test coupler was independent of the coupler/draft sill system failure mode. In other words, based on the load path, the stresses on the coupler would have been similar even if the system had taken the coupler failure path.

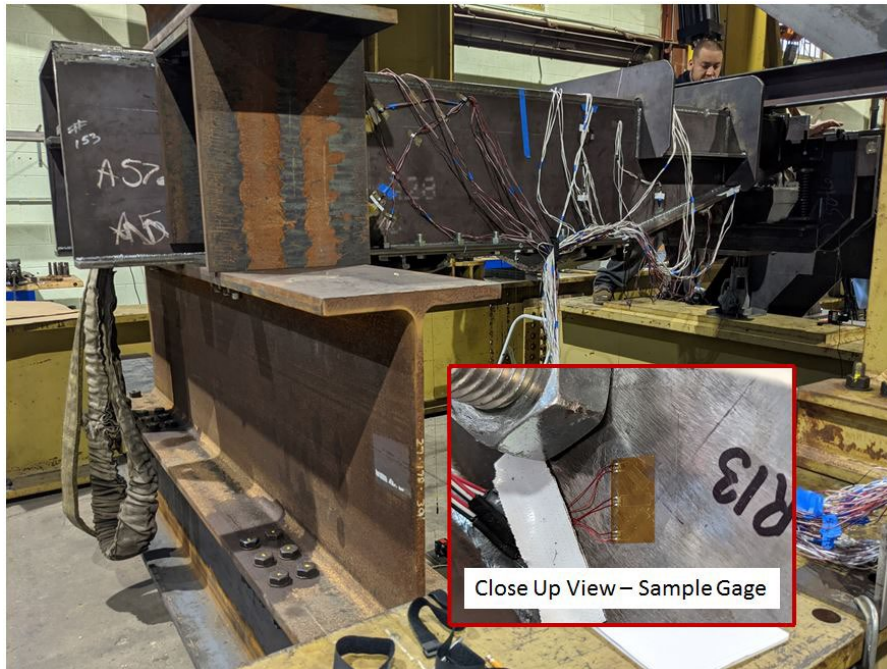
Figure B 1. Example Strain Gauge Application

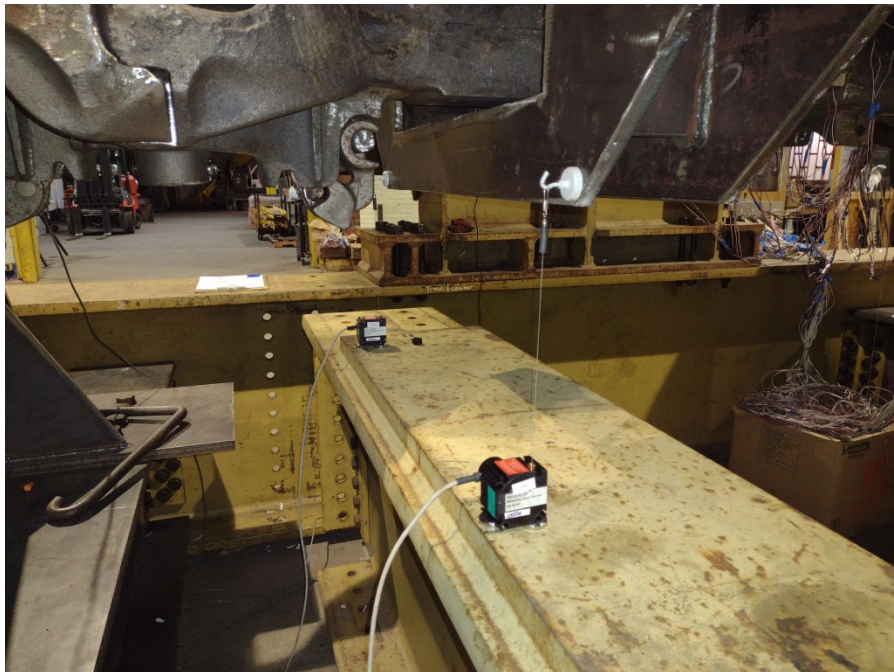
Figure B 2. Example Displacement Transducer Application
