U.S. Department  
of Transportation  
**Federal Railroad  
Administration**

# Load Environment Characterization of Tank Car Stub Sill During Revenue Operations

6. AUTHOR(S) Timothy Martin ORCID <a href="https://orcid.org/0000-0002-5280-3142">0000-0002-5280-3142</a>				
7. PERFORMING ORGANIZATION NAME(S) AND ADDRESS(ES) ENSCO, Inc 5400 Port Royal Rd., Springfield, VA 22151			8. PERFORMING ORGANIZATION REPORT NUMBER  SERV-REPT-0003074

9. SPONSORING/MONITORING AGENCY NAME(S) AND ADDRESS(ES) U.S. Department of Transportation Federal Railroad Administration Office of Railroad Policy and Development Office of Research and Development Washington, DC 20590			10. SPONSORING/MONITORING AGENCY REPORT NUMBER  DOT/FRA/ORD-23/34

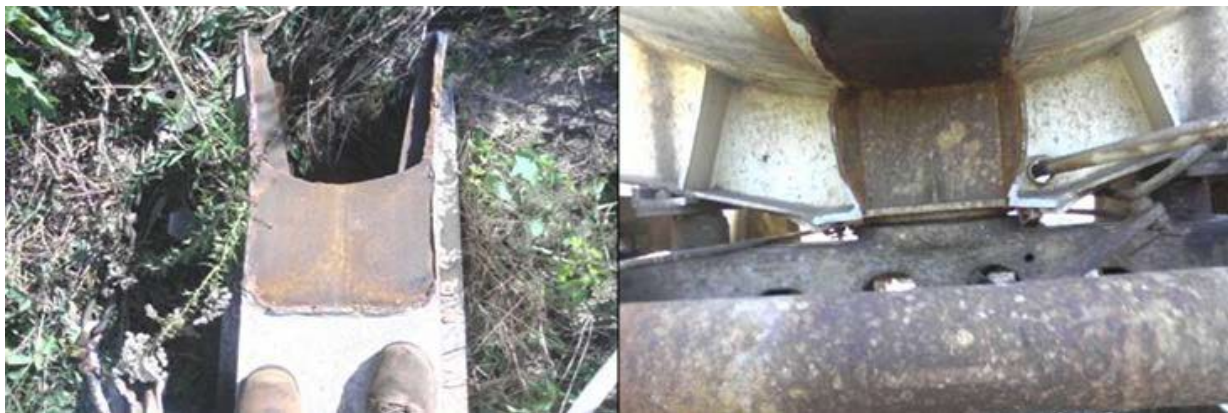
**Figure 1. Stub Sill Fracture Observed in Callahan, FL, from December 2009 (Sundaram, 2014)**

Examples of stub sill fractures observed by CSX Transportation are shown in [Figure 1](#) and [Figure 2](#). These fractures are catastrophic in nature. However, the industry has improved weld design so that the weld between the head brace and stub sill should fail before the weld between the pad and tank.

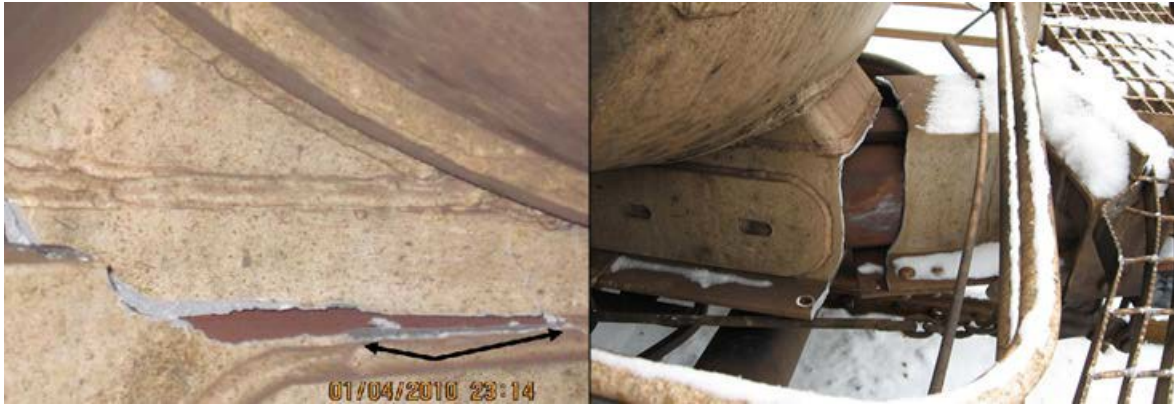
**Figure 2. Stub Sill Fracture Observed in Charleston, WV, from January 2010 (Sundaram, 2014)**

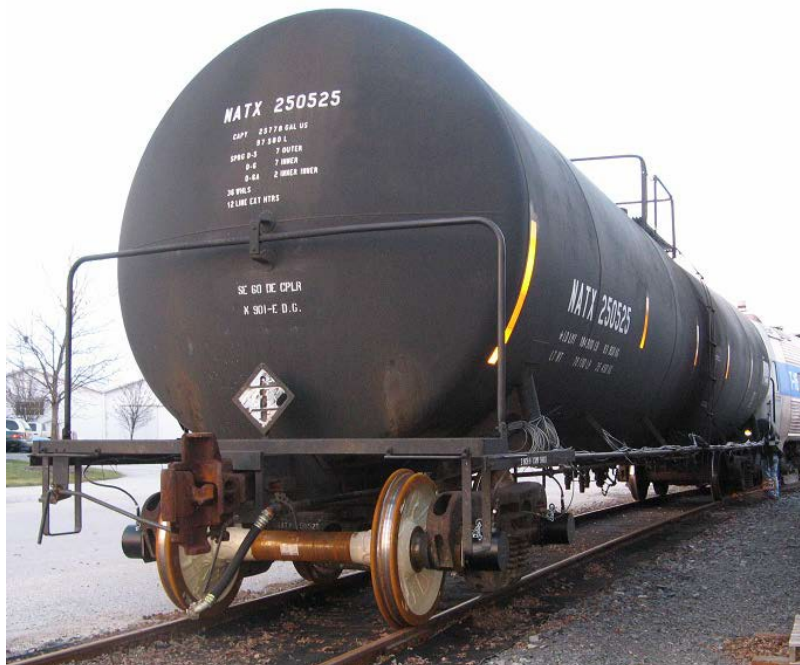
**Figure 3. Instrumented Tank Car**

To better characterize the load environment of tank car operations in yards, a research team conducted a cooperative test program at Amsted Rail's test facility in Camp Hill, PA, in 2018. Under that effort, the team instrumented a tank car loaned to FRA by Union Tank Car with multiple transducers including accelerometers, instrumented couplers, and strain gauges. Researchers employed a data collection system that supported the high sampling rates required for conducting impact testing and collected impact data for various car configurations, end-of-car units, and coupling speeds. [Figure 3](#) shows the study tank car provided by Union Tank Car. [Figure 4](#) shows a detailed view of the end of the tank car with the stub sill attachment. A previous report by FRA (Meymand, 2019) documented the results of this impact testing.

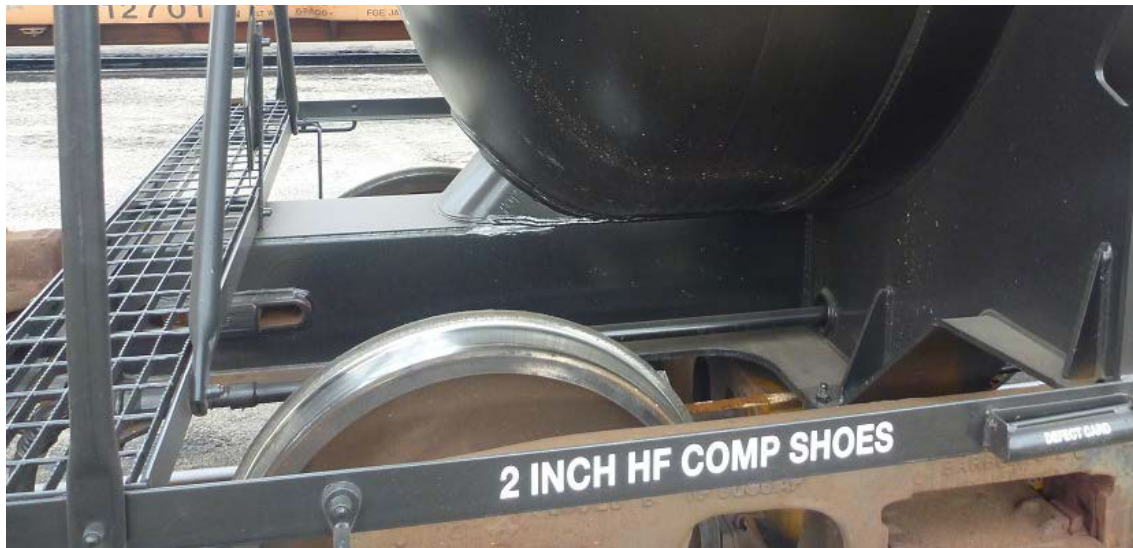
**Figure 4. Detail View of the Stub Sill and Head Brace Attached to the Tank of the Instrumented Tank Car**

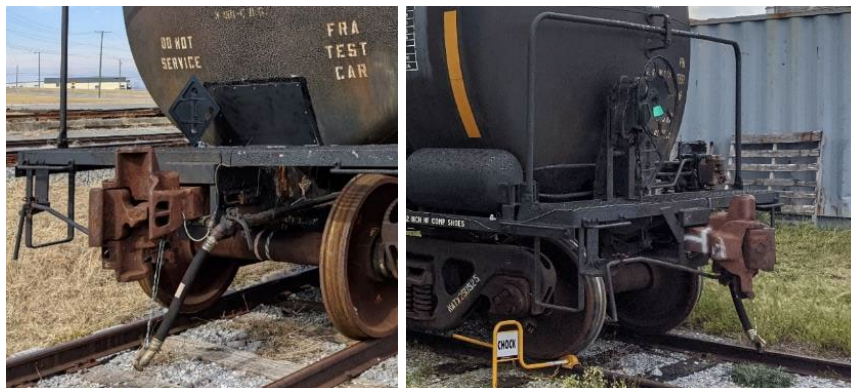
Figure 6. Instrumented Couplers for Measuring Longitudinal Coupler Forces (A-End on Left, B-End on Right)

Researchers measured the longitudinal coupler forces on both the A-end and B-end of the tank car. Two instrumented couplers outfitted with strain gauge bridges measured the longitudinal forces. Figure 6 shows an image of instrumented couplers installed on both ends of the car.

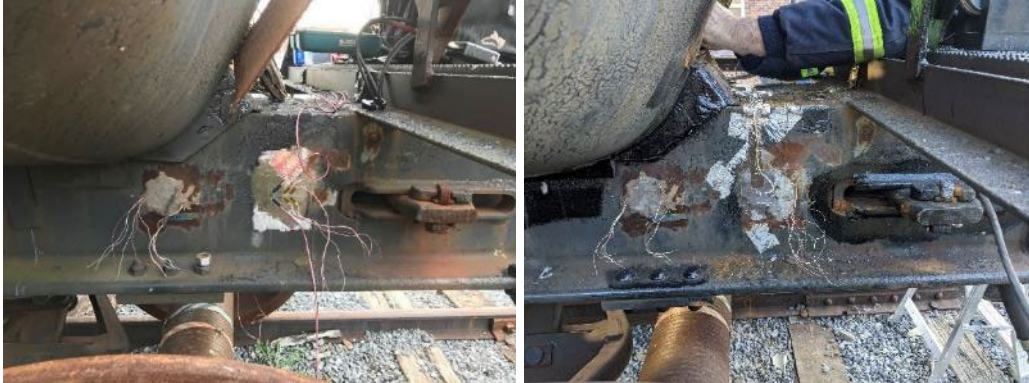
To measure vertical forces, the team mounted a pair of shear strain gauges on each side of the stub sill (Figure 7). The left picture shows the old gauges in black, while the right picture shows the new gauges covered with tape. Researchers wired the shear strain gauges to form a full bridge. The mounting process included grinding and polishing the coupler surface to provide a smooth area to which the strain gauges were welded. The team used RTV silicone rubber coatings as protective and waterproofing coatings. Team members applied these shear strain gauges only on the A-end of the instrumented tank car.

**Figure 7. Strain Gages Installed on the Stub Sill for Measuring Vertical Coupler Force (Old on Left, New on Right)**

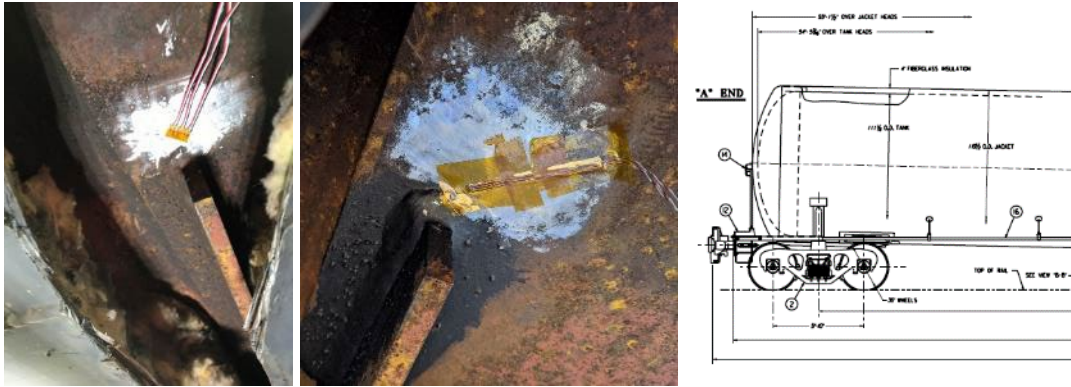
Figure 9 shows the rosette strain gauge installed under the car at the end of the stub sill. This gage is referred to as the in-board strain gauge. The left picture shows the old installation, while the center picture shows the new installation after it has been covered with transparent tape.

**Figure 9. In-Board Strain Gage Installed Under the Car at the End of the Stub Sill Beam (Old on Left, New in Center)**

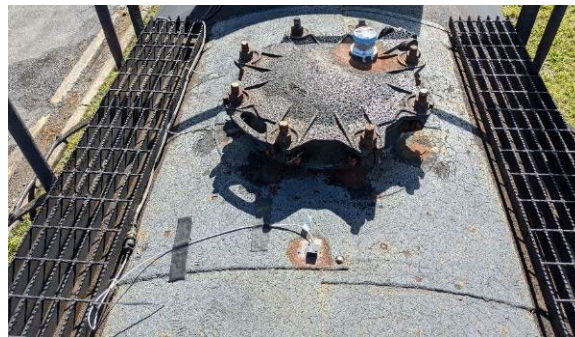
The team installed five accelerometers at multiple locations on the tank car. Figure 13 shows a tri-axial accelerometer mounted on top of the carbody to measure accelerations in longitudinal, lateral, and vertical directions. Figure 14 shows two tri-axial accelerometers mounted on the stub sill at each end of the car and one accelerometer mounted to the axle.

**Figure 13. Tri-Axial Accelerometer Mounted on Top of the Carbody**

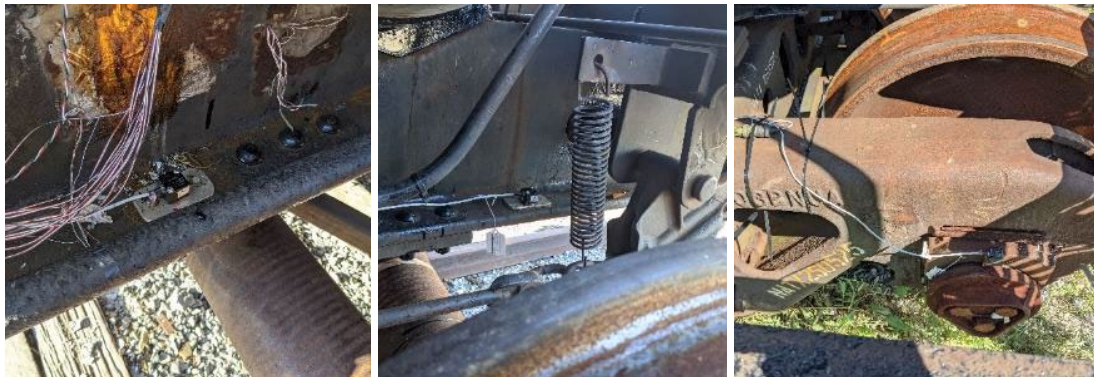
**Figure 14. Accelerometers Mounted on the Stub Sills and Axle (Stub Sill A-End on Left, Stub Sill B-End in Center, Axle on Right)**

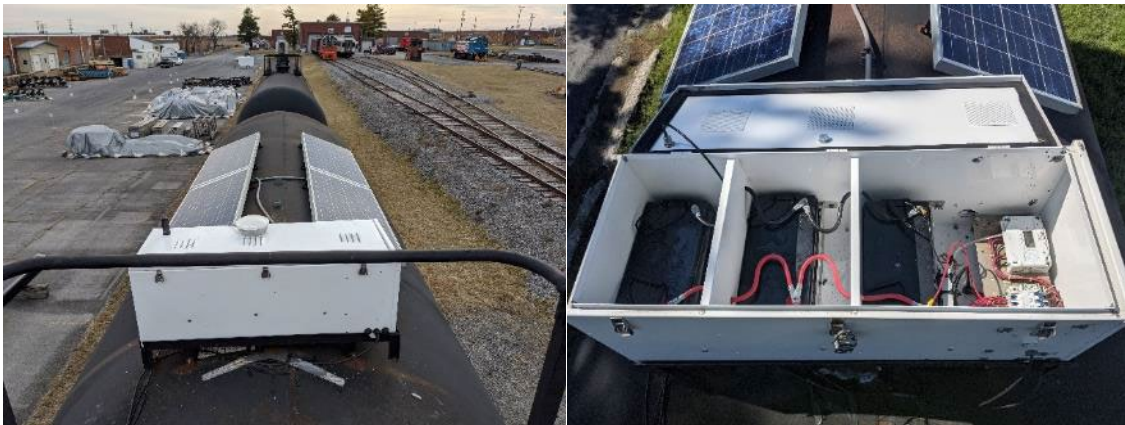
Four 115 W, 12 V solar modules, solar panels, and a set of 110 Ah, 12 V AGM batteries powered the system. [Figure 16](#) shows the solar panels and the battery box. The battery box also contained the electronics that controlled battery charging.

**Figure 16. Solar Panel and Battery Box on Top of Instrumented Tank Car**

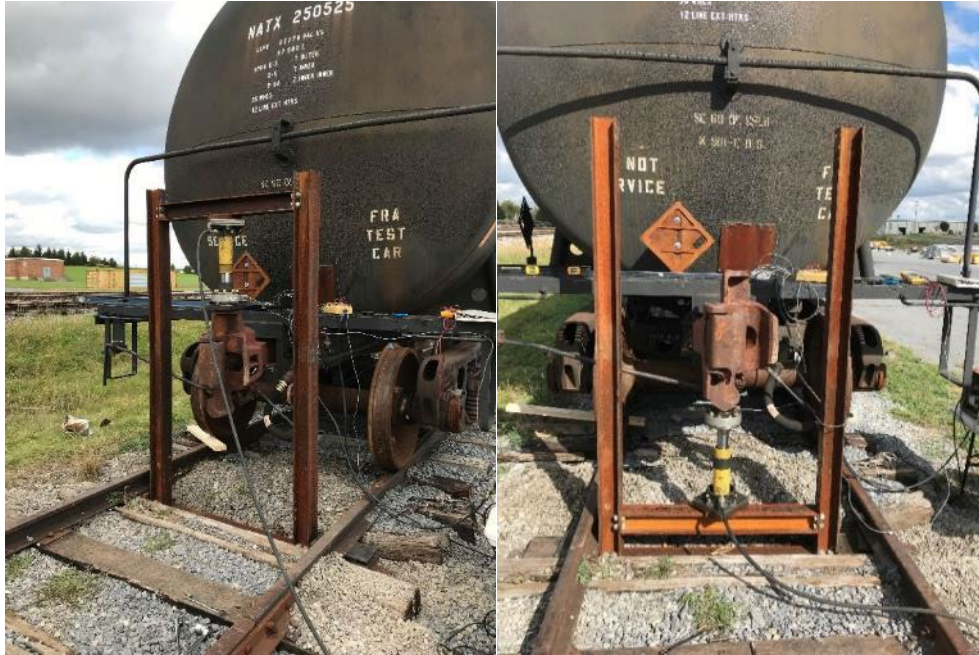
Researchers calibrated the vertical coupler force in the field using a custom load fixture consisting of a metal frame, a calibrated load cell, and a hydraulic ram to apply vertical loads. [Figure 17](#) shows the calibration fixture when downward (left) and upward (right) vertical forces were applied.

**Figure 17. Vertical Coupler Force Calibration Setup (Downward Force on Left, Upward Force on Right)**

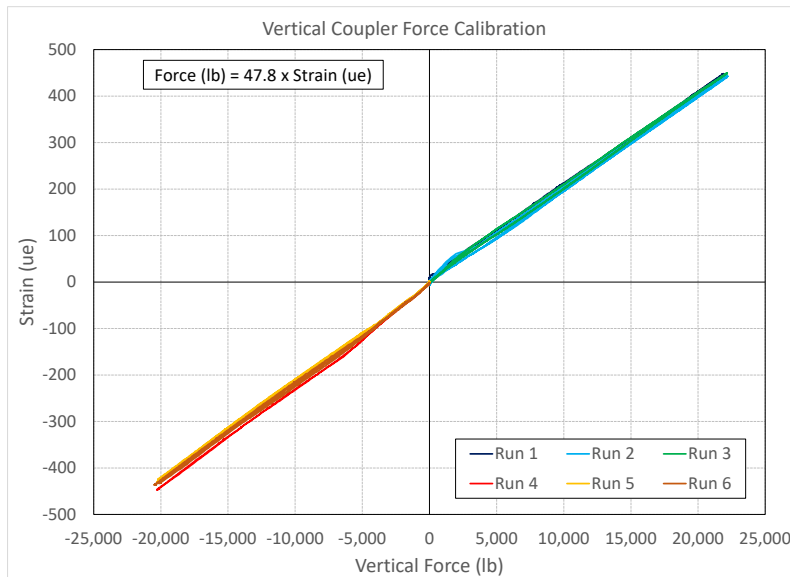
The team measured the applied force and the strain gauges' full bridge output at several points for both upward and downward loadings. The procedure was conducted three times in each direction. [Figure 18](#) shows a graph of the calibration results for the vertical coupler force.

**Figure 18. Vertical Coupler Force Calibration Results**

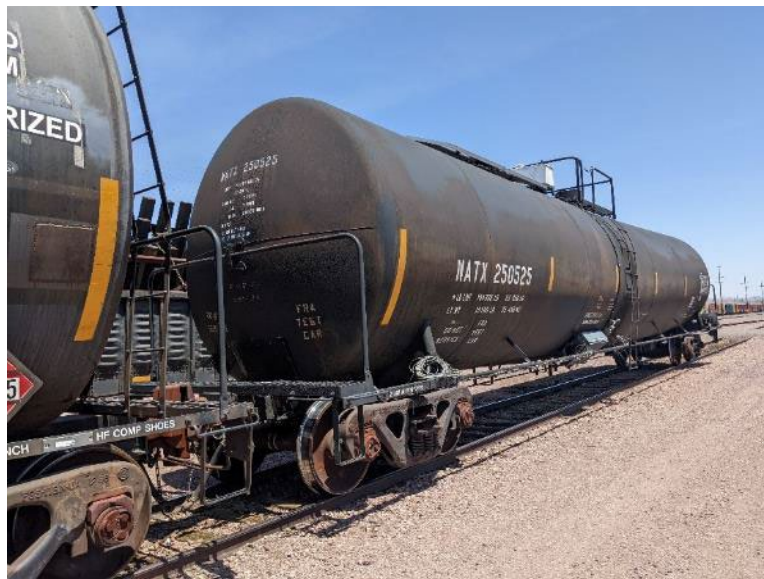
The research team conducted the autonomous test program on two Class I railroads across the United States between March 2022 and December 2022. The test program included a series of railroad moves across portions of the country. [Figure 19](#) shows the instrumented tank car in a yard during the autonomous testing.

**Figure 19. Instrumented Tank Car in a Yard During Autonomous Test**

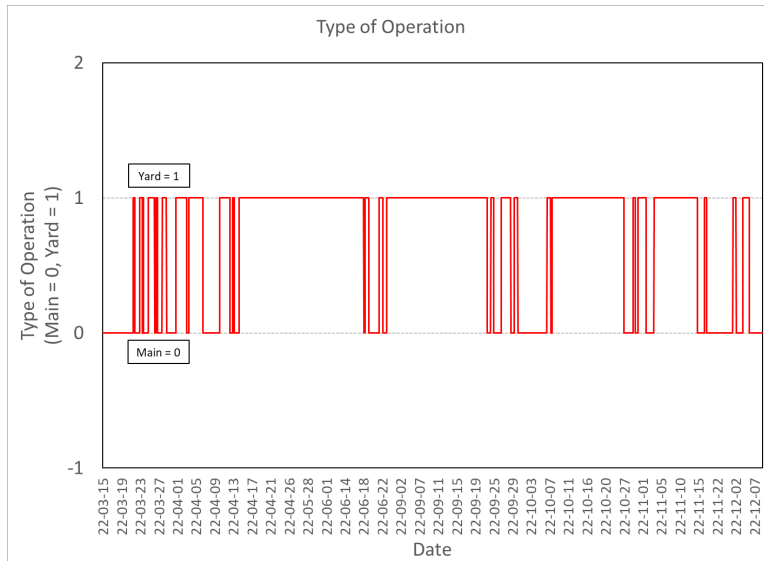
To determine if the movement was main or yard operation, the team mapped the GPS coordinates to see if the location was in a yard. If the tank car experienced many short movements in a yard location, this was considered yard operation for this analysis. On the other hand, if the tank car merely stopped at a single location in a yard, this was considered main operation for this analysis since no coupling action occurred. [Figure 20](#) shows a plot of the type of operation by date for the entire testing period. Note that much of the time was spent in yards waiting to be put in a different consist.

**Figure 20. Type of Operation (or Movement) for the Entire Test**

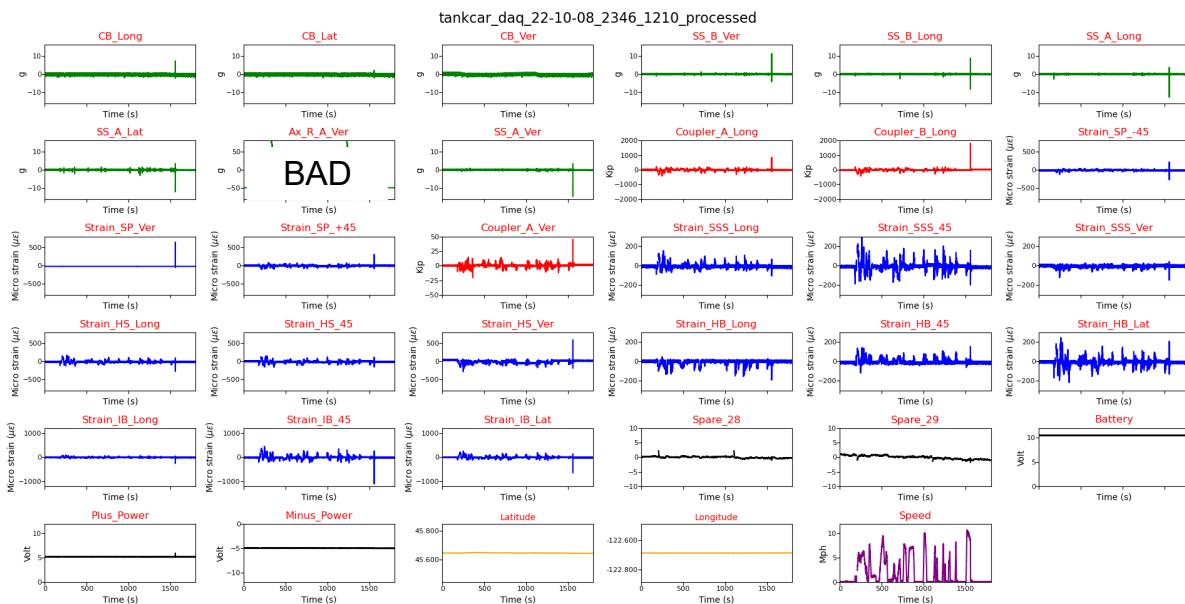
The team plotted all channels from each data file. Figure 21 shows an example of these plots from the data file with the largest longitudinal coupler force. By using the summary file and the individual file plots, each file was evaluated to determine whether the data it contained was good or bad. If there was a bad channel in a particular file, only that channel was excluded for that file. After reviewing all data files, it was determined that most of the data was good with a few exceptions (as noted in Section 2.3).

**Figure 21. Plot with Highest Yard Longitudinal Coupler Forces (Yard 1, Full File)**

Figure 21 plots 30 minutes for all channels from a sample file with the highest longitudinal coupler forces. Figure 22 shows a highly magnified view of the peak signals from the same file. These plots show the accelerations in green, forces in red, strains in blue, and speed in purple. The speed signal shows many short movements from 0 to 10 mph. This is indicative of yard movements while the railroad assembles the train consist. These plots show many peaks in the forces, acceleration, and strains corresponding to these movements. The magnified view shows the biggest peak in the longitudinal coupler force at approximately 1556 seconds. This corresponds to a sudden drop in speed which was probably caused by the yard impact during the assembly of the train consist. Most of the other channels also show significant peaks at this point.

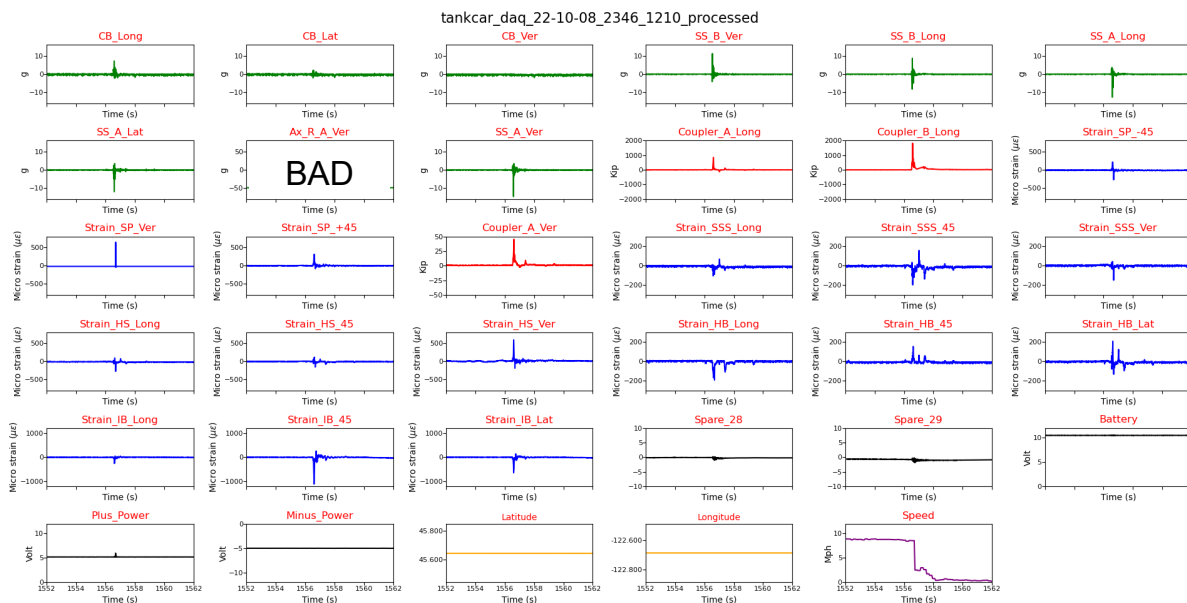
**Figure 22. Magnified Plot with Highest Hard Longitudinal Coupler Forces (Yard 1, Magnified)**

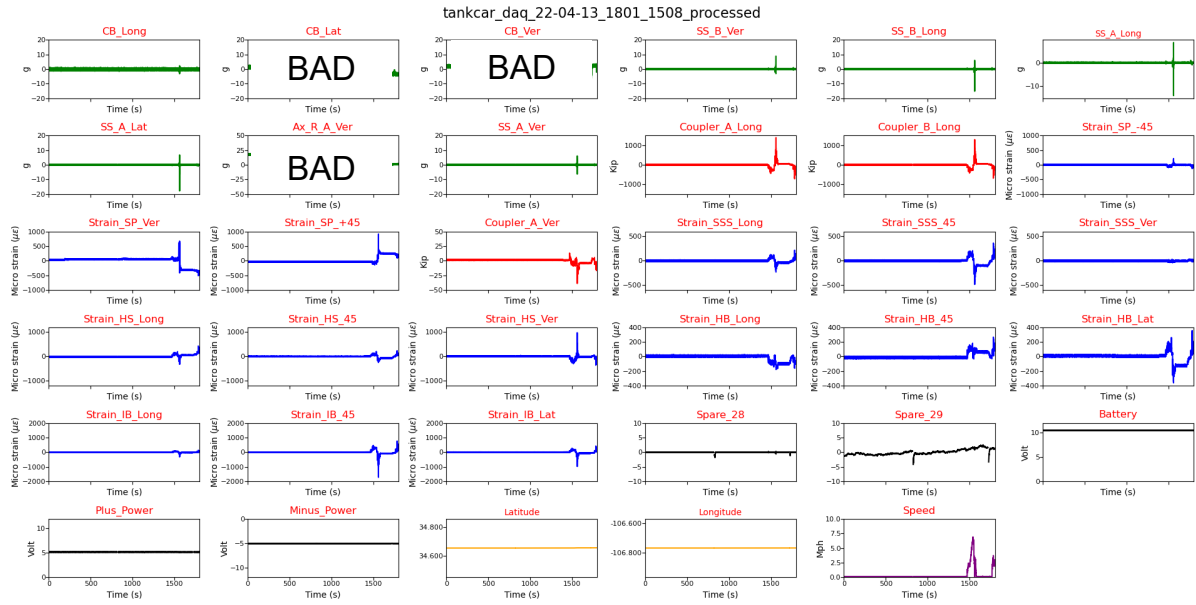
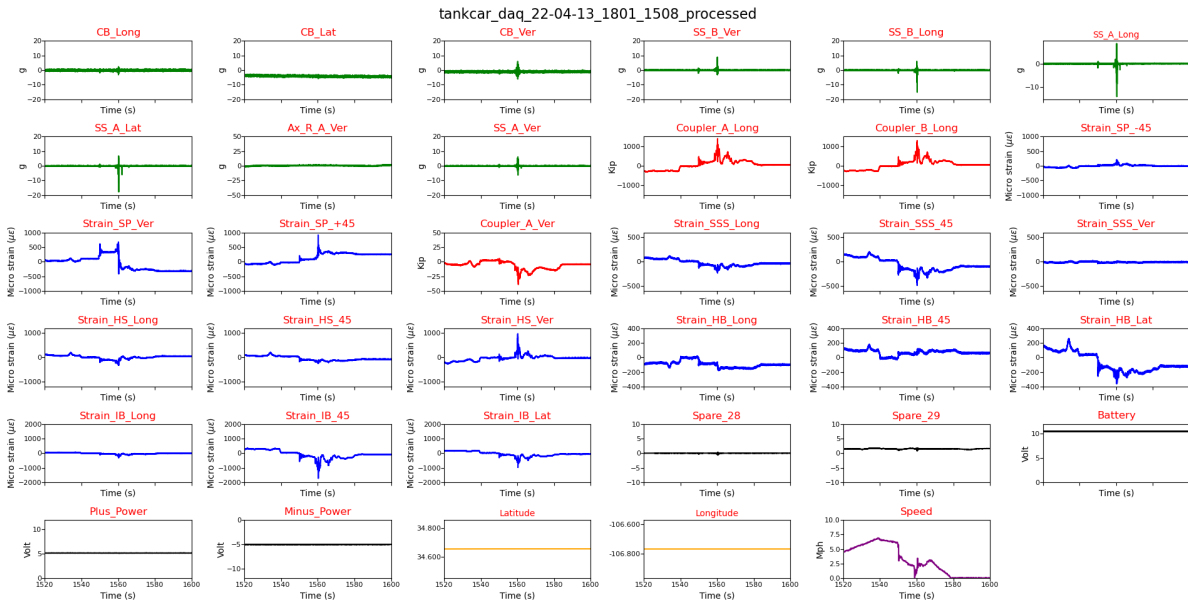
Figure 23 and Figure 24 plot the full file and magnified view of the second highest longitudinal coupler force for yard operations, respectively. Figure 25 and Figure 26 plot the full file and magnified view of the third highest longitudinal coupler force for yard operations, respectively. Figure 27 and Figure 28 plot the full file and magnified view of the fourth highest longitudinal coupler force for yard operations, respectively. All of these yard operation plots are indicative of yard movements as part of the train consist assembly.

**Figure 23. Plot with Second Highest Yard Longitudinal Coupler Forces  
(Yard 2, Full File)**

**Figure 24. Zoomed-In Plot with Second Highest Yard Longitudinal Coupler Forces  
(Yard 2, Magnified)**

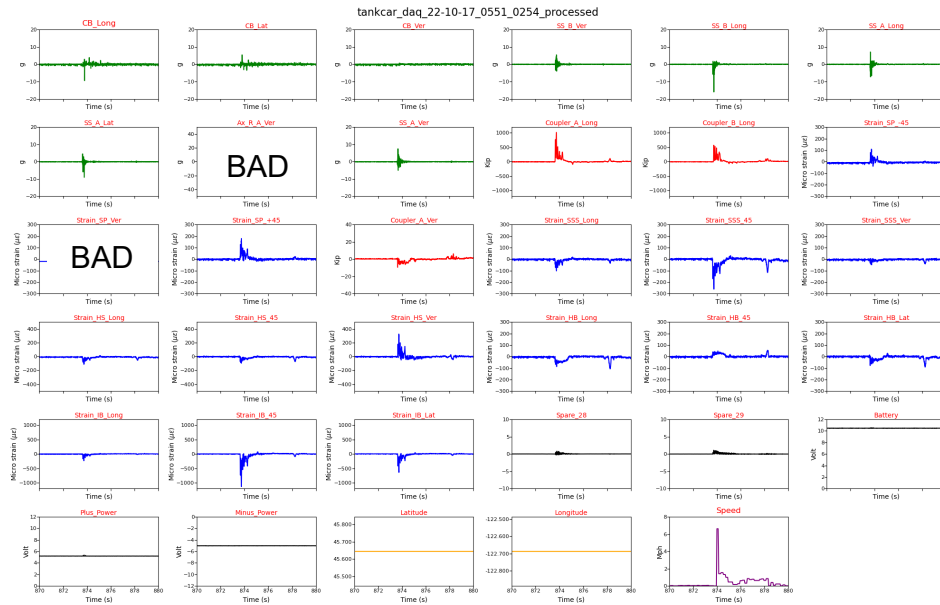
**Figure 25. Plot with Third Highest Yard Longitudinal Coupler Forces (Yard 3, Full File)**

**Figure 26. Zoomed-In Plot with Third Highest Yard Longitudinal Coupler Forces (Yard 3, Magnified)**

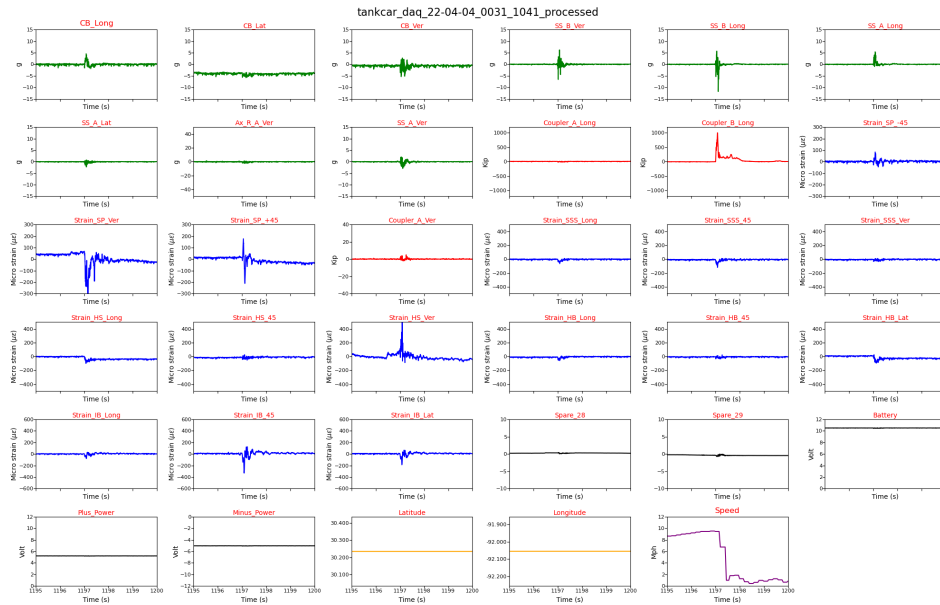
**Figure 27. Plot with Fourth Highest Yard Longitudinal Coupler Forces (Yard 4, Full File)**

**Figure 28. Zoomed-In Plot with Fourth Highest Yard Longitudinal Coupler Forces (Yard 4, Magnified)**

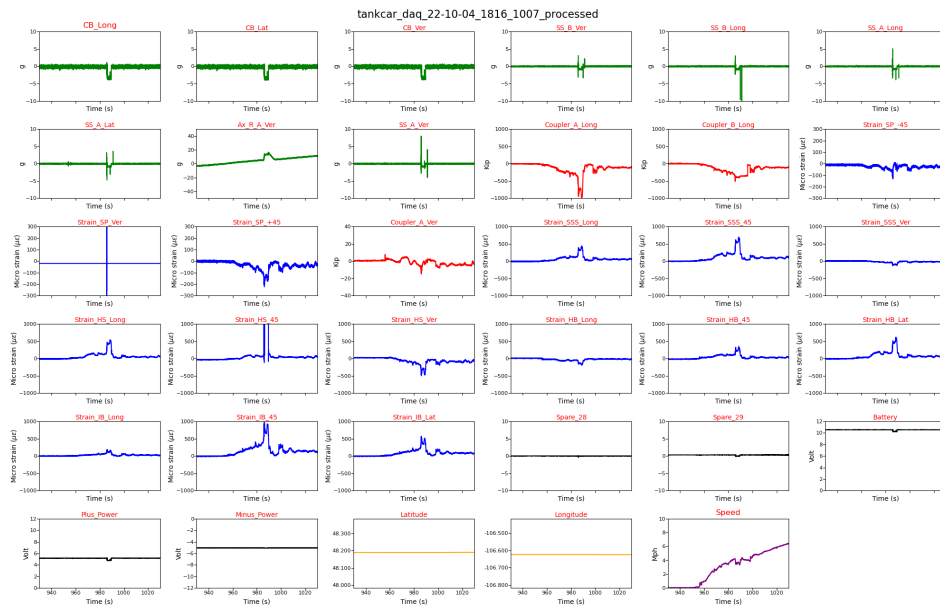
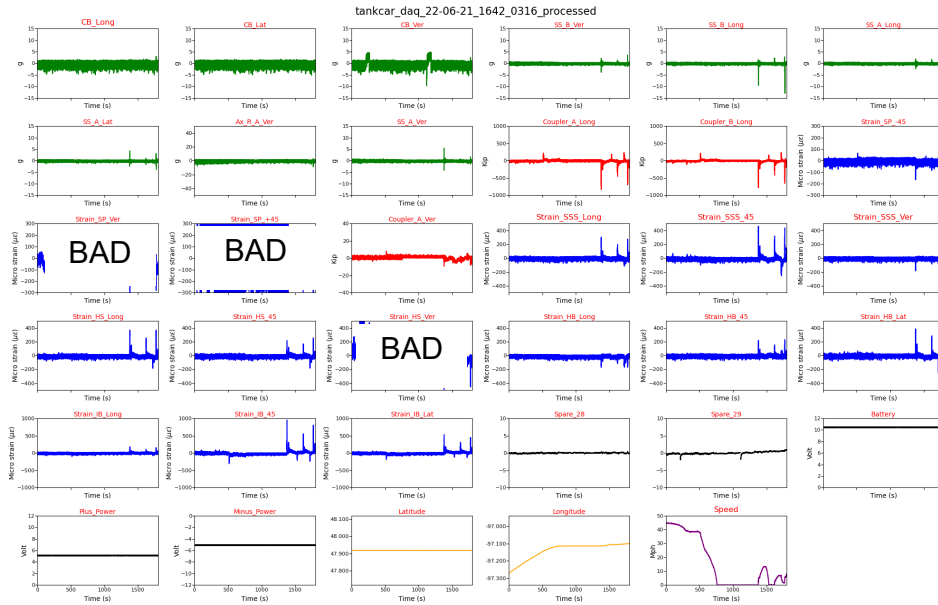
these main operation plots show speed changes in normal mainline operation. These generally happen when the train is accelerating or on rare occasions when breaking.

**Figure 29. Plot with Highest Main Longitudinal Coupler Forces (Main 1, Full File)**

**Figure 30. Zoomed-In Plot with Highest Main Longitudinal Coupler Forces (Main 1, Magnified)**

**Figure 31. Plot with Second Highest Main Longitudinal Coupler Forces (Main 2, Full File)**

**Figure 32. Zoomed-In Plot with Second Highest Main Longitudinal Coupler Forces (Main 2, Magnified)**

**Figure 33. Plot with Third Highest Main Longitudinal Coupler Forces (Main 3, Full File)**

**Figure 34. Zoomed-In Plot with Third Highest Main Longitudinal Coupler Forces (Main 3, Magnified)**

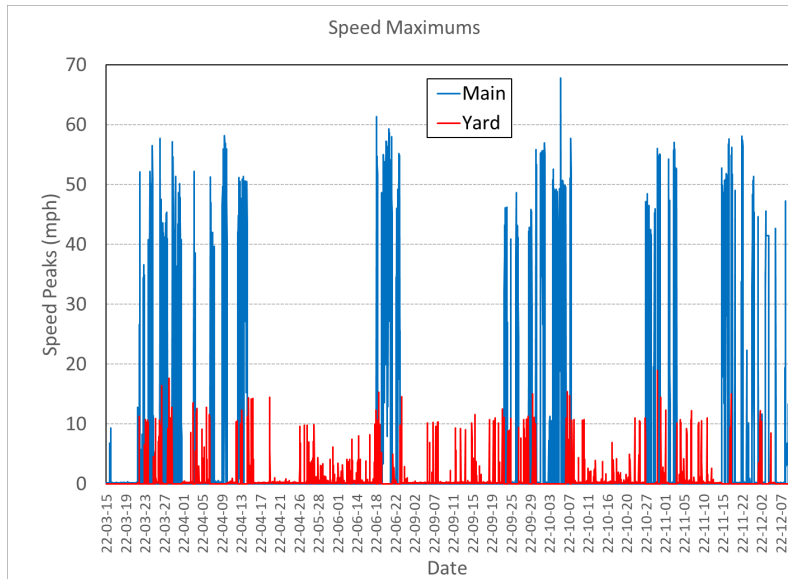
peak speeds up to 67 mph with most of the mainline at peaks between 40 and 60 mph. The yard operations generally had peaks under 15 mph.

**Figure 37. Maximum Speeds for Entire Test Program**

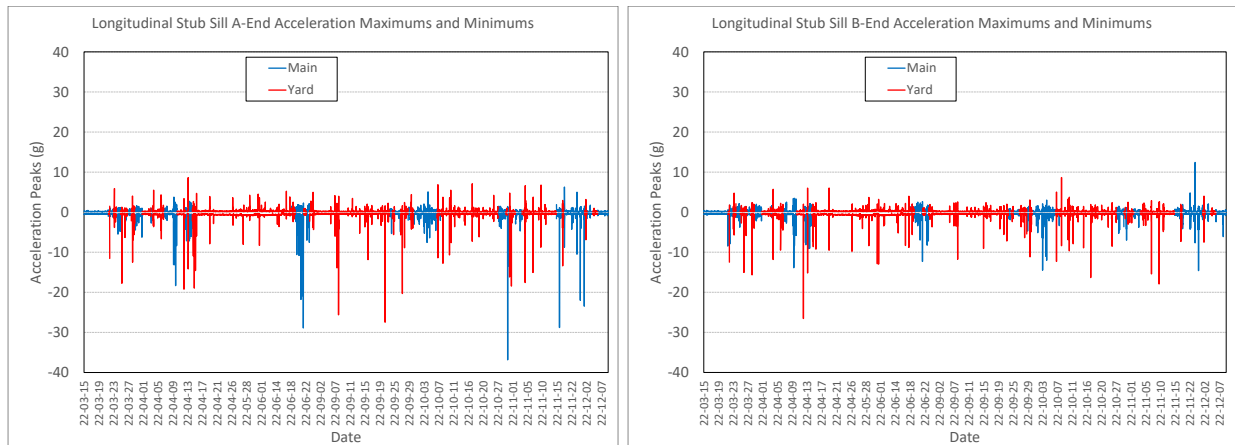
The team then analyzed the accelerations. [Figure 38](#) shows the two stub sill longitudinal accelerations (the longitudinal direction was the most important for this analysis). The main operations are shown in blue while the yard operations are shown in red. This figure shows many large peaks for both main and yard operations. The data showed that there are many more negative peaks than positive peaks. It was presumed that the number of peaks would be roughly equal because it was assumed that the tank car would change its orientation in the train consist periodically at random. However, information on the tank car orientation was not available. It is possible that the autonomous testing was performed with the tank car in one prevalent orientation.

**Figure 38. Stub Sill Longitudinal Acceleration Peaks (Left is A-End, Right is B-End)**

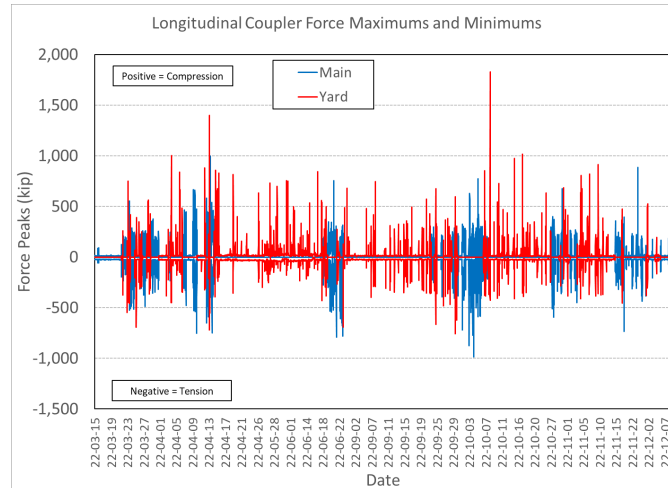
One of the main factors affecting stub sill damage is the longitudinal coupler force. Figure 39 shows longitudinal coupler force peaks during the entire test program. The main operations are shown in blue while the yard operations are shown in red.

**Figure 39. Longitudinal Coupler Force Peaks**

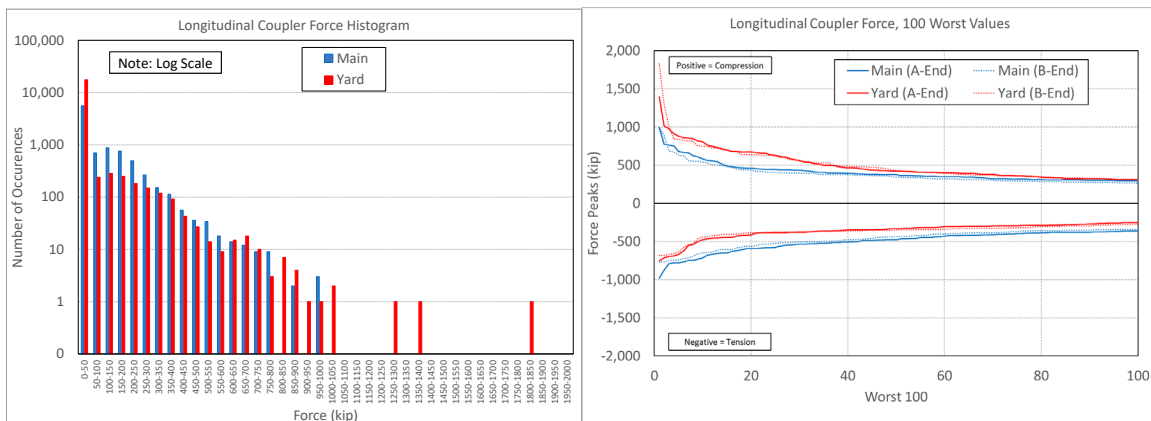
Figure 40 shows a histogram of the longitudinal coupler forces and the worst 100 values. The main operations are shown in blue while the yard operations are shown in red. The histogram shows the number of events using a bin size of 50 kips and uses a log scale on the vertical axis for the counts. To get a better understanding of the highest values, the 100 worst values are also plotted.

**Figure 40. Longitudinal Coupler Force Histogram (Left Shows Histogram, Right Shows 100 Worst Values)**

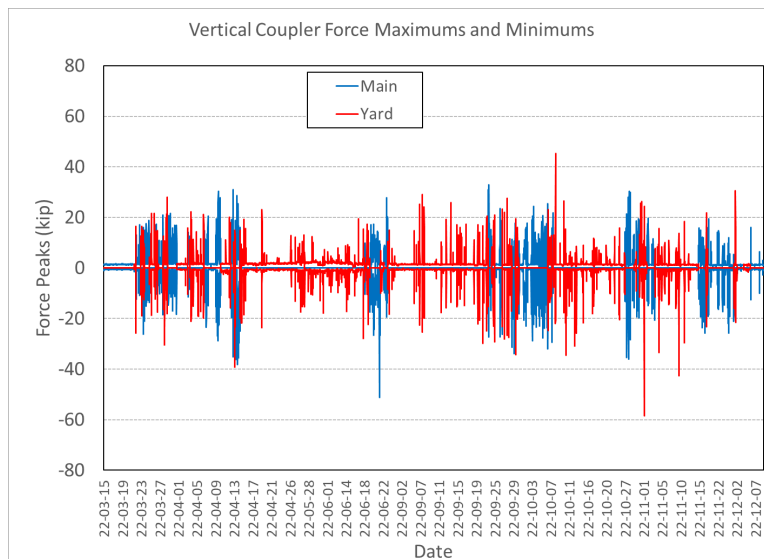
Another factor affecting stub sill damage is the vertical coupler force. Figure 42 shows vertical coupler force peaks during the entire test program. The main operations are shown in blue while the yard operations are shown in red.

**Figure 42. Vertical Coupler Force Peaks**

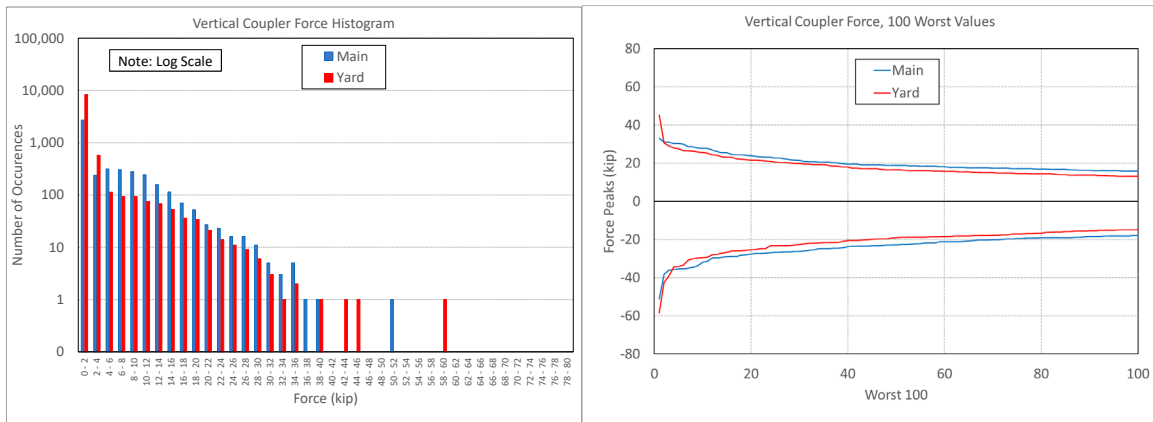
**Figure 43. Vertical Coupler Force Histogram (Left Shows Histogram, Right Shows 100 Worst Values)**
