U.S. Department
of Transportation
Federal Railroad
Administration

Side Impact Test and Analyses of a DOT-113C120W9 Tank Car with Cryogenic Lading

1. REPORT DATE (DD-MM-YYYY) 1/16/2024		2. REPORT TYPE Technical Report		3. DATES COVERED (From - To) May 2022	
4. TITLE AND SUBTITLE Side Impact Test and Analyses of a DOT-113C120W9 Tank Car with Cryogenic Lading			5a. CONTRACT NUMBER DTFR53-11-D-00008 TTCI-11-033		
			5b. GRANT NUMBER		
			5c. PROGRAM ELEMENT NUMBER		
			5d. PROJECT NUMBER

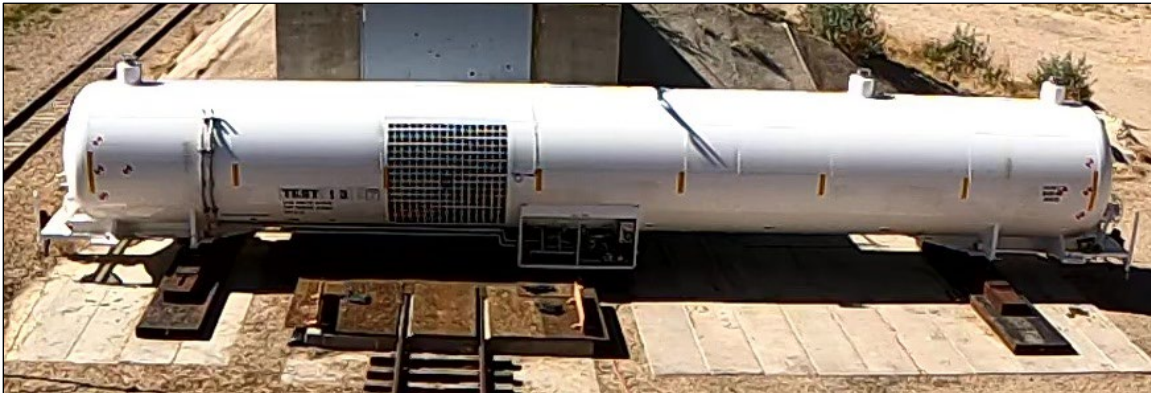
Figure 1. DOT-113 Tank Car Mounted on Support Skids

The test was performed by sending a ram car into the side of the tank car, which was mounted on skids and backed by a rigid impact barrier as shown in [Figure 1](#).

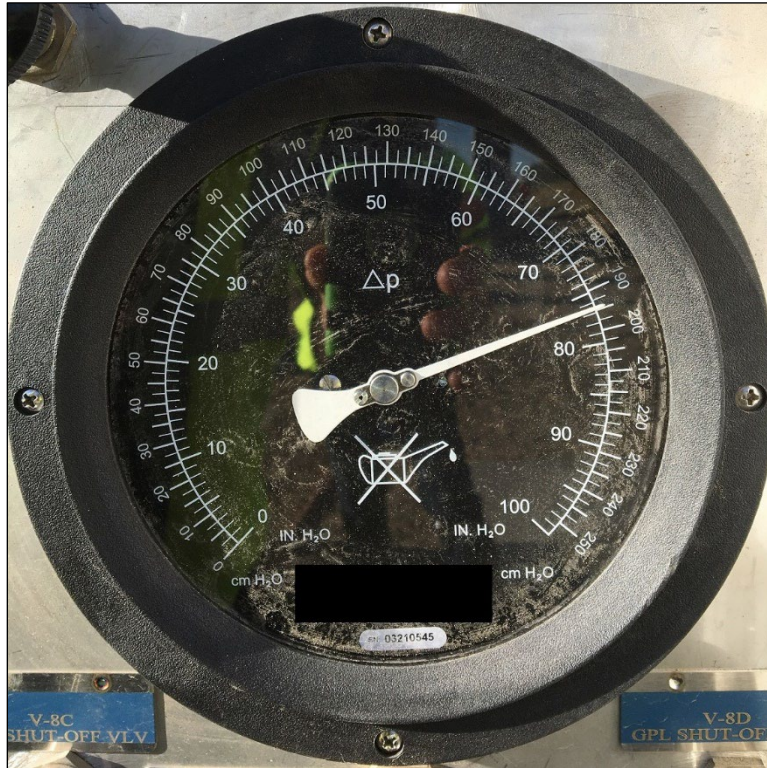
Figure 5. Static Head Pressure Gauge

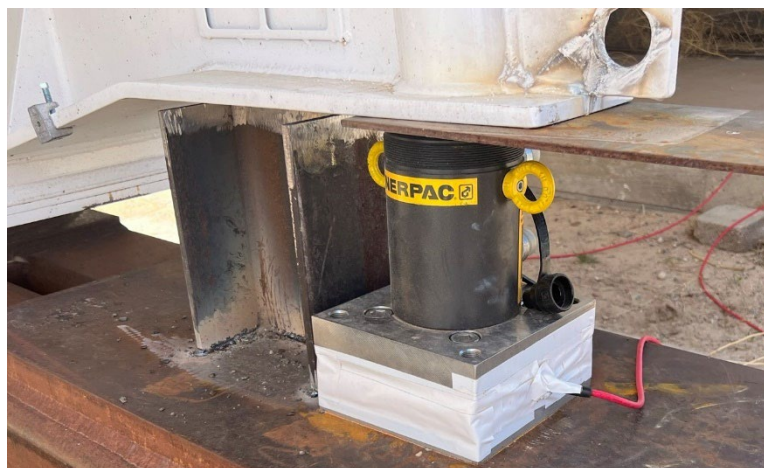
Figure 6. Load Cell with Hydraulic Ram Positioned on Top to Transfer Weight from Center Plate to Load Cell

During the planning phase of Test 13, it was decided that, in addition to the static head pressure gauge and trycock that were employed for the previous two tests, it would also be beneficial to use the weight of the car to better measure the actual liquid level. Knowing the weight of the LN₂ contained in the tank car, the temperature of the LN₂, and the pressure inside the tank car made it possible to calculate the actual height of the LN₂ with a higher degree of confidence than solely relying on the static head pressure measurement. Four 100-kip load cells were used to weigh the car. One load cell was placed under each end of the two bolsters (see Figure 6). After the tank car was filled to the desired level, the car was raised, the load cells were removed, and the car was lowered back down onto the center bowl on the skid. The empty weight recorded for the car was 111,400 lb, and the weight recorded for the car after filling was 322,500 lb. Based on these weight measurements, the tank car contained approximately 211,100 lb of LN₂. It should be noted that the weight measured by the load cells drifted upward by approximately 1.5 percent

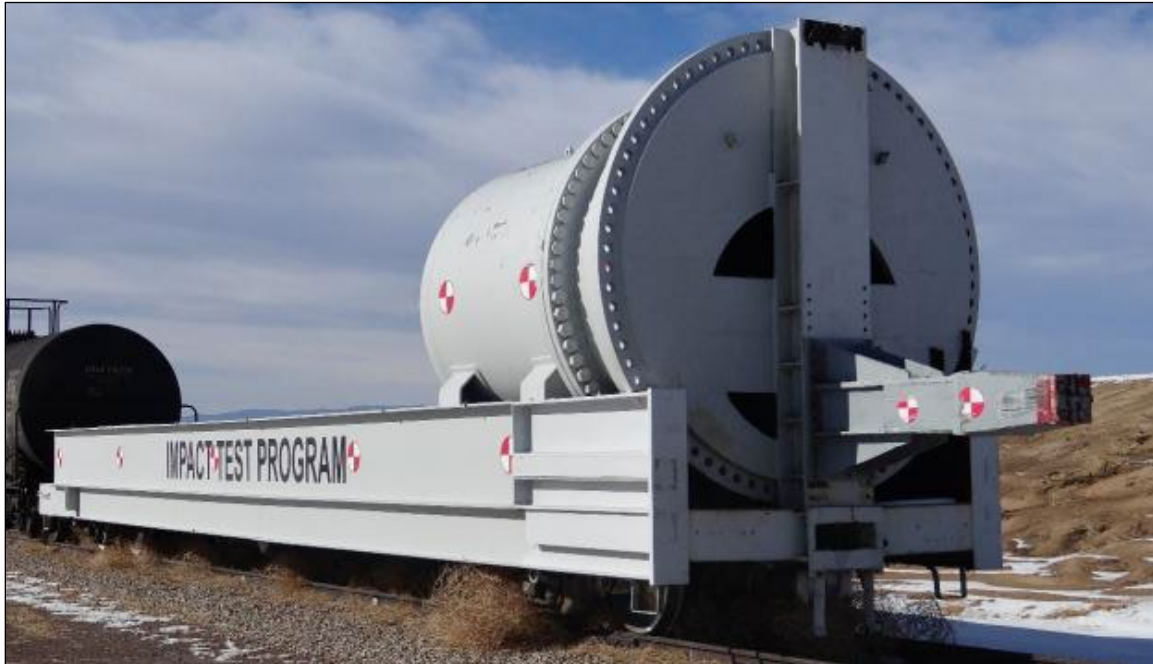
The indenter was positioned to align as closely as possible with the mid-height of the target tank car. The ram car (a photo from a previous test is shown in [Figure 7](#)) was a modified flat car with an 8-foot ram installed on the leading end. This ram car, which was used in previous tank car tests, has a shortened tank attached to the ram end. A 12 by 12-inch indenter with 1.0-inch radii on the edges and corners was used in the test. The same indenter was used in the impact test of a DOT-111 tank car [11], a DOT-112 tank car [12], a DOT-117 tank car [14], a DOT-105 tank car [13], and a second DOT-111 tank car meeting voluntary industry standard CPC-1232 [16]. This same indenter was also used on the previous tests of a legacy DOT-113 [3] and DOT-113 surrogate [4], which were both filled with water, and a DOT-113 surrogate filled with LN2 [6].

Figure 7. Ram Car and Head

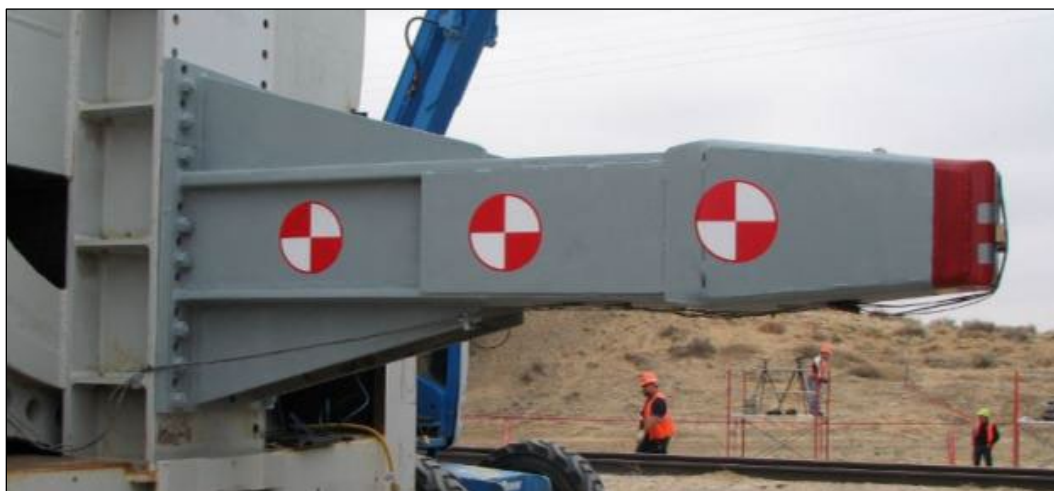
Figure 8. Ram Arm with 12 by 12-inch Indenter

[Figure 8](#) shows the 12 by 12-inch indenter attached to the ram car from a previous test.

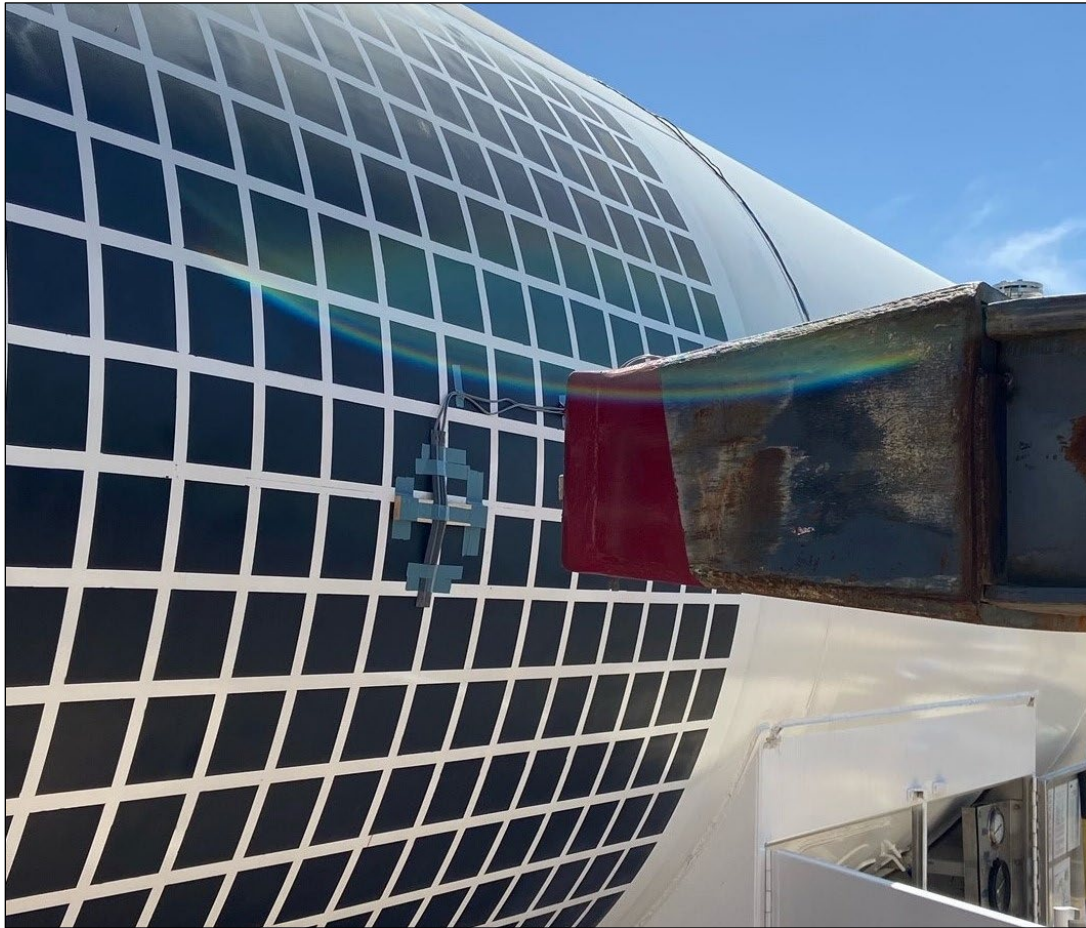
Figure 9 shows the ram car aligned with the tank car. The ram car was weighed before the test to confirm the actual weight, which was 297,000 lb.

Figure 9. Ram Arm with 12 by 12-inch Indenter Aligned with the Impact Zone on the Tank Car

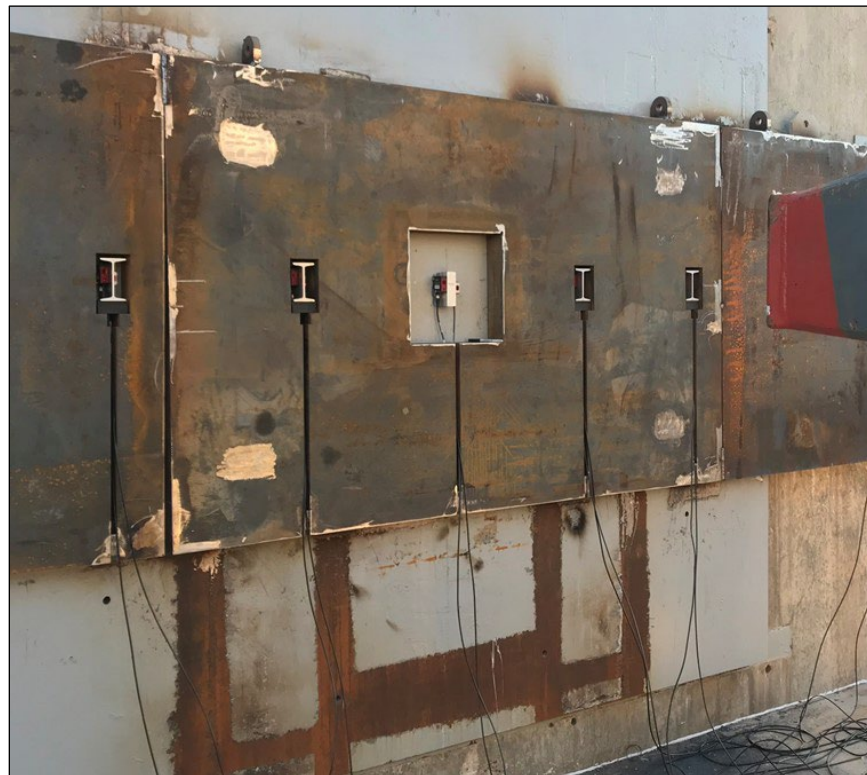
Figure 14. Lasers Displacement Transducers on Crash Wall

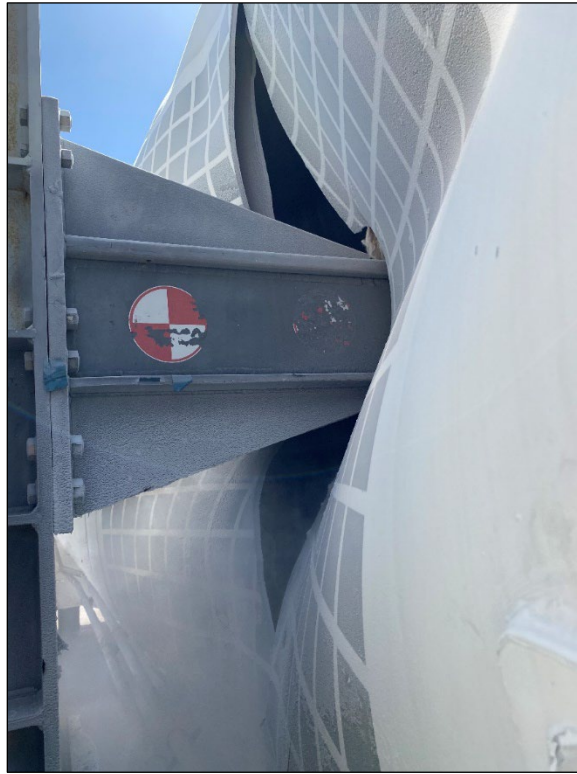
Figure 17. Ram Arm Embedded in Tank Car After Conclusion of Test

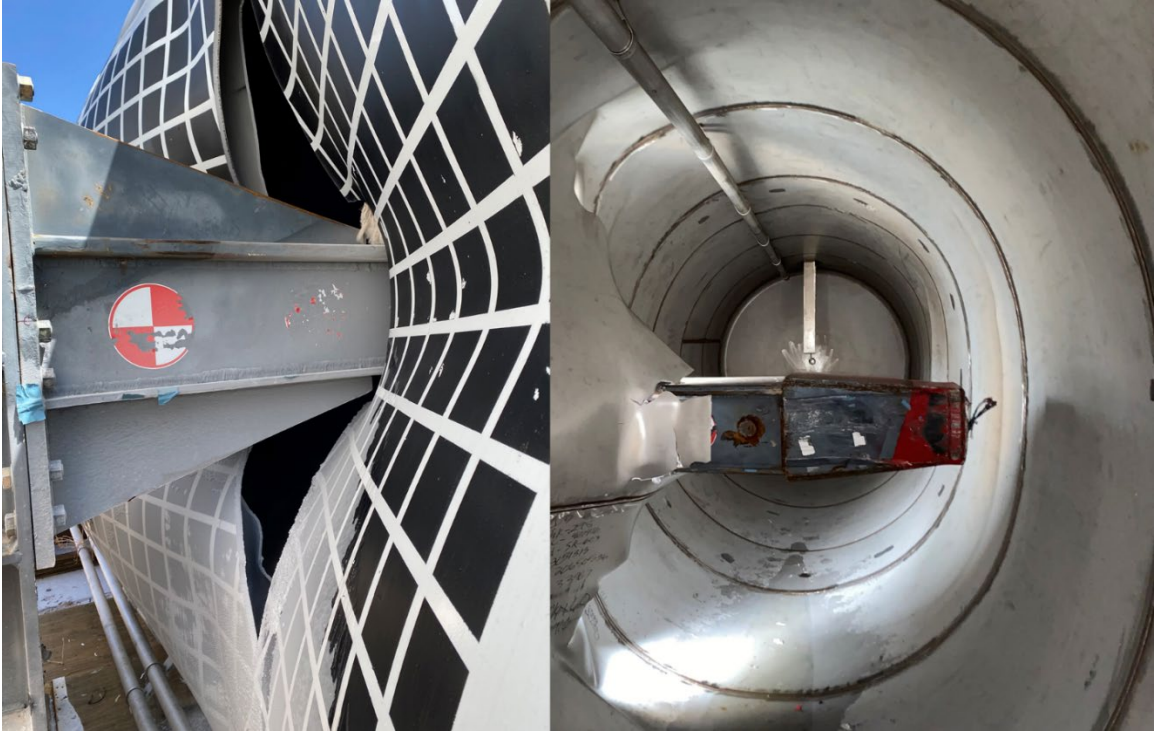
Figure 19. Exterior (left) and Interior (right) Views of Tank Damages from West Side Prior to Impactor Removal

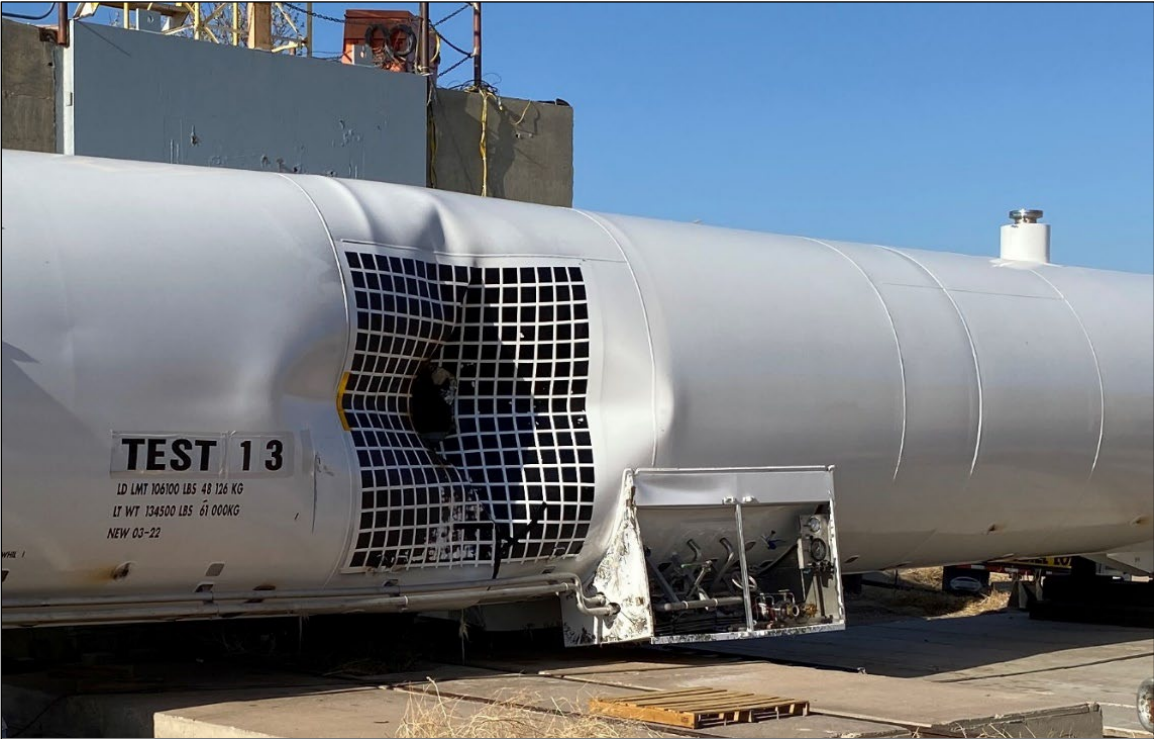
Figure 20 shows the damage to the impacted side of the tank car following removal of the ram car. Figure 21 shows a more detailed view of the impact zone.

Figure 20. Tank Car after Separating from the Ram Car (impact side)

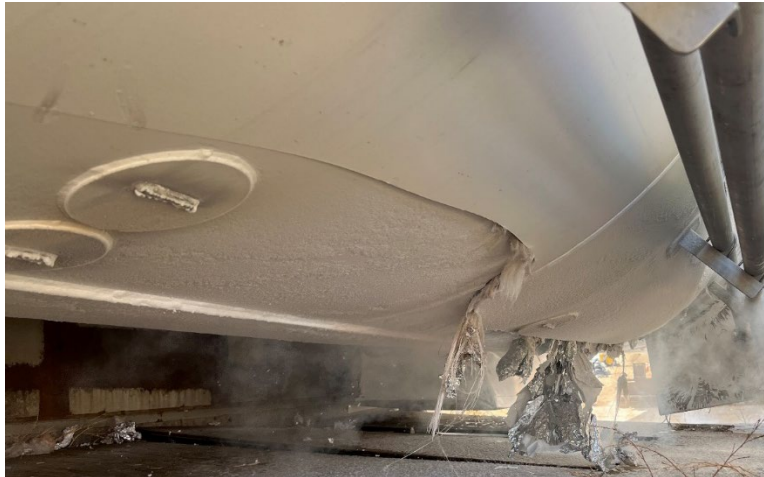
In addition to the direct damage caused by the impact, the release of LN2 into the annular space between the inner and outer tanks and the dousing of the outside of the outer tank with LN2 caused the bottom of the outer tank to split from induced stresses. The outer tank was exposed to LN2 while still carrying its own weight, which could have caused a brittle fracture of the outer tank's material. Figure 23 shows the bottom of the outer tank's shell looking toward the B (west) end of the tank car. This photograph was taken immediately after impact, with visible frost observable on the bottom of the tank. MLI from within the annular space has been partially ejected through the crack in the outer tank's shell.

Figure 23. Split in Bottom of Tank Caused by Thermal Stress

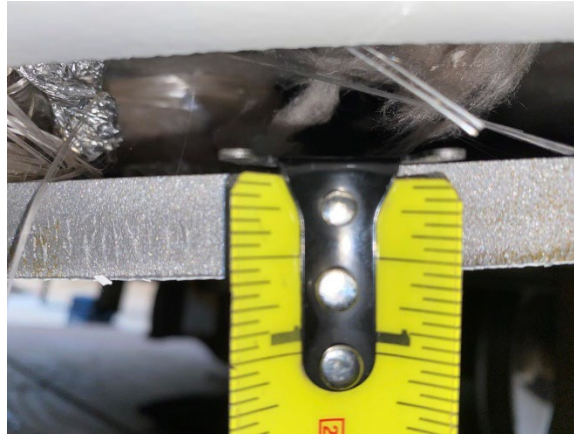
Figure 25 contains a photograph of a tape measure placed along the fracture surface of the crack. The outer tank of the DOT-113 was made of TC-128B steel having a nominal thickness of 9/16 inch. This measurement confirmed that the crack in the outer tank propagated without reducing the tank shell's thickness.

Figure 25. Thickness of Outer Tank Along Thermal Crack

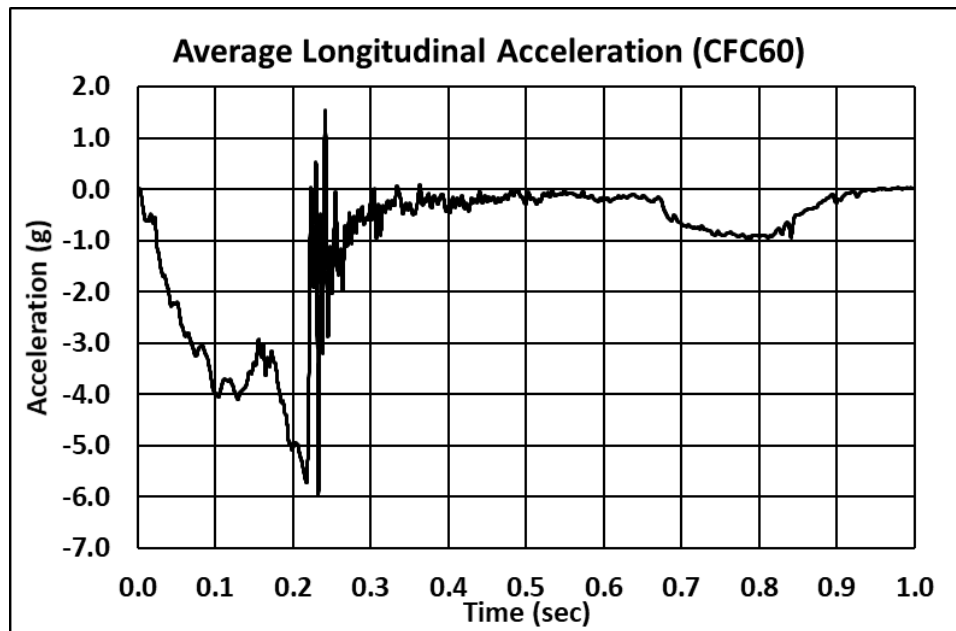
The longitudinal acceleration of the ram car was one of the primary measurements in the test. Multiple accelerometers were installed on the ram car to capture this data. The data were then used to determine the impact energy, the deceleration of the ram car, and the contact forces between the ram and target tank car. The ram car's average longitudinal acceleration history, calculated from the onboard accelerometer data, is shown in [Figure 30](#). It should be noted that the longitudinal accelerometer BA1CX was culled from this average, as the data it recorded showed significant deviation from the remaining accelerometers after about 0.16 seconds.

Figure 30. Longitudinal Acceleration Data (Averaged)

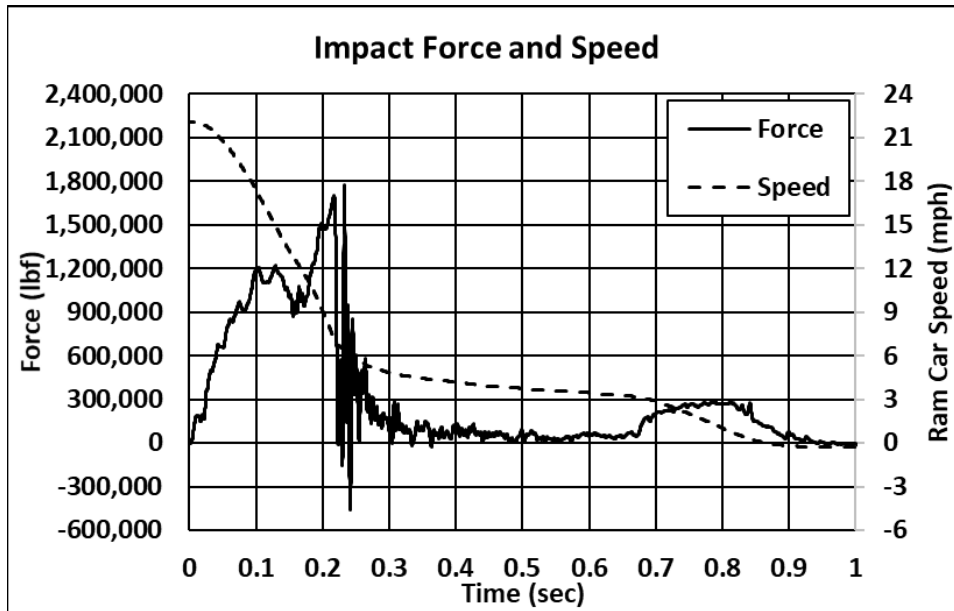
The ram car velocity history for this test was calculated by integrating the average longitudinal acceleration of the ram car and using the measured impact speed as an initial condition. The contact forces between the ram and target tank car were calculated as the product of the average acceleration and the mass of the ram car. [Figure 31](#) shows both the force-time and velocity-time histories for the ram car.

Figure 31. Impact Force and Ram Car Speed

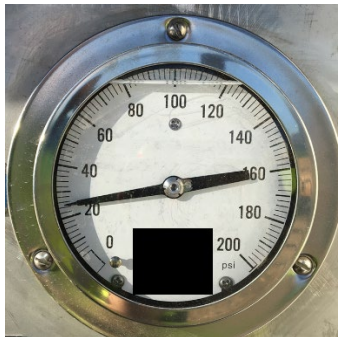
Figure 41. Mechanical Pressure Gauge Prior to Test

Additionally, a mechanical pressure gauge measured a pressure of between 24 and 25 psig prior to impact (see Figure 41). This value is slightly higher than the average pre-test pressures measured by the pressure transducers.

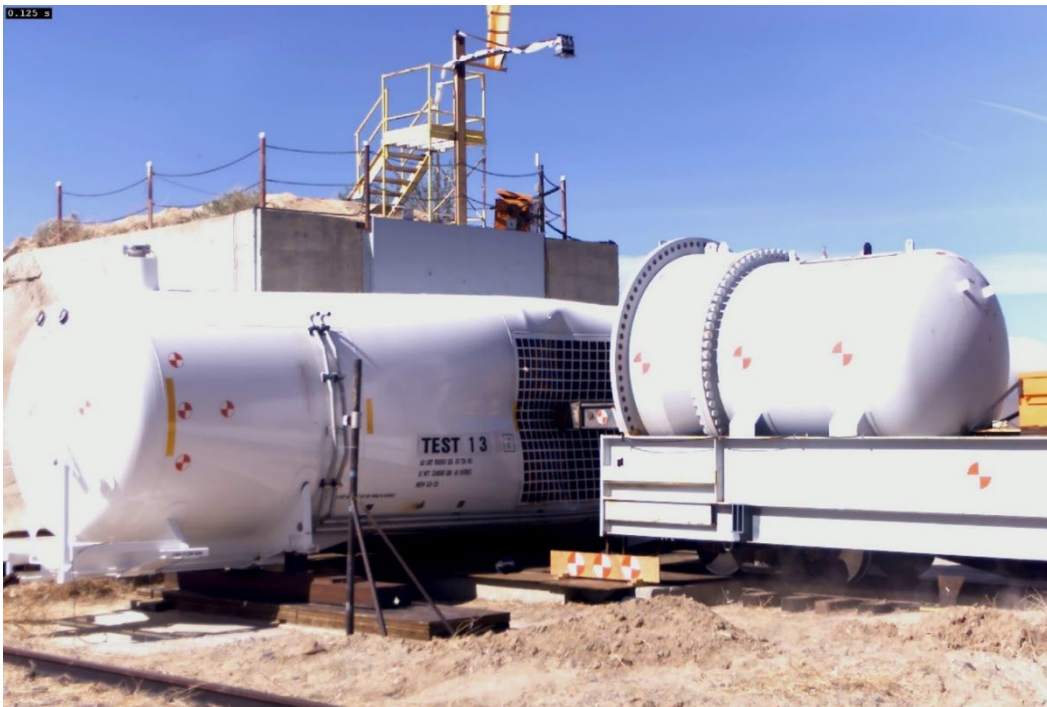
Figure 45 shows a frame extracted from a 1000 fps HS isometric camera at 0.125 seconds. At that time, the indentation in the outer tank is apparent but there is no evidence of tank tearing.

Figure 45. Frame from Isometric HS Video at 0.125 s

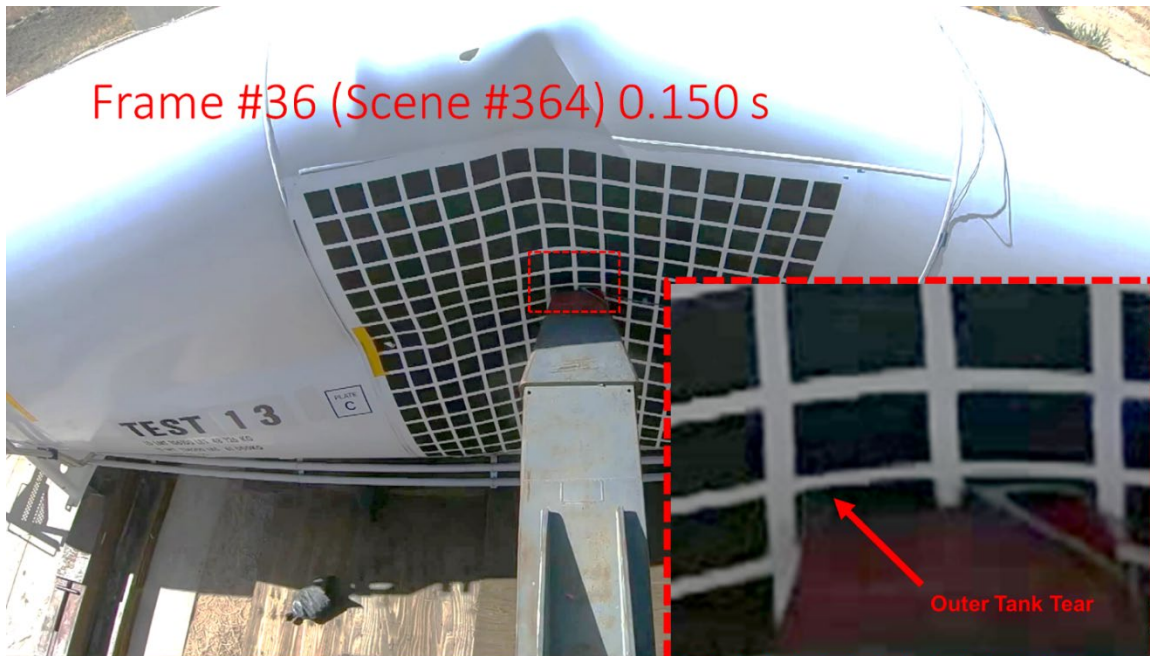
Figure 45 contains a still frame extracted from the onboard video at 0.150 seconds, with an inset image featuring a close-up view of the point of impact. This frame was the first frame with an observed tear in the outer tank.

Figure 47. Frame from Onboard Video at 0.150 s

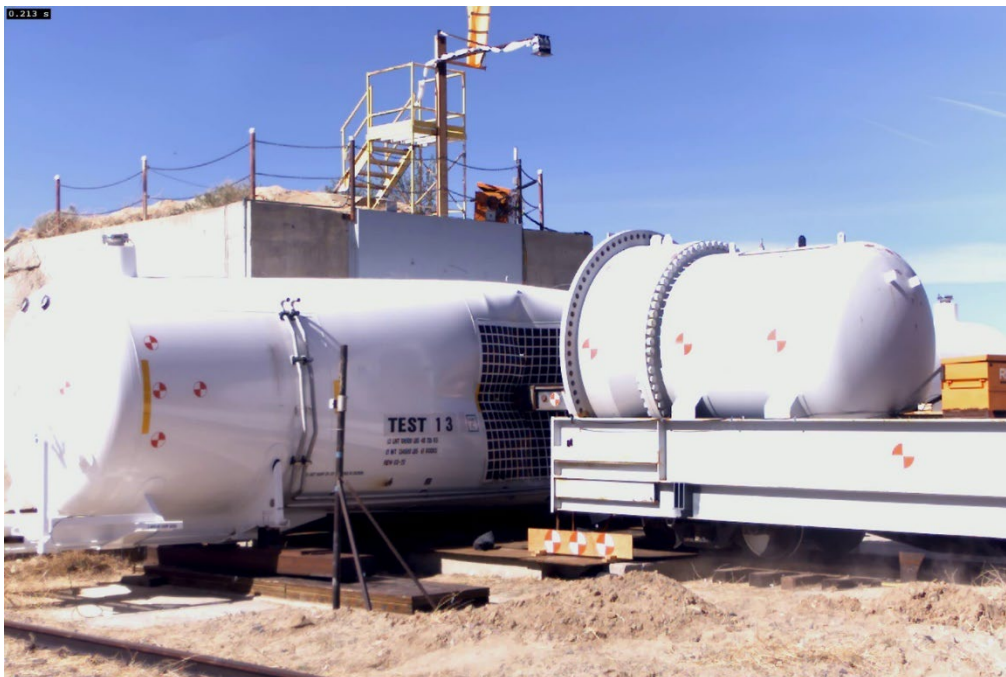
Figure 49 contains a frame extracted from the isometric HS video at 0.213 seconds. The indentation in the tank car has grown larger since the previous frame shown from this video (Figure 45). No evidence of N₂ leakage from the inner tank is visible in Figure 49.

Figure 49. Frame from Isometric HS Video at 0.213 s

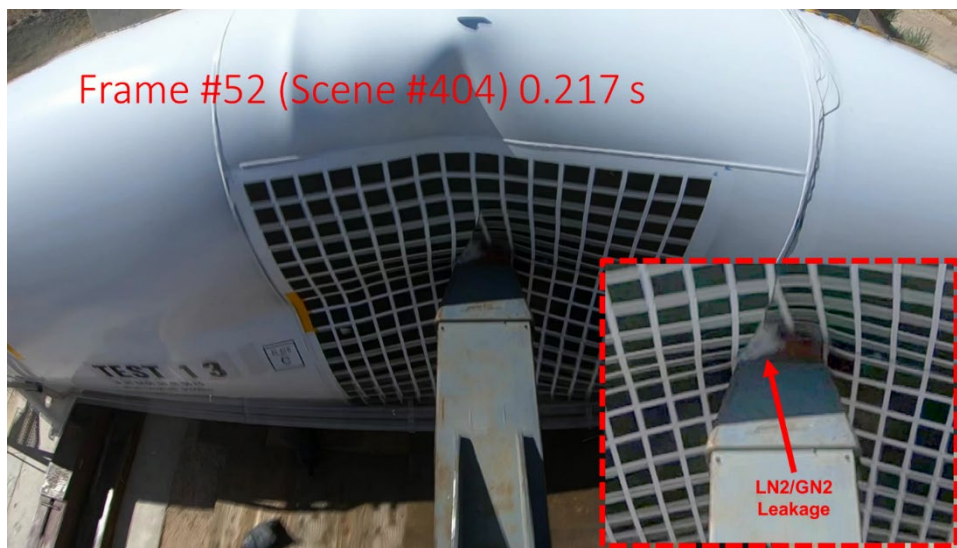
Figure 51 contains a frame extracted from the onboard video at 0.217 seconds.

Figure 51. Frame from Onboard Video at 0.217 s

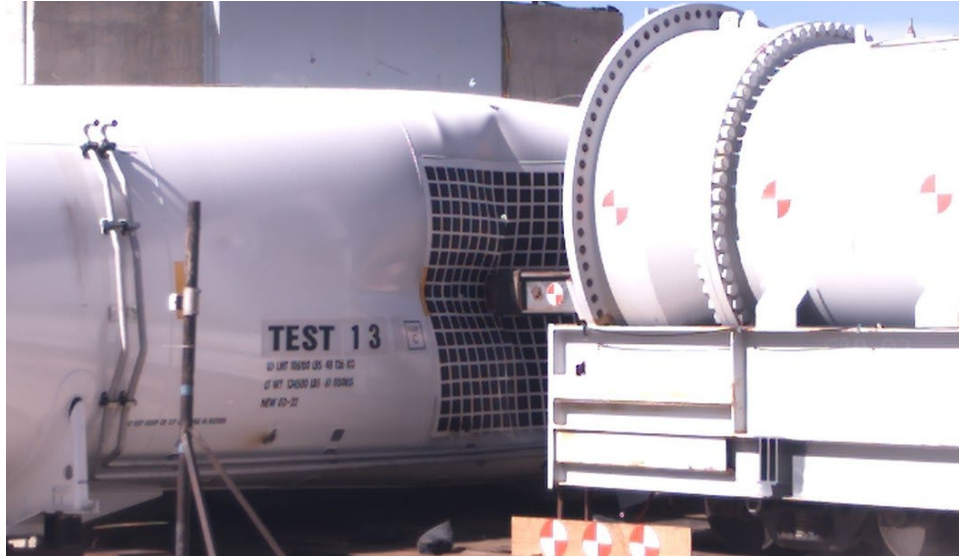
Figure 52. Still Frame from HS Video Taken at 0.222 s

Figure 52 contains a still frame extracted from the isometric HS video of the test at 0.222 seconds, the approximate time at which the inner tank punctures. This figure shows the extent of the deformation that occurred up to that point.

the impactor force had dropped to 406.4 kips from the global peak force (1,689 kips) that occurred at 0.213 seconds. This rapid drop in force is associated with the inner tank puncturing.

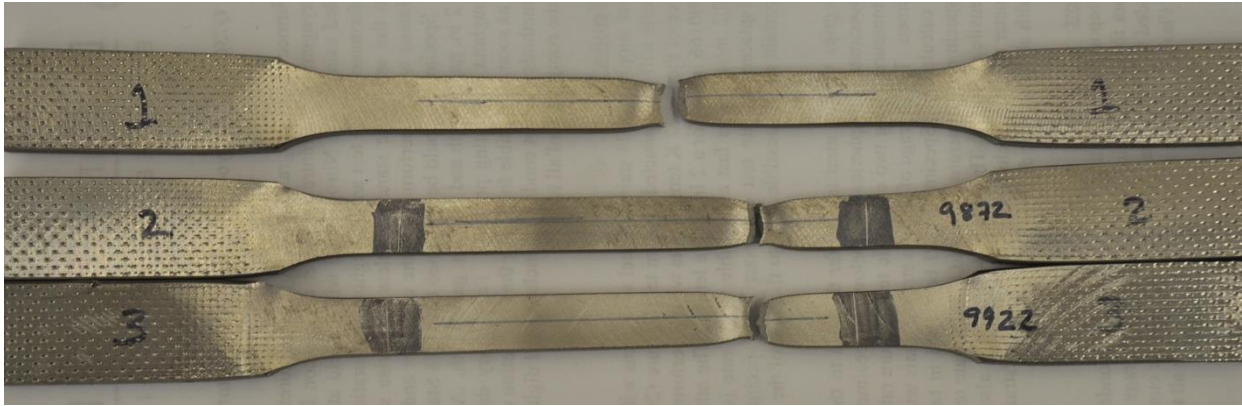
Figure 3: 295 K Specimens displaying the minor deformation at the shoulders

All 295 K specimens displayed some distortion at the shoulder due to slippage within the grips as seen in Figure 3.

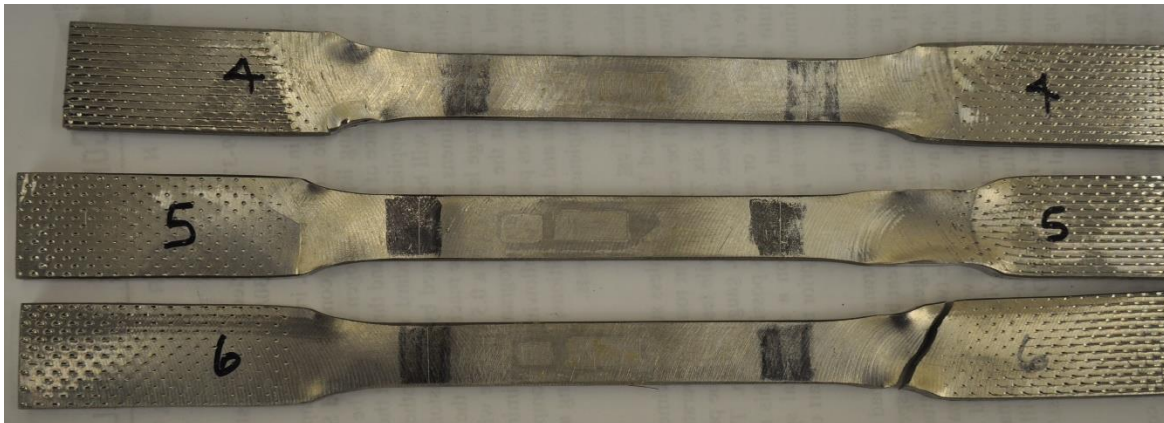
Figure 4: 77 K standard load rate specimens

The 77 K specimens all showed similar distortions, the tests of Specimens 4 and 5 were ended prior to tensile failure of the material due to extension limits of the load frame. Specimen #6 failed through the radiused section as seen in Figure 4.

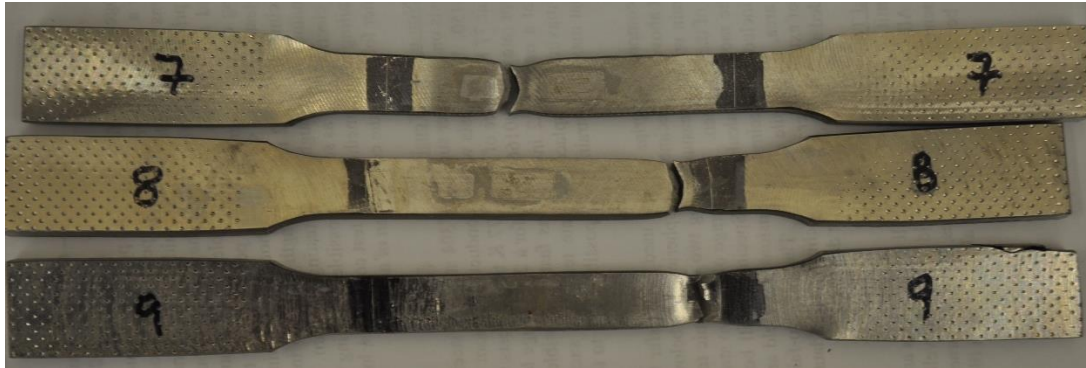
Figure 5: 77 K Rapid Rate specimens

All of the rapid rate 77 K specimens held appropriately and failed within normal parameters in a 'cup and cone' fashion as demonstrated in Figure 5.
