UTILIZATION OF UNMANNED AERIAL VEHICLES IN ACCIDENT RECONSTRUCTION

The Volpe National Transportation Systems Center (Volpe), under the direction of the Federal Railroad Administration's (FRA) Office of Research, Development and Technology (RD&T), conducted a research study to evaluate the effectiveness of using Unmanned Aerial Vehicles (UAVs) (also known as drones) and photogrammetry software to expedite the accident reconstruction process.

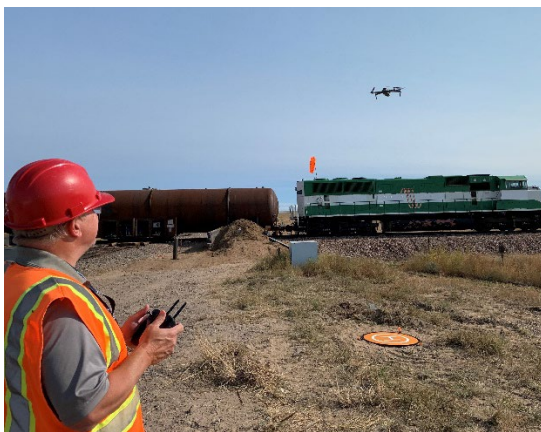
Figure 1. Researcher using drone to capture accident scene imagery

In September 2021, RD&T conducted an impact test at the Transportation Technology Center (TTC) in Pueblo, CO, where a truck collided with a train. Volpe collected drone imagery of the post-crash scene in an effort to better understand what is involved in capturing the required incident data for a simulated highway-rail grade crossing environment. [Figure 1](#) shows a Volpe researcher using a drone to capture aerial imagery from the accident scene.

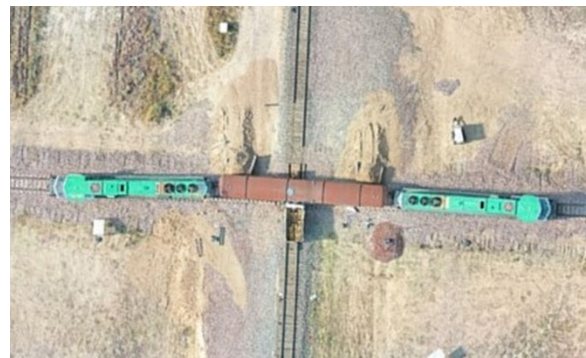
Figure 2. Orthomosaic of highway-rail grade crossing impact test

Volpe processed this data and took several measurements similar to those that would be taken at an actual accident scene. [Figure 2](#)

shows an orthomosaic image produced from the data collected from this scene.

The preponderance of the highway-rail grade crossing collision test images captured at the TTC were taken autonomously by the drone from a height of 75 feet. These were used to produce a single orthomosaic image using Pix4D software. This image was then imported into a geographic information system (GIS) software package called QGIS. This is a free, open-source GIS product that enabled Volpe to take measurements that are accurate because the orthomosaic was overlaid onto the Web Mercator coordinate reference system.

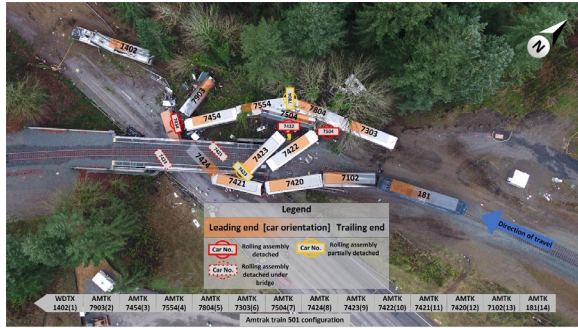
Figure 3. Annotated aerial view of Dupont, WA, derailment scene captured by a Washington State Patrol aircraft equipped with a FLIR Systems camera (National Transportation Safety Board 2019)

Federal investigators have often requested imagery from other sources, especially those with helicopters, to try to better establish the positions at which railcars and vehicles came to rest. [Figure 3](#) shows an image obtained by investigators of the Amtrak derailment near Dupont, WA, in 2017. State law enforcement took this photograph from an aircraft, overlaid with railcar numbers and other notes. As valuable as this image was to investigators, it is not accurate enough to be used for measurements.
