U.S. Department
of Transportation
Federal Railroad
Administration

LiDAR Grade Crossing Data Collection and Storage Services for High Profile Grade Crossings

1. REPORT DATE (DD-MM-YYYY)		2. REPORT TYPE Technical Report		3. DATES COVERED (From - To) 8/18/2022 – 12/18/2023	
4. TITLE AND SUBTITLE LiDAR Grade Crossing Data Collection and Storage Services for High Profile Grade Crossings				5a. CONTRACT NUMBER	
				5b. GRANT NUMBER	
				5c. PROGRAM ELEMENT NUMBER

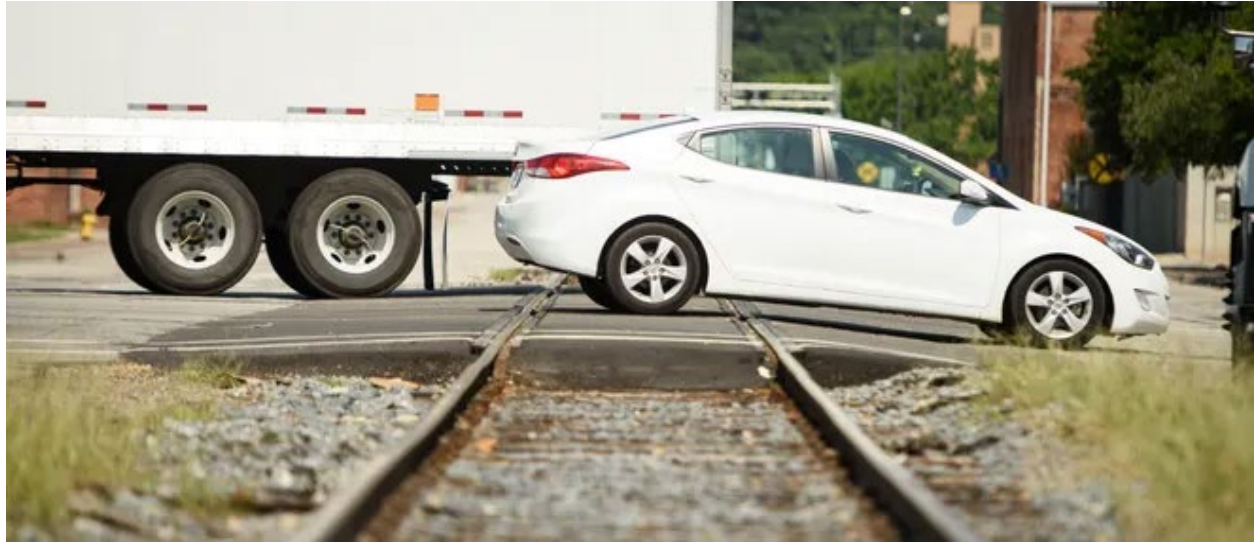
shows a common humped crossing being negotiated by a passenger sedan. Humped crossings typically do not pose a significant risk to passenger vehicles except in the most extreme cases because their short wheelbase and typical ground clearance reduces the chance of the vehicle undercarriage becoming stuck on the tracks or adjacent roadway surfaces.

Figure 2: A humped high-profile grade crossing being negotiated by a passenger vehicle

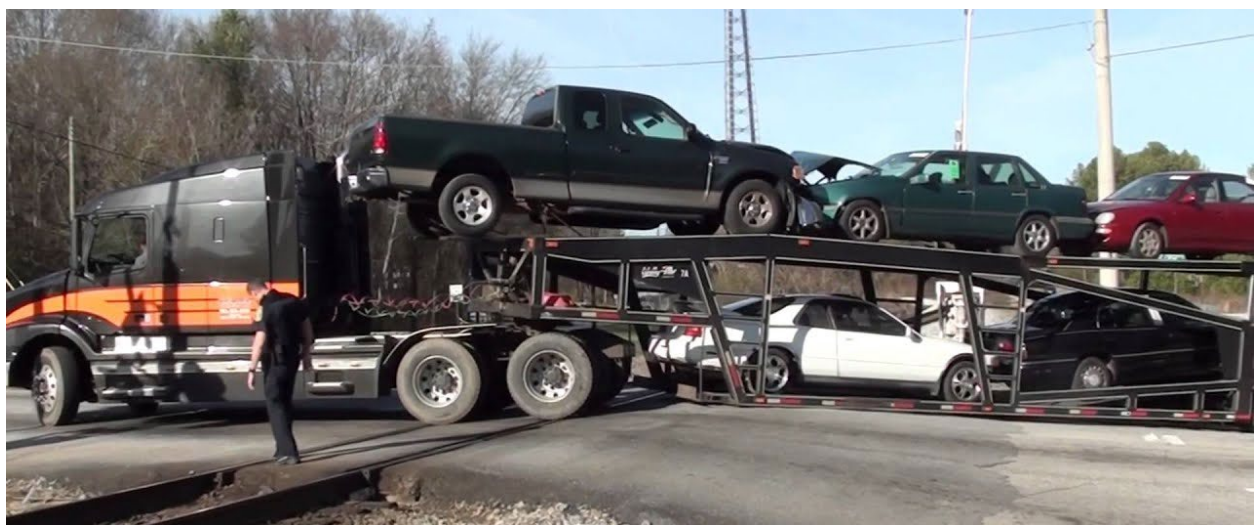
However, humped crossings can pose a significant risk to the passage of long, low-clearance vehicles such as automobile transport trailers, heavy equipment transports, and other low-clearance trailers. [Figure 3](#) shows an automobile transport trailer that has become stuck on a humped crossing. As these vehicles pass across the grade crossing, their long wheelbases cause the supporting axles to contact the roadway at points on either side of the tracks. When both contacts points are lower than the tracks, in the case of a humped crossing, more undercarriage clearance is required to pass over the crossing. This can result in long-wheelbase, low-clearance vehicles becoming stuck on the tracks.

Figure 3: A automobile transport trailer stuck on a humped high-profile grade crossing

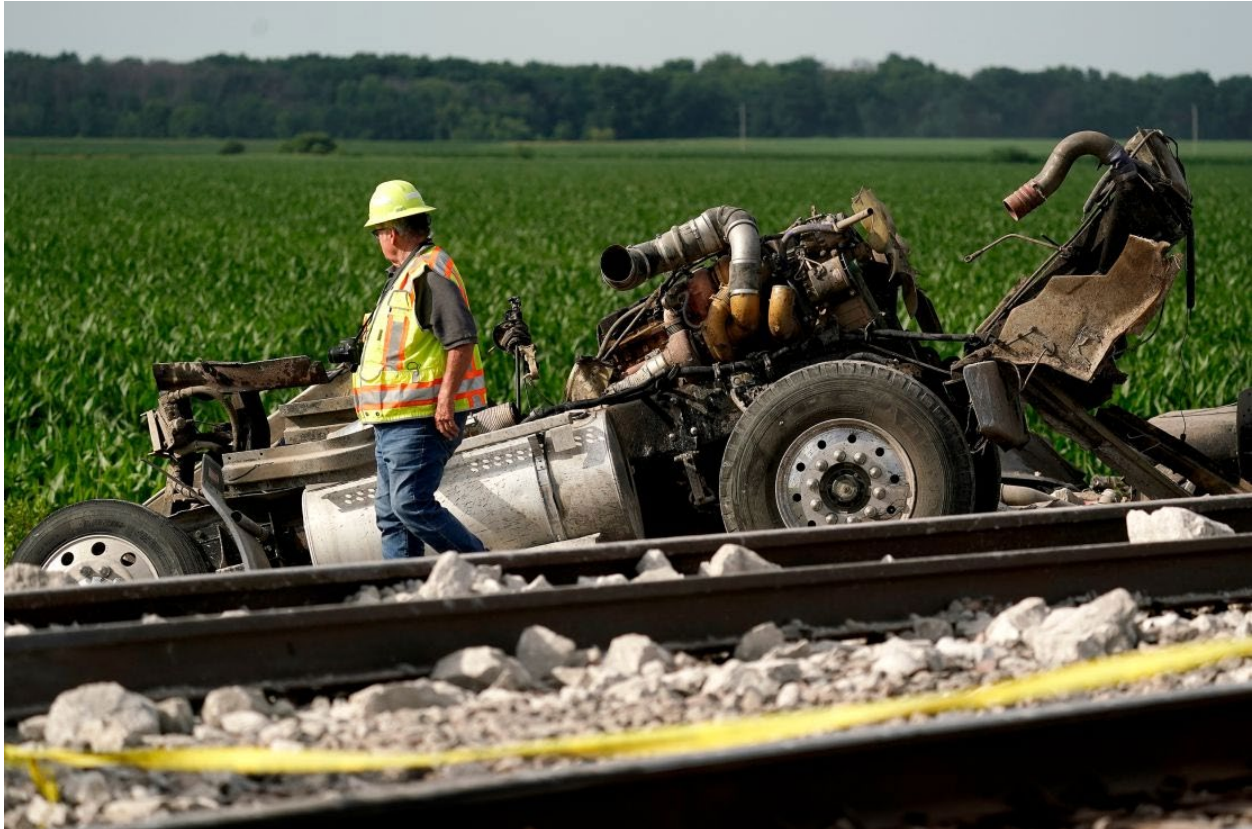
Figure 4: The remainder of a semi-truck involved in a train collision

Collisions involving trains and road vehicles are extremely dangerous for motorists because of the weight and speed/energy of typical rail vehicles. Ideally, motorists exit their vehicle immediately after becoming stranded in a crossing, but this does not always happen, or the vehicle becomes stuck immediately before a collision. The later scenario is common when a motorist attempts to cross in front of an oncoming train, often the result of misjudging the distance or speed of the train. Typically, the motor vehicle involved in the collision is destroyed (Figure 4).

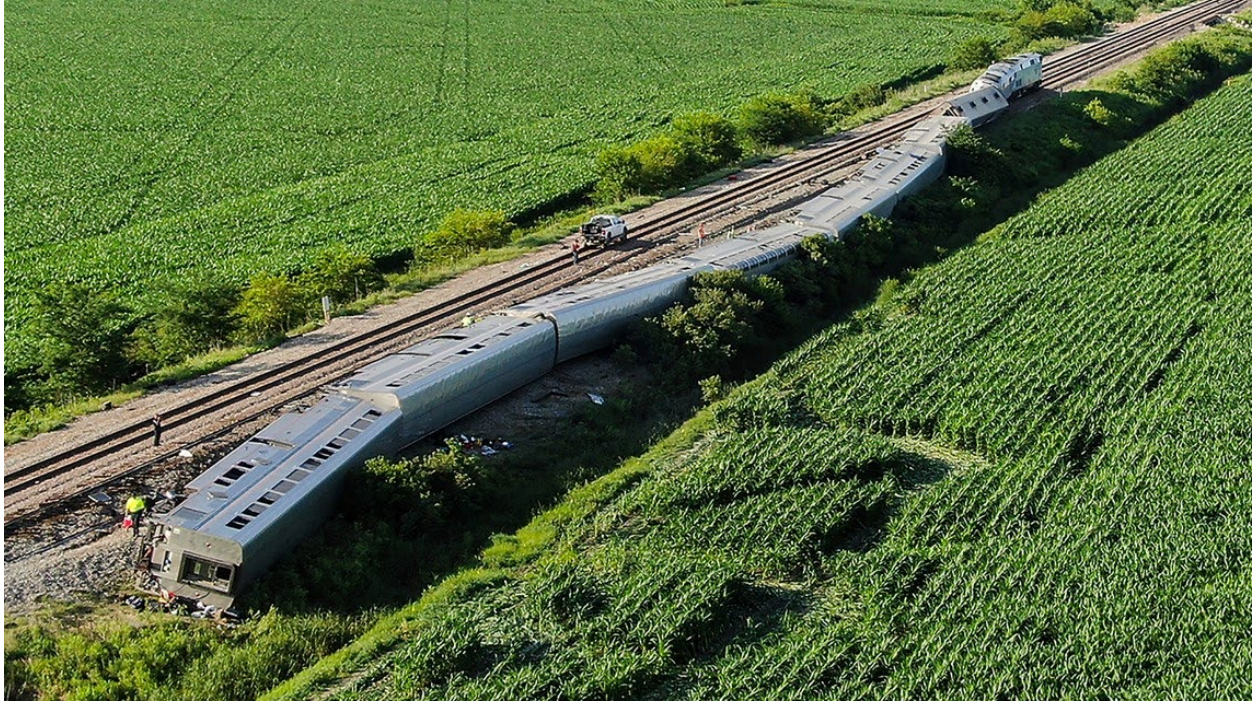
Figure 5: An Amtrak train that derailed after striking a dump truck stuck in a humped crossing

Collisions with motor vehicles also present a significant risk to trains. Following a collision, a train may derail if the vehicle debris is trapped under the train, resulting in injury or loss of life to the train crew and/or passengers, significant damage to the track infrastructure, and other complications such as the release of hazardous materials carried as cargo. A notable collision occurred on June 27, 2022, when an Amtrak passenger train struck a dump-truck that was stranded on a humped crossing in rural Missouri (Figure 5). The collision resulted in the derailment of the Amtrak train and caused four fatalities and 150 injuries, 40 of which required hospitalization. The crossing involved in this incident was a passive crossing, protected only by crossbuck signage. In addition to being a humped HPGC, the intersection angle between the roadway and track, as well as the presence of overgrown vegetation, severely limited motorists' line-of-sight toward the approaching train.

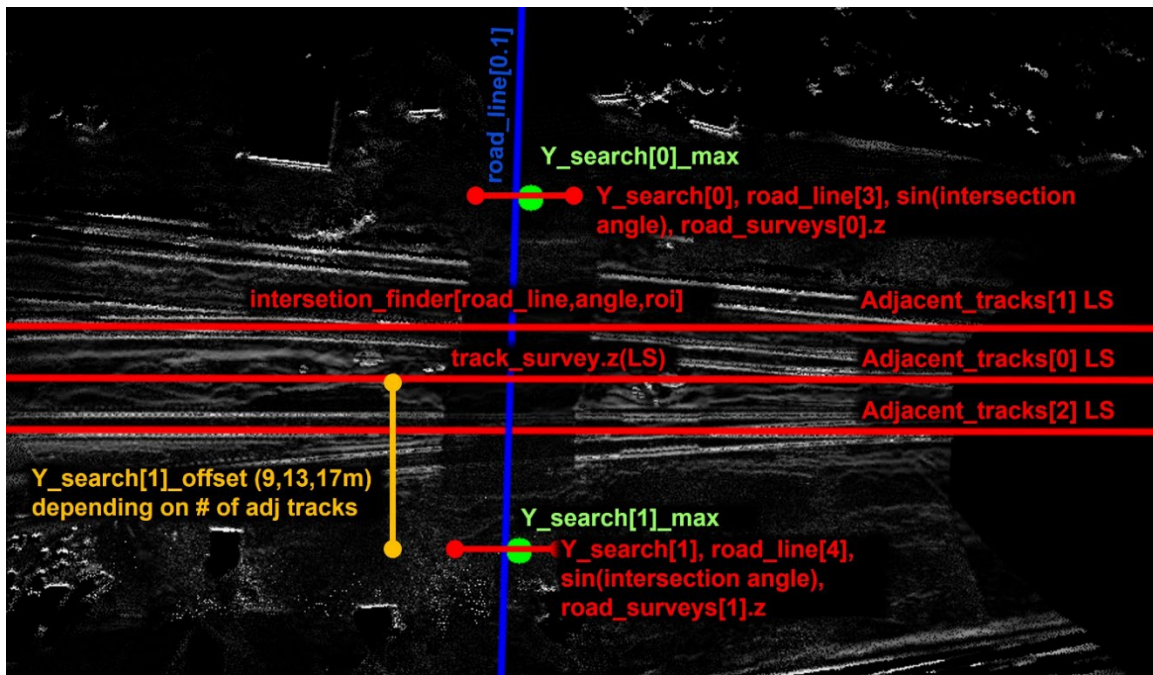
Next, detection of adjacent tracks was performed, and their coordinates saved if detected. A k-dimensional tree search was performed between the track centerline coordinates and the roadway surface to identify locations where the planer deviation is to be calculated. This search was performed at an offset of nine meters on both sides of the survey vehicle's track, or in the case of multiple tracks, nine meters from the first and last tracks in the crossing. The resulting locations within the roadway (denoted " Y_search " in Figure 17) were used to calculate the largest difference in elevation on either side of the crossing. The maximum elevation found within the search locations, along with the coordinates where the maximum is located, were stored in the " Y_search_max " variable. The results from both sides of the crossing were stored and the larger of the two was reported as the planer deviation of the crossing. The " Y_search_max " results were then plotted as green dots on an overlay image and saved as shown in Figure 17.

Figure 17: Grade crossing scene after SVM segmentation annotated with search algorithm variables

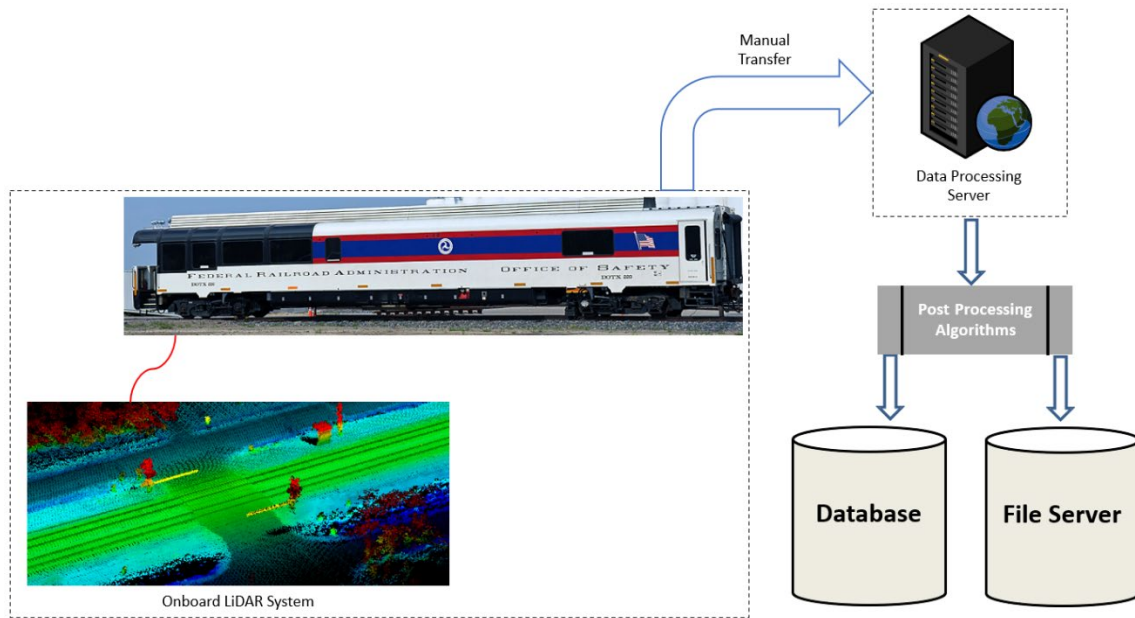
The original data flow was composed of a manual data transfer off the ATIP collection vehicle via external hard drive, followed by post-processing of the data on a local workstation (Figure 20). This process was labor intensive and resulted in delayed access to the collected crossing scans and resulting measurements.

Figure 20: Schematic showing data flow with manual offloading

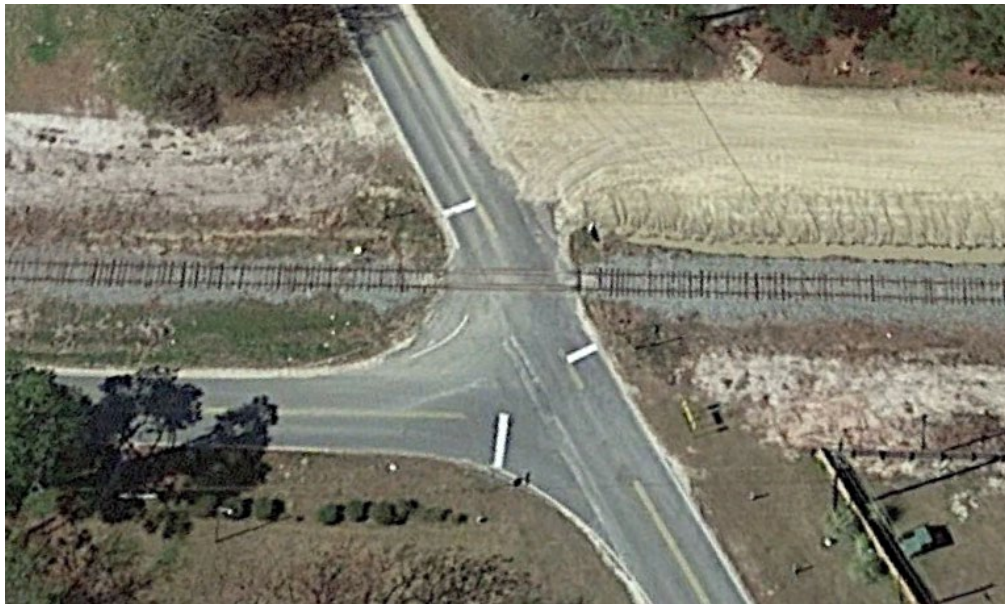
The largest error found during validation occurred at crossing 732405Y. This is a complex crossing with a paved road intersecting the tracks at approximately 45° and a secondary road that parallels the track and merges at the crossing ([Figure 29](#)).

Figure 29: Satellite imagery showing crossing 732405Y

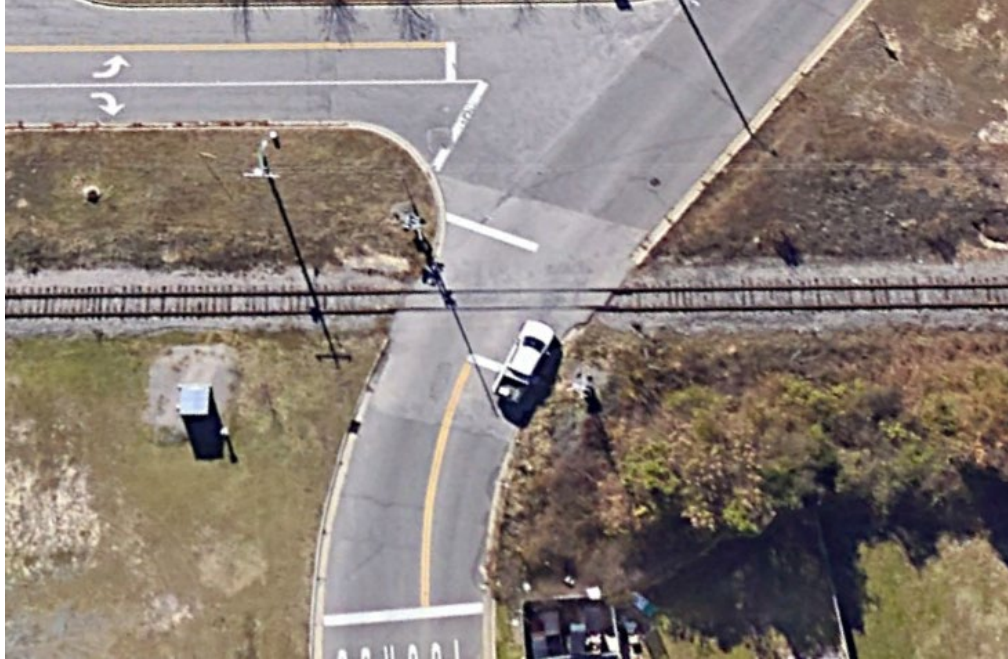
The largest error found during validation of locations with sharp intersection angle occurred at crossing 847210G. This crossing includes a curved roadway intersecting a single main track (Figure 33).

Figure 33: Satellite imagery showing crossing 847210G

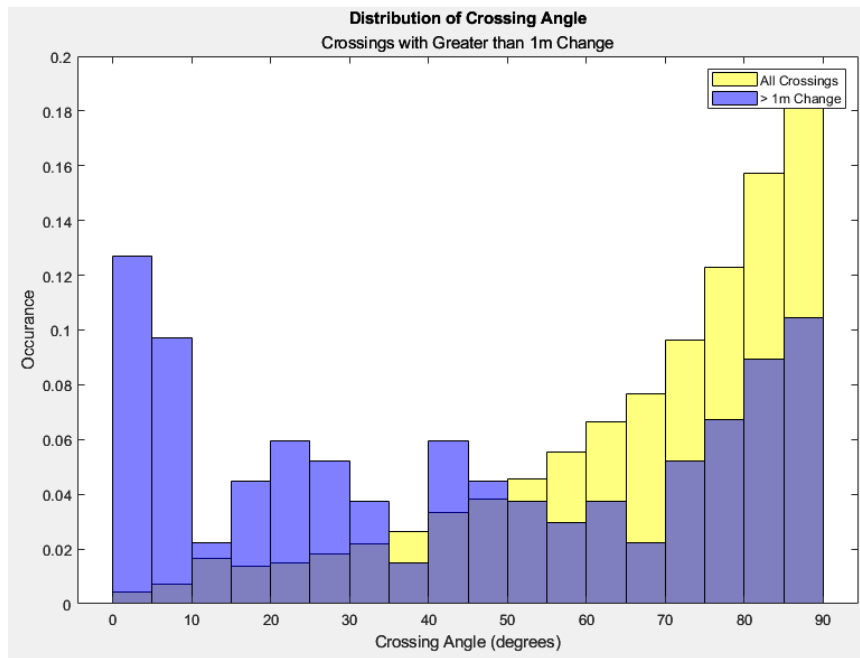
Figure 45: Histogram showing distribution of crossing angle for locations with a change in reported planer deviation greater than 1 m

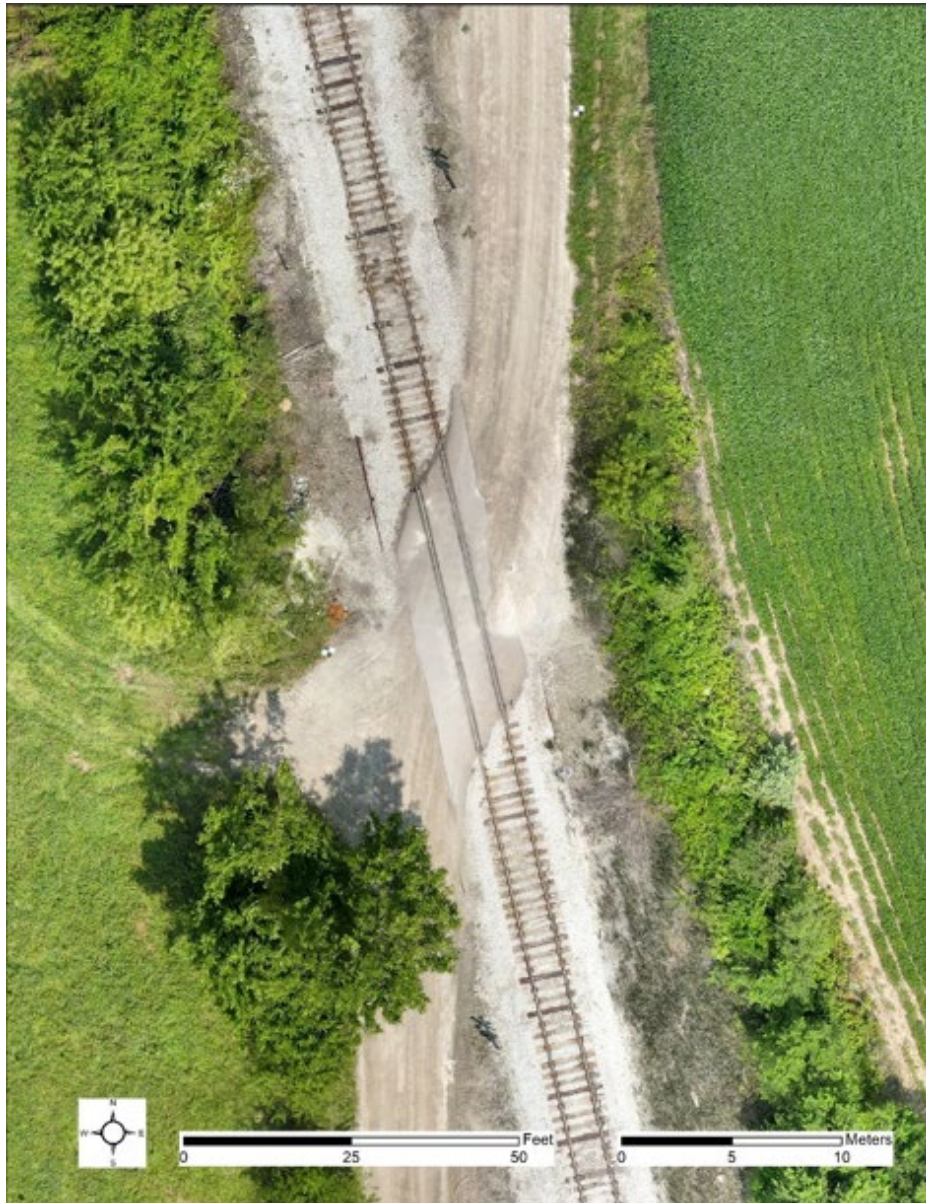
Figure 55: Overhead view of crossing 000165X - Dundee Azalia Road collected using the Crossing-i system

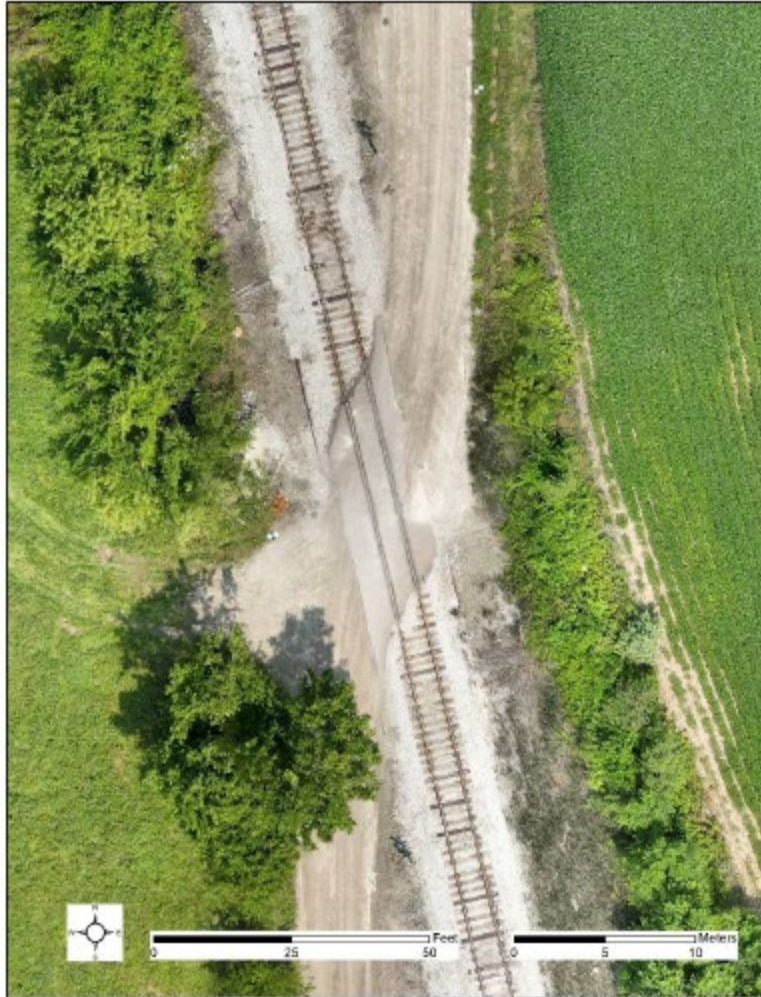
Figure 4: 000165X - Dundee Azalia Rd. which has a unique crossing geometry with the road curving right before crossing.
