U.S. Department of
Transportation

Slab Track Field Test and Demonstration Program for Shared Freight and High-Speed Passenger Service

1. AGENCY USE ONLY (Leave blank)		2. REPORT DATE August 2010		3. REPORT TYPE AND DATES COVERED Technical Report
4. TITLE AND SUBTITLE Slab Track Field Test and Demonstration Program for Shared Freight and High-Speed Passenger Service			5. FUNDING NUMBERS RR19/HG272

6. AUTHOR(S) Dingqing Li				
7. PERFORMING ORGANIZATION NAME(S) AND ADDRESS(ES) U.S. Department of Transportation Research and Innovative Technology Administration John A. Volpe National Transportation Systems Center 55 Broadway Cambridge MA 02142-1093			8. PERFORMING ORGANIZATION REPORT NUMBER DOT-VNTSC-FRA-10-05

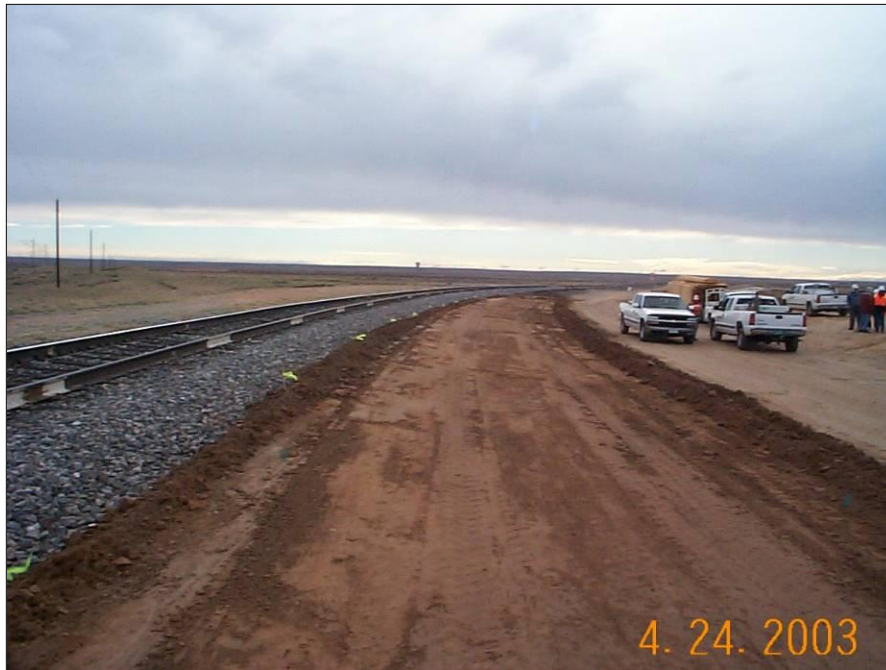
Figure 7. Subgrade Surface for Slab Track Test Section

To prepare for the slab track construction, the existing ballasted track was removed. The subgrade was then graded to the proper line and elevation. The subgrade soil consists of silty sand (PI = 5.9, LL = 18.5). Soil moisture content varied between 5 and 12 percent. The surface of the subgrade was recompact at an optimum moisture content of 10.5 percent. The modulus of the soil was above 10,000 psi with compressive strength above 50 psi. The subgrade soil was considered as strong as track foundation support. Figure 7 shows the final prepared subgrade surface. Note, from the IDBT to the DFST, the subgrade has a slight downhill grade (0.4 percent).

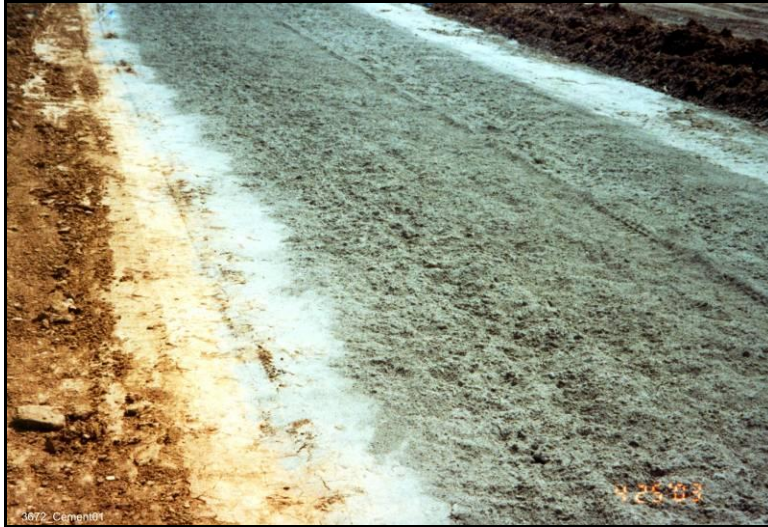
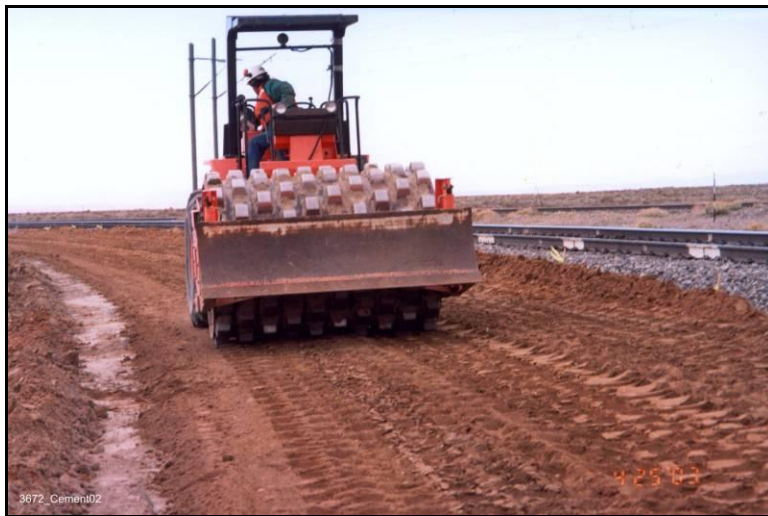
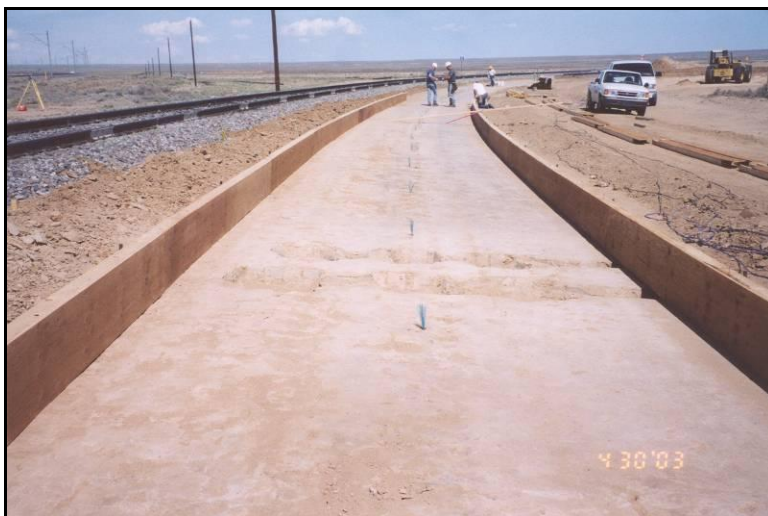
Figure 8. Soil Cement Subbase Surface for Slab Track Test Section

The subbase is a 6-inch soil cement layer. This layer was installed by mixing 5 percent of cement (based on soil weight) with the soil from the borrow area (the same silty sand) and was compacted at an optimum moisture content of 12.5 percent. Compaction was specified to be 98 percent of the maximum (modified Proctor), with the maximum being 118 pounds per cubic foot (pcf). The target compressive strength was 700 psi, with subsequent cores showing actual strength between 780 and 840 psi. Figure 8 shows several pictures of the construction of the test section and the final surface of the soil cement layer.

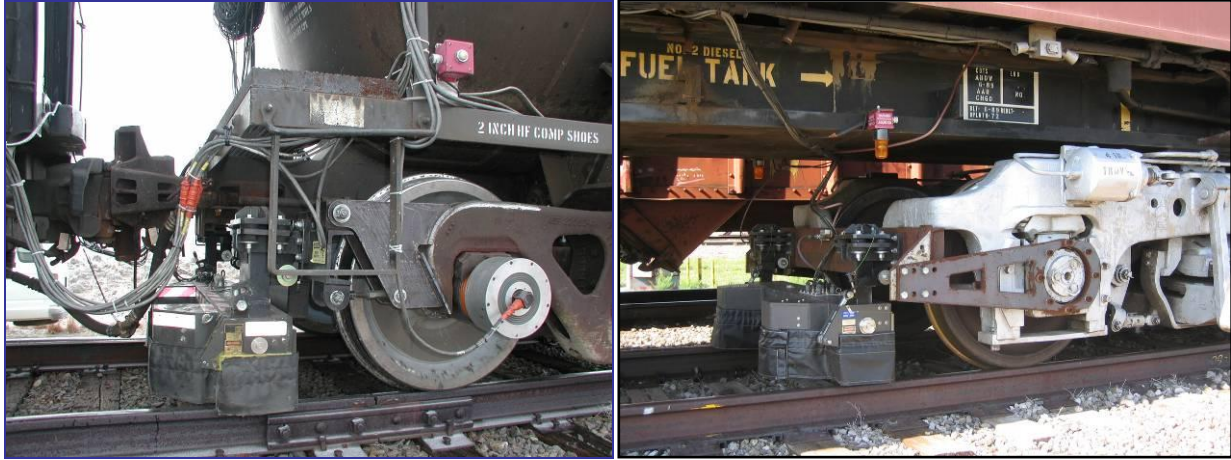
Figure 18. TTCI's Track Geometry Measurement System Attached to an Empty Tank Car (left) and TTCI's Track Loading Vehicle (right)

TTCI’s track geometry measurement system (TGMS) was used to measure track geometry conditions of the slab track. This system is an inertia/laser-based noncontact measurement system purchased from Imagemap, Inc. The system has been used extensively on the test tracks at TTC as well as on revenue service tracks for various research and testing projects. The system is portable, which means it can be installed onto the trucks of various vehicles. At the early phase of the slab track project, this system was attached to an empty freight vehicle (tank car). Later, the system was moved and installed on TTCI’s track loading vehicle (TLV) (see Figure 18).

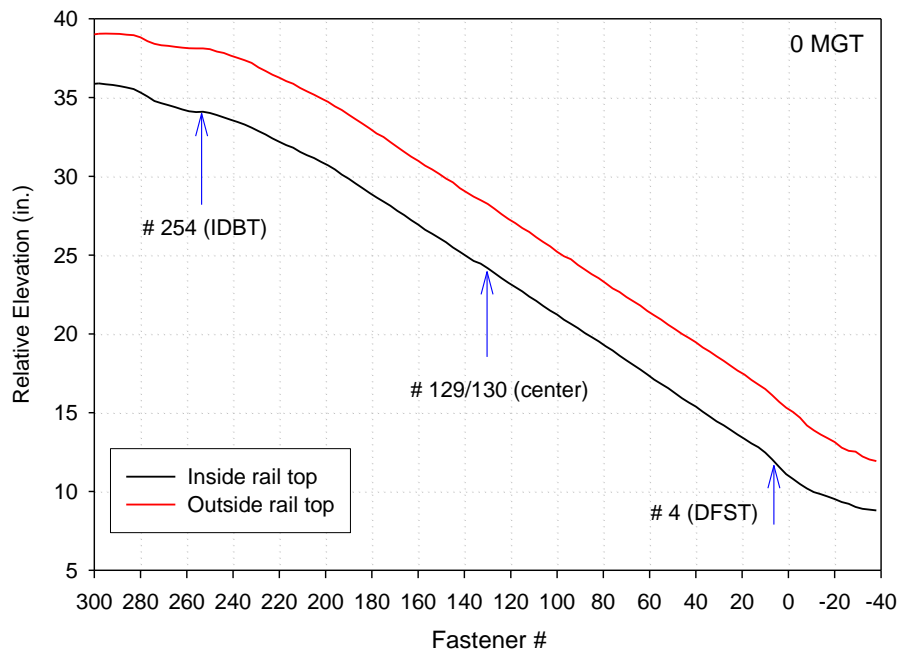
Figure 19. Initial Rail Surface Elevation Results

Figure 19 shows the initial TOR elevation survey results for both rails in the test section. As illustrated, a 4-inch superelevation exists between the outside (high) and inside (low) rails. As mentioned in Subgrade, a slight downhill grade (0.4 percent) exists from the IDBT to the DFST. Figure 19 illustrates that the slab track test section (both the IDBT and the DFST) had a very smooth surface condition. In contrast, the surface condition in the transitions showed more variation. Initial TOR elevation results were used to calculate the settlement of the slab track test section by subtracting later TOR elevation survey results from the reference values.

Figure 20 shows that the slab track test section had a very smooth surface and little crosslevel deviation, consistent with the results shown in Figure 19. The surface of the transitions, however, is not as smooth but is still well within the allowable limits shown in Table 3.

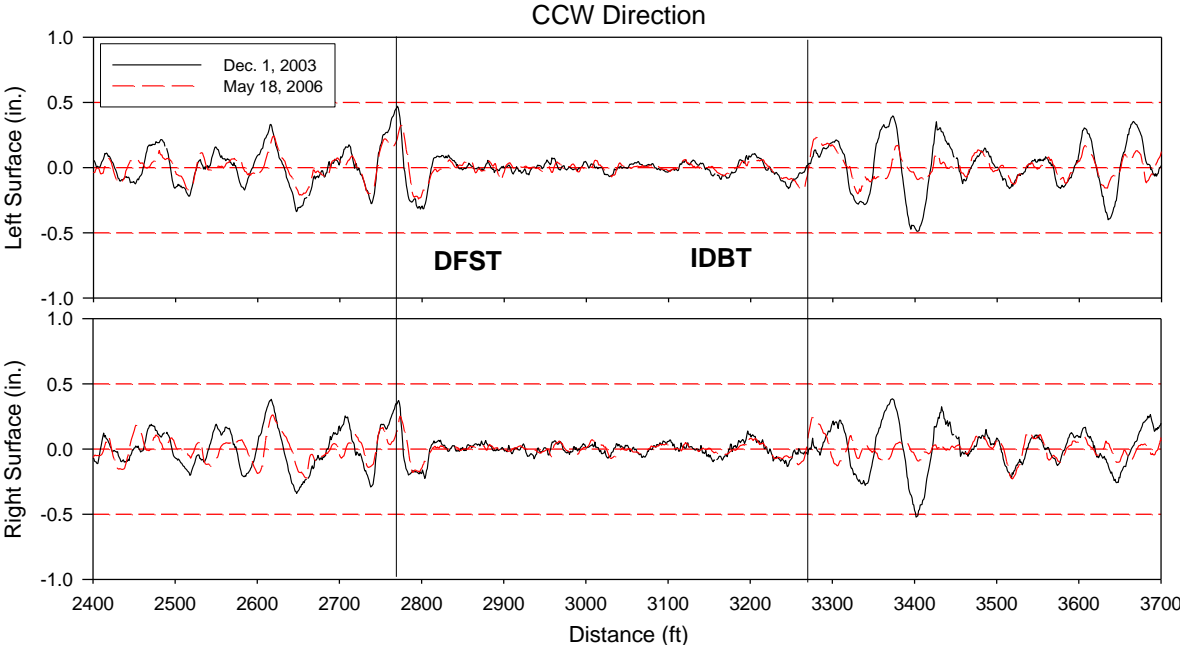
Figure 28. Change of Track Surface over Time

Figure 28 shows the comparison of surface test results from the beginning to the end of the testing program. As shown, the surface of the slab tracks (DFST and IDBT) is superior to that of the adjacent ballasted track. Larger deviations at the ends of the slabs were caused by the rougher track in transitions.

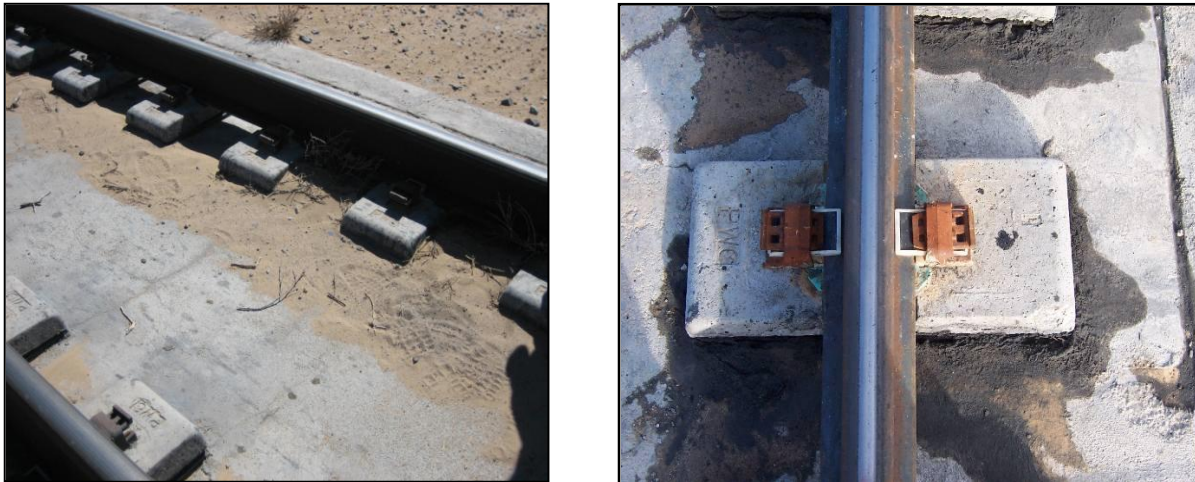
Figure 30. Fine Sand Deposit and Buildup of Gray Material around IDBT Tie Blocks

After a few million gross tons into the testing program, fine windblown sand and buildup of a gray material was observed around tie blocks on the IDBT slab surface. Figure 30 shows the fine sand deposit and gray material around the ties.

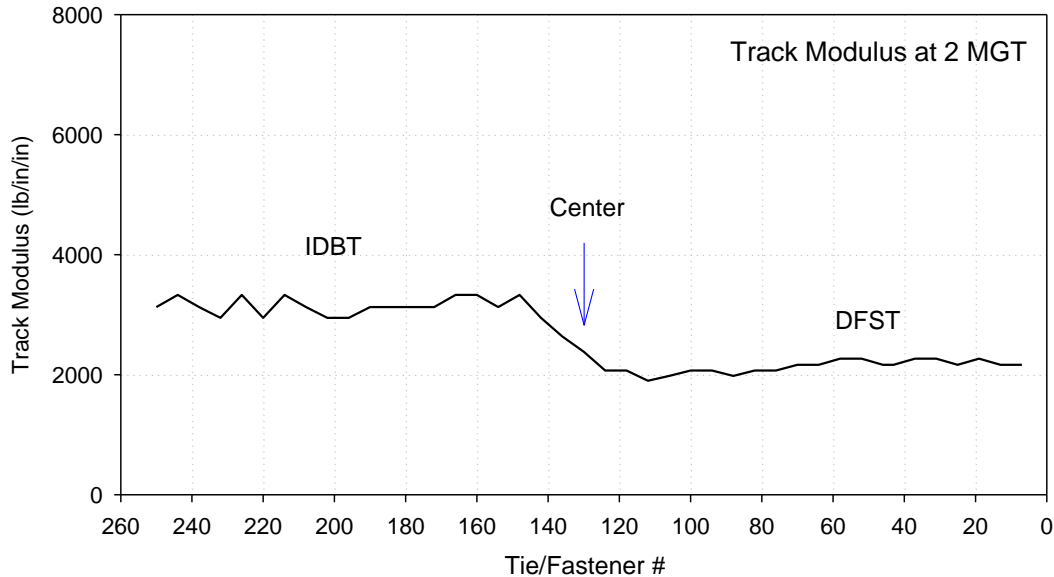
Figure 31. Track Modulus Test Result of Slab Track (IDBT and DFST)

The test results shown in Figure 31 were independently verified by other measurements conducted at the same time, such as vertical track deflection test results under dynamic wheel loads, and TLV in-motion track stiffness test results, presented in the following section.

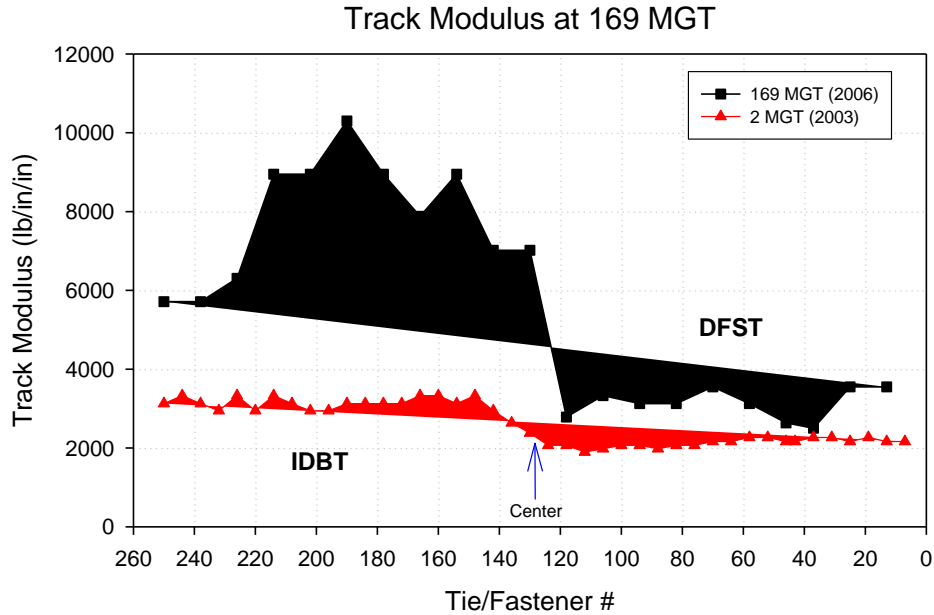
Figure 34. Track Modulus Test Results of Slab Track (IDBT and DFST) at 169 MGT

The test results shown in Figure 34 were also corroborated by the track vertical deflection results presented in Section 6. Under dynamic wheel loads, the magnitude of vertical deflections between the rail base and the concrete slab resulting from the rubber boots and pads decreased over time from the early test to the test conducted toward the end of the testing program.
