**Essential Fish Habitat Assessment Report
for the
All Aboard Florida Passenger Rail Project
from Orlando to Miami, Florida**

Prepared for:
United States Army Corp of Engineers

Prepared by:
AMEC Environment & Infrastructure, Inc.
404 SW 140th Terrace
Newberry, Florida 32669

September 2013

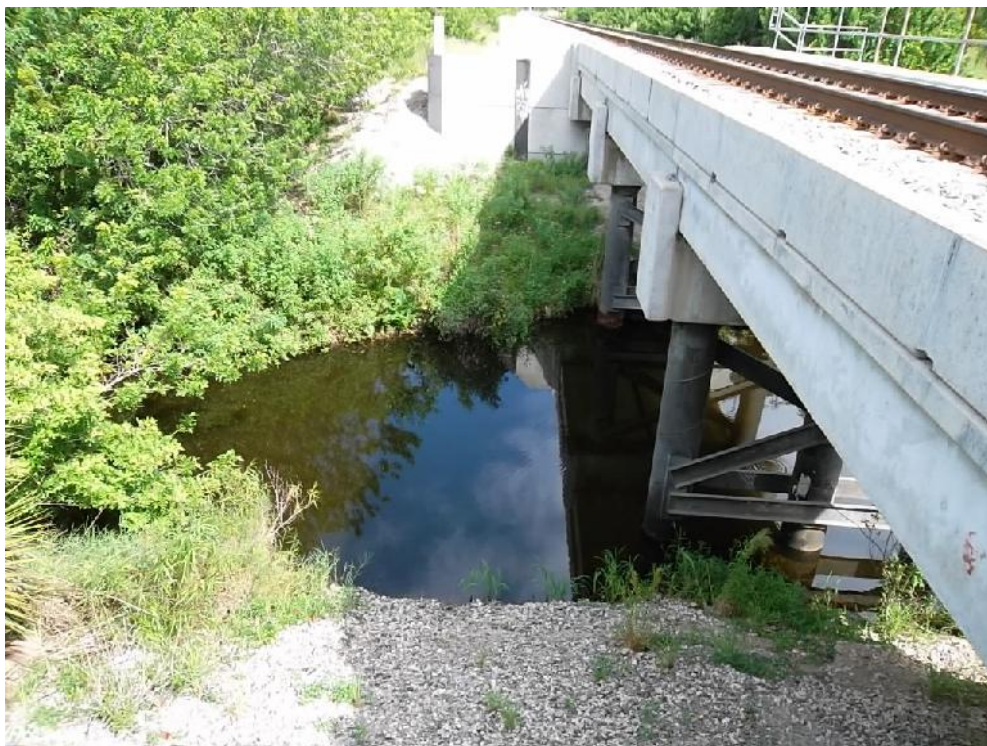
Photograph 1. Existing rail bridge over Horse Creek (Brevard County), with concrete pedestrian access; view to south.

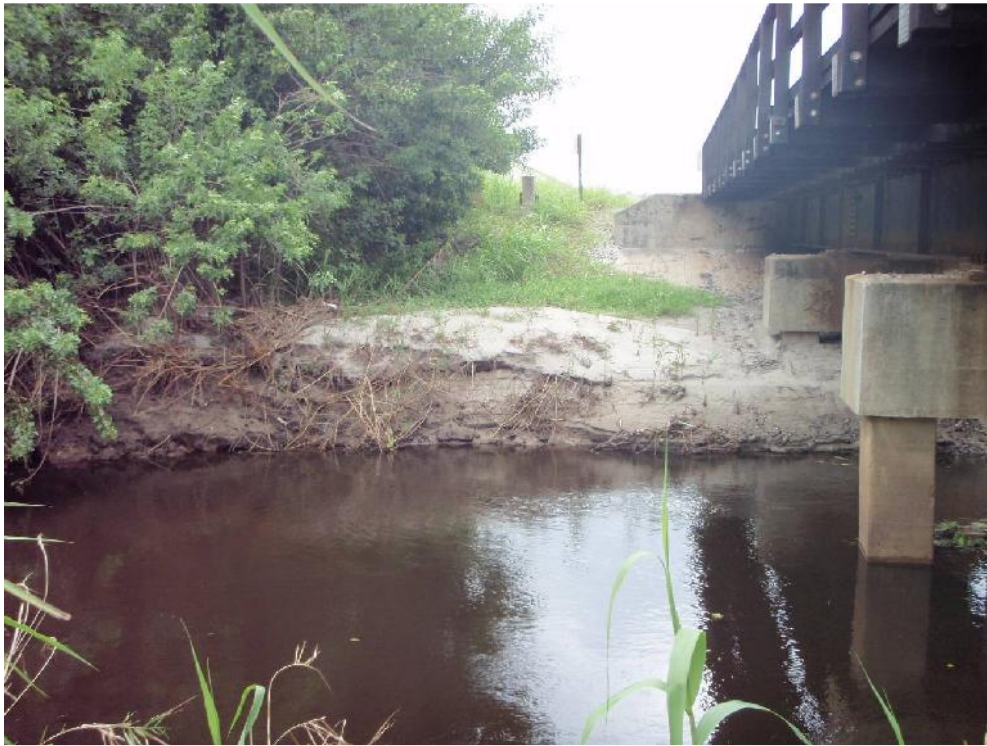
Photograph 2. Sedimentation beneath the South Canal Bridge, with Elephant grass and Brazilian pepper dominant vegetation; view to north.

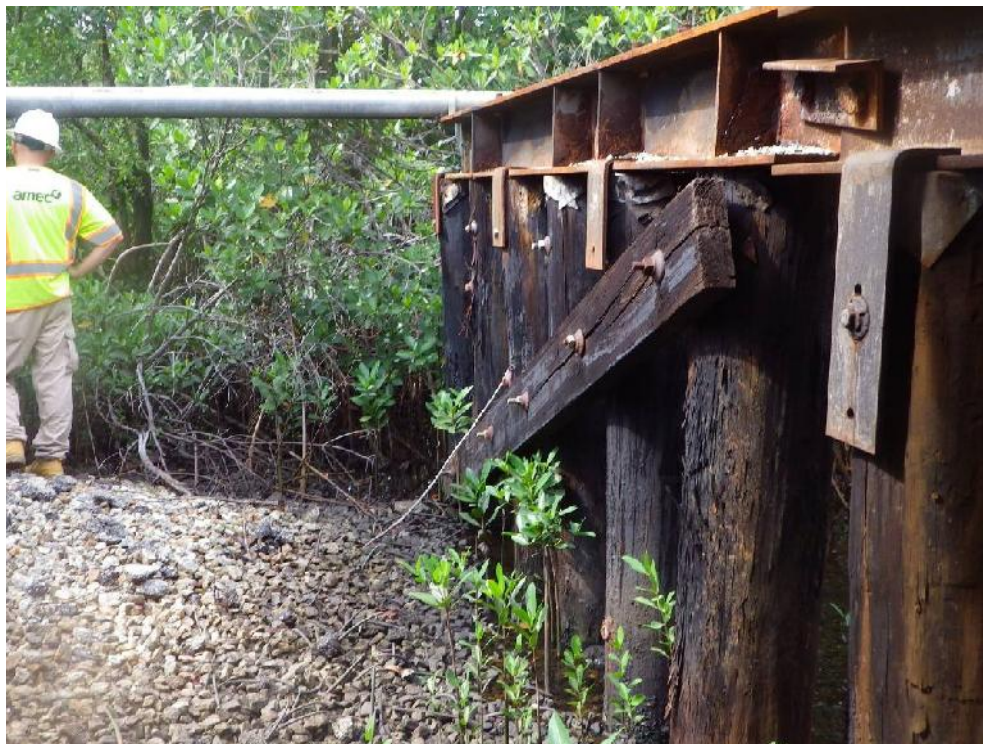
Photograph 2. Red mangrove propagules were observed growing under existing bridge during the site visit.

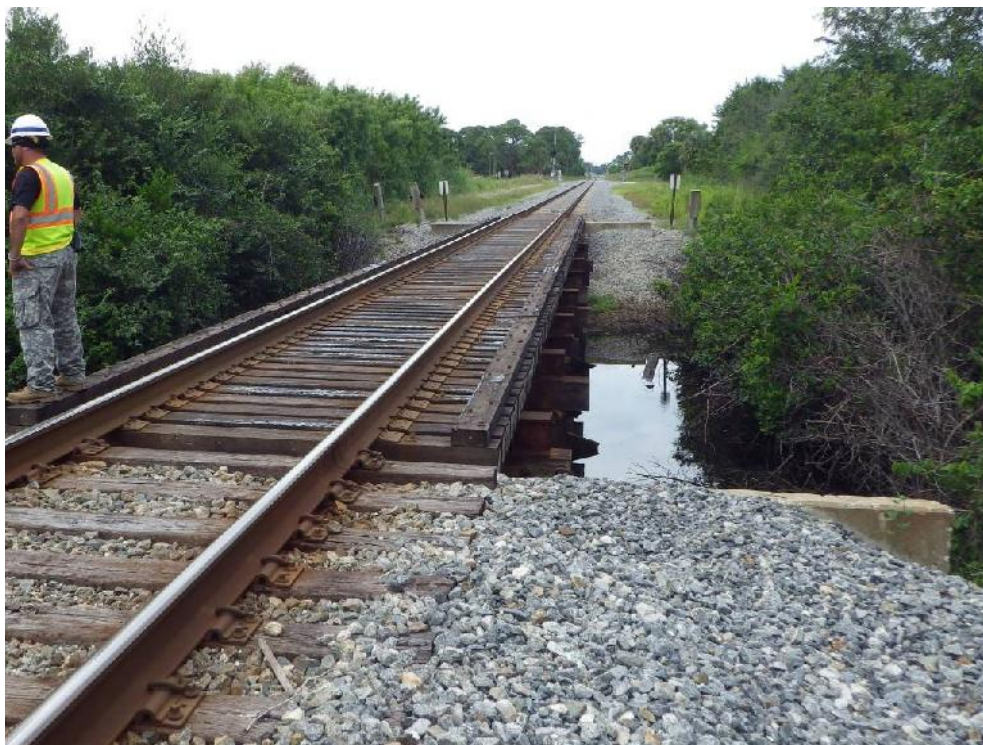
Unnamed Tributary 1 (MP 266.86)

Photograph 1. The bridge at MP 266.86 crosses a creek about 20 feet wide surrounded by red mangrove wetlands.

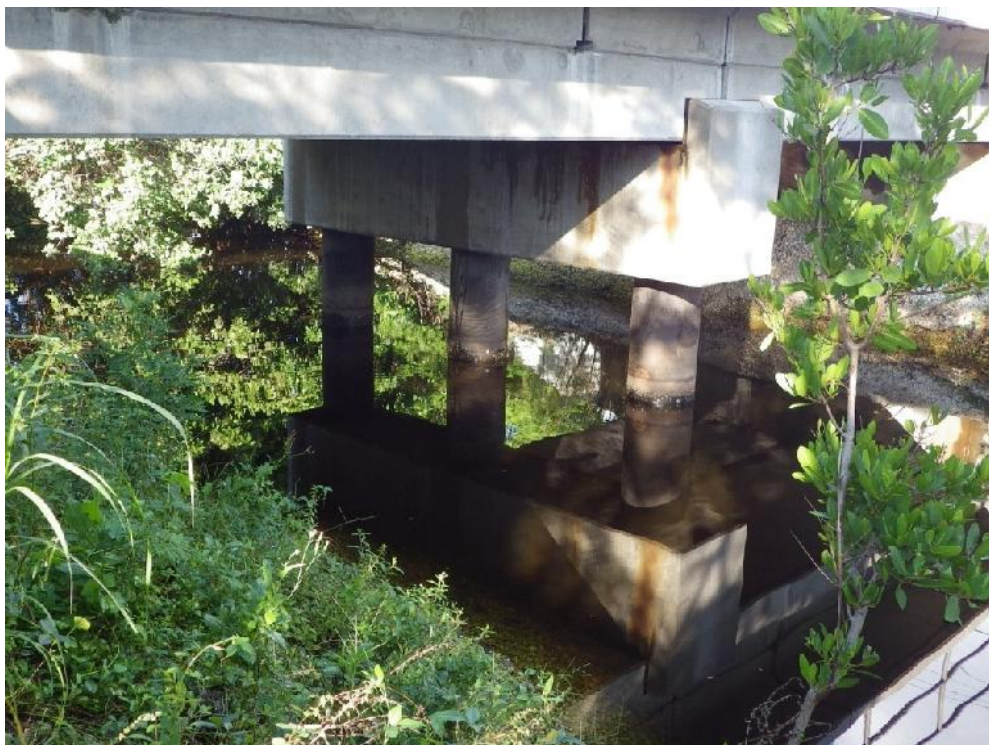
Unnamed Tributary 2 (MP 266.58)

Photograph 1. The railroad bridge at MP 266.58 has a row of 3 pilings in the water and ballast on the shoreline.

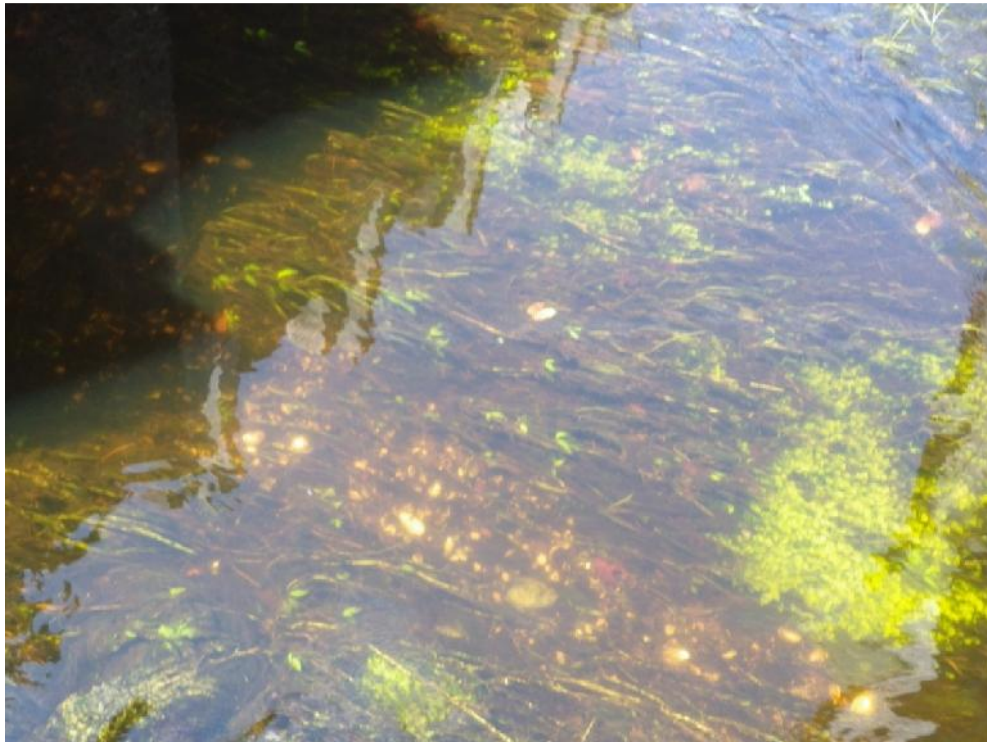
Photograph 2. Eel grass observed in stream.

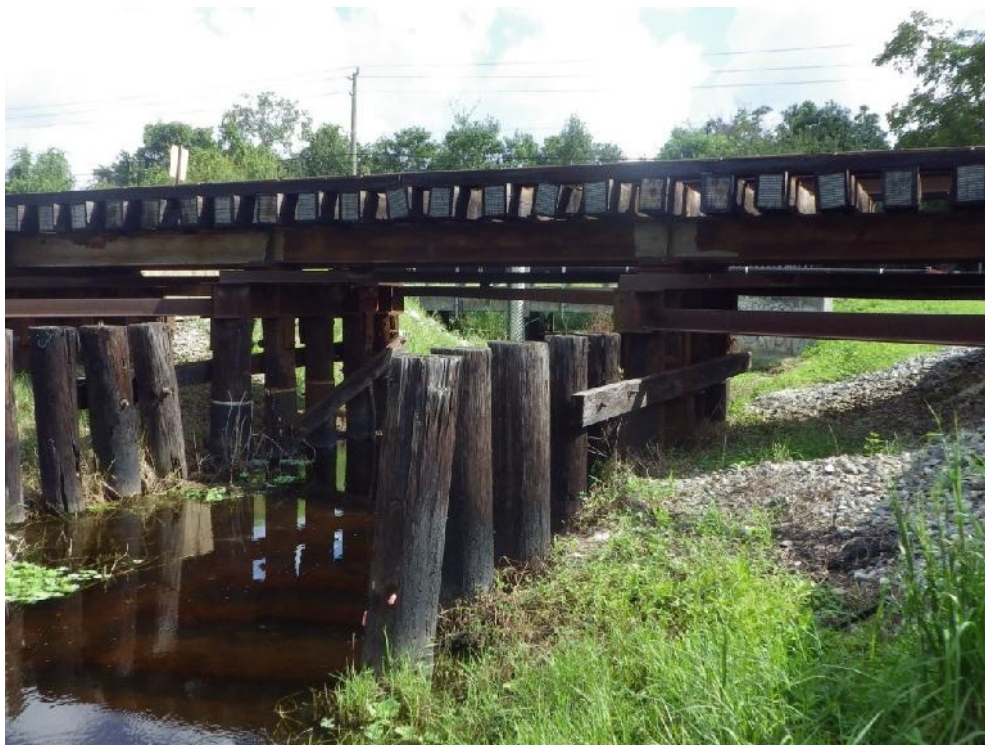
Tributary to Manatee Creek 2 (MP 267.34)

Photograph 1. The bridge crosses the Tributary to Manatee Creek 2 with two sets of four pilings. The shore is covered with ballast and riprap.

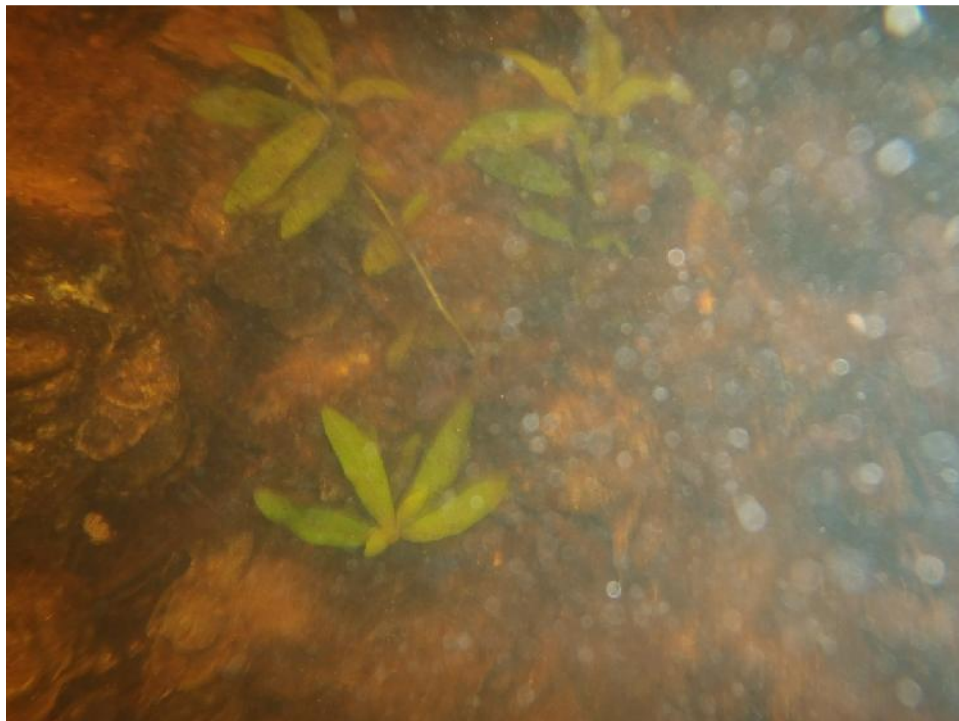
Photograph 4. *Hygrophila* sp. observed within the assessment area.

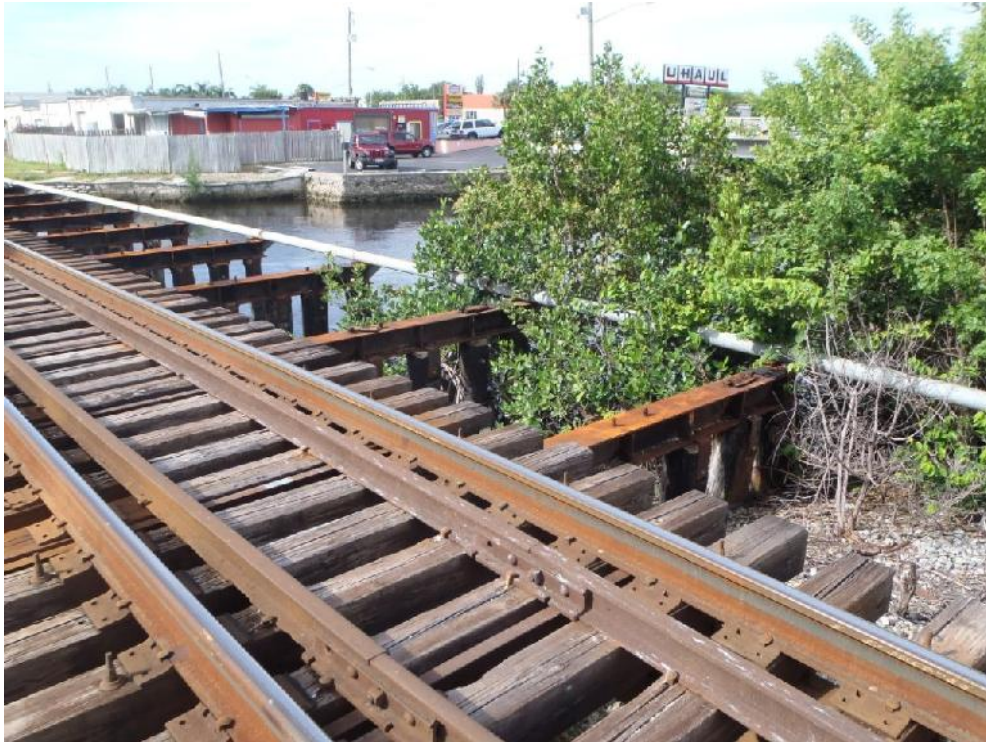
North Fork of the Middle River

Photograph 1. Facing south at mangroves growing into the former west bridge.

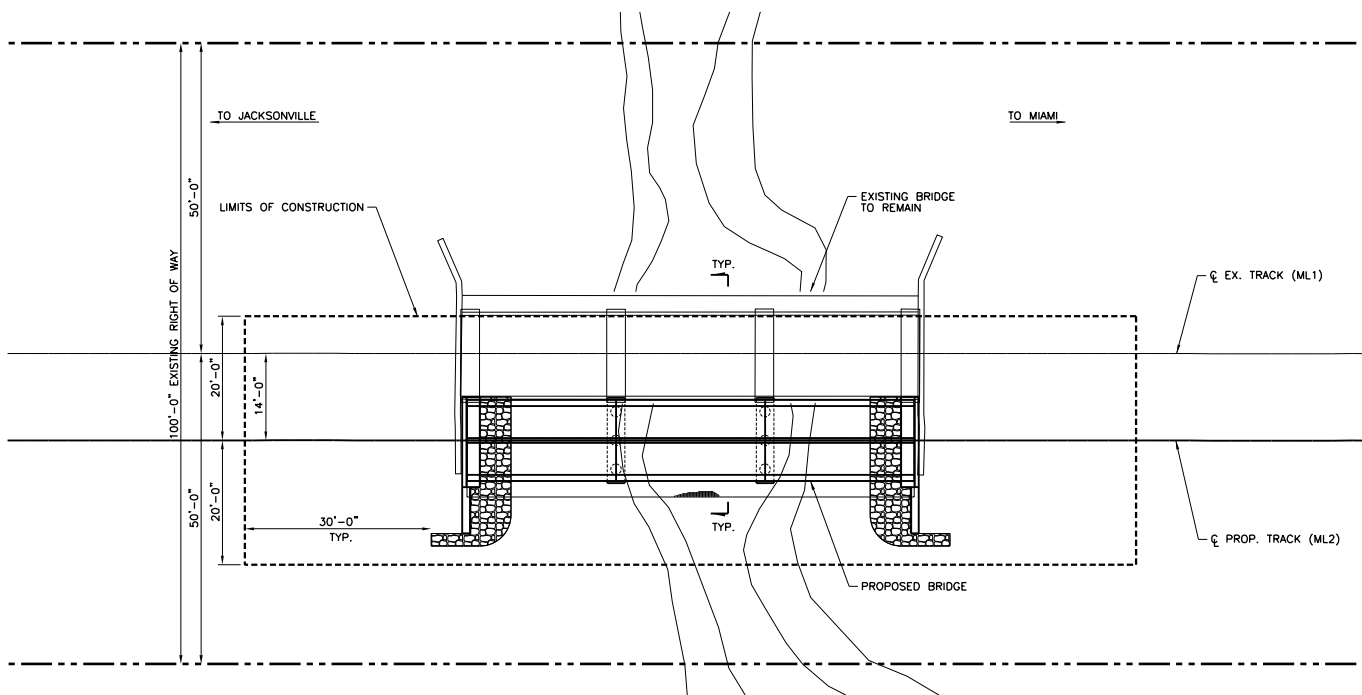
- NOTES**
1. Design Live Load: Cooper E80, Plus 6" Future Additional Ballast.
 2. Specifications: A.R.E.M.A. Manual for Railway Engineering, dated 2012: Chapter B - Concrete Structures.
 3. All Existing Timber Piles Shall be Cut Off 2'-0" Below Mudline.

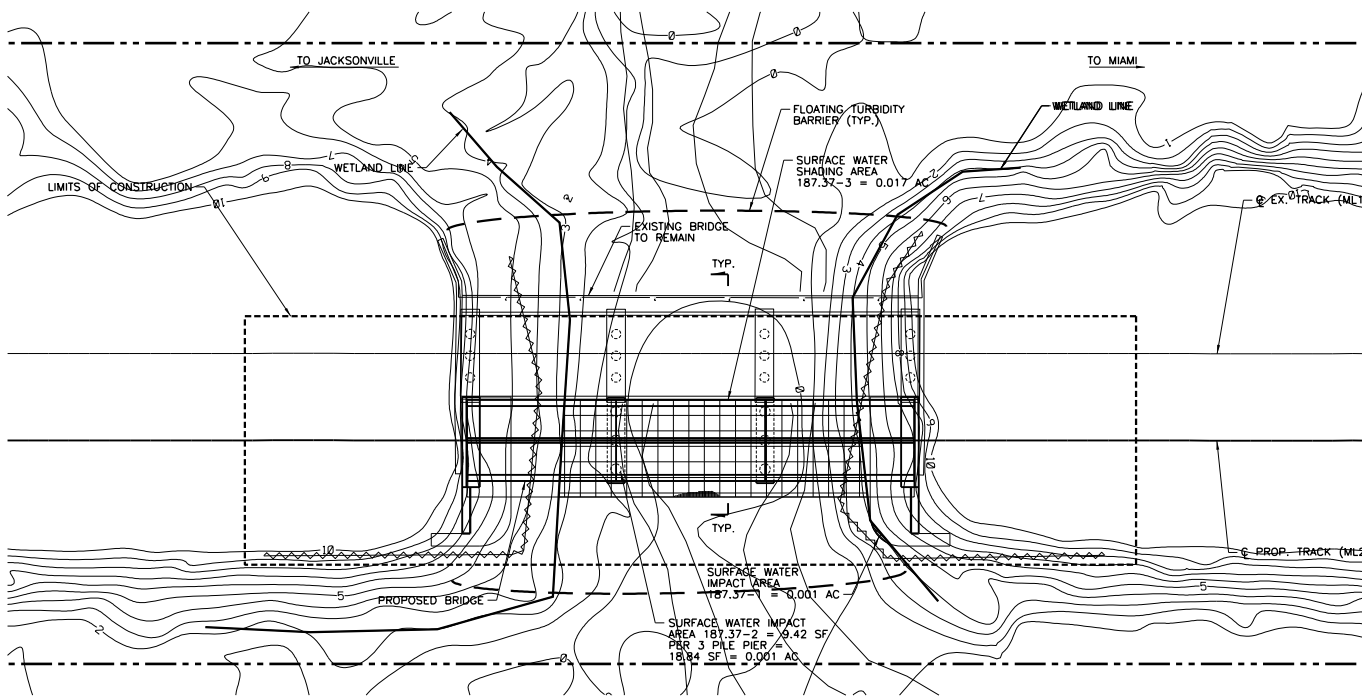
- NOTES**
1. FLOATING TURBIDITY BARRIER PLACED UPSTREAM AND DOWNSTREAM OF CONSTRUCTION LIMITS.
 2. BEDDING STONE SHALL BE BALLAST.
 3. INDIVIDUAL RIPRAP STONES SHALL VARY IN WEIGHT FROM 25 TO 100 LBS.

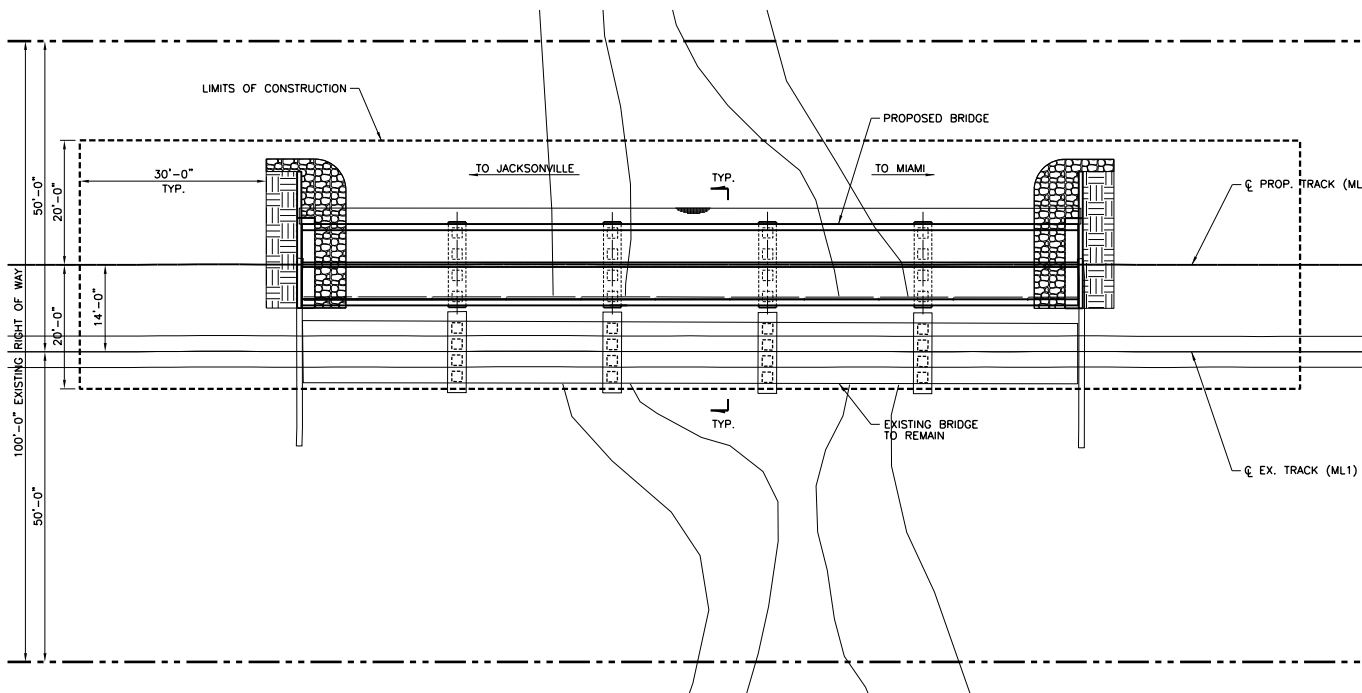
PROJ NO: 304120040_040
SCALE: AS NOTED
DATE: 2/10/2013
DESIGNED BY: MYC
DRAWN BY: DJS
CHECKED BY: DEB
SHEET TITLE:
**SOUTH CANAL
BRIDGE 230.03
GENERAL PLAN
AND ELEVATION**

- NOTES
- Design Live Load: Cooper E80, Plus 6" Future Additional Ballast.
 - Specifications: A.R.E.M.A. Manual for Railway Engineering, dated 2012: Chapter B - Concrete Structures.
 - All Existing Timber Piles Shall be Cut Off 2'-0" Below Mudline.
