Developing a Reliable Signal Wire Attachment Method for Rail

1. AGENCY USE ONLY (Leave blank)	2. REPORT DATE November 2014	3. REPORT TYPE AND DATES COVERED Final (September 2011–June 2013)	
4. TITLE AND SUBTITLE Developing a Reliable Signal Wire Attachment Method		5. FUNDING NUMBERS DTFR53-12-C-00002

9. SPONSORING/MONITORING AGENCY NAME(S) AND ADDRESS(ES) U.S. Department of Transportation Federal Railroad Administration Office of Railroad Policy and Development Office of Research and Development Washington, DC 20590		10. SPONSORING/MONITORING AGENCY REPORT NUMBER DOT/FRA/ORD-14/33

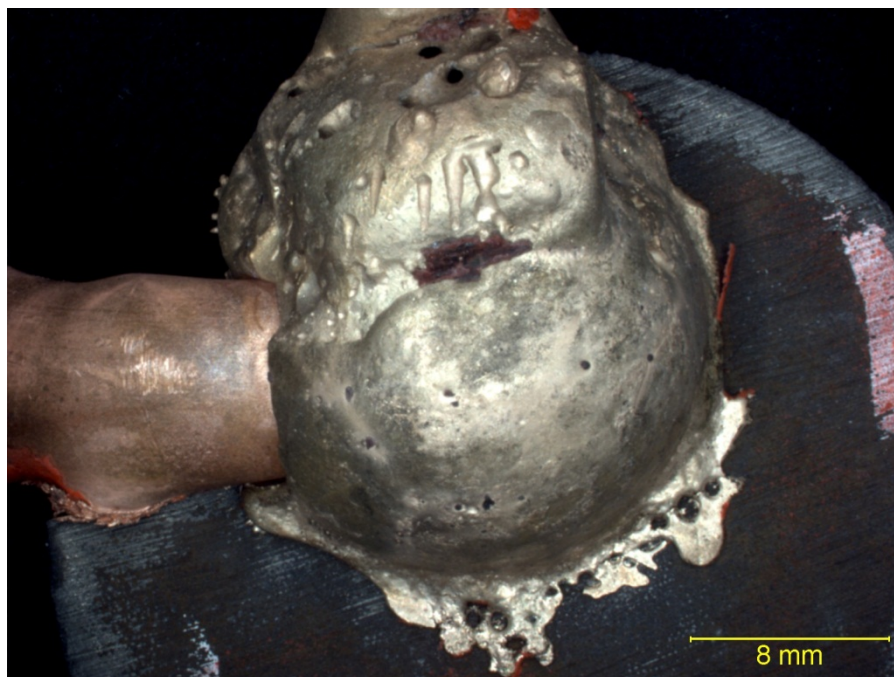
Figure 1. Exothermic RWI Joint

Welded bonds require heat to make the weld and this heat can change the microstructure of the rail steel. Martensite, a hard and brittle microstructure, is formed as a result of rapid cooling (quenching) of the heated steel. Untempered martensite weakens the steel and can lead to cracking under load. In general, the exothermic weld/braze joints can perform well if they are properly executed. However, there are many critical steps in the process to guarantee quality of the joint, making it a risky process to perform in the field. Thorough cleaning of the rail and fit-up of the mold to rail are critical to the success of the operation.

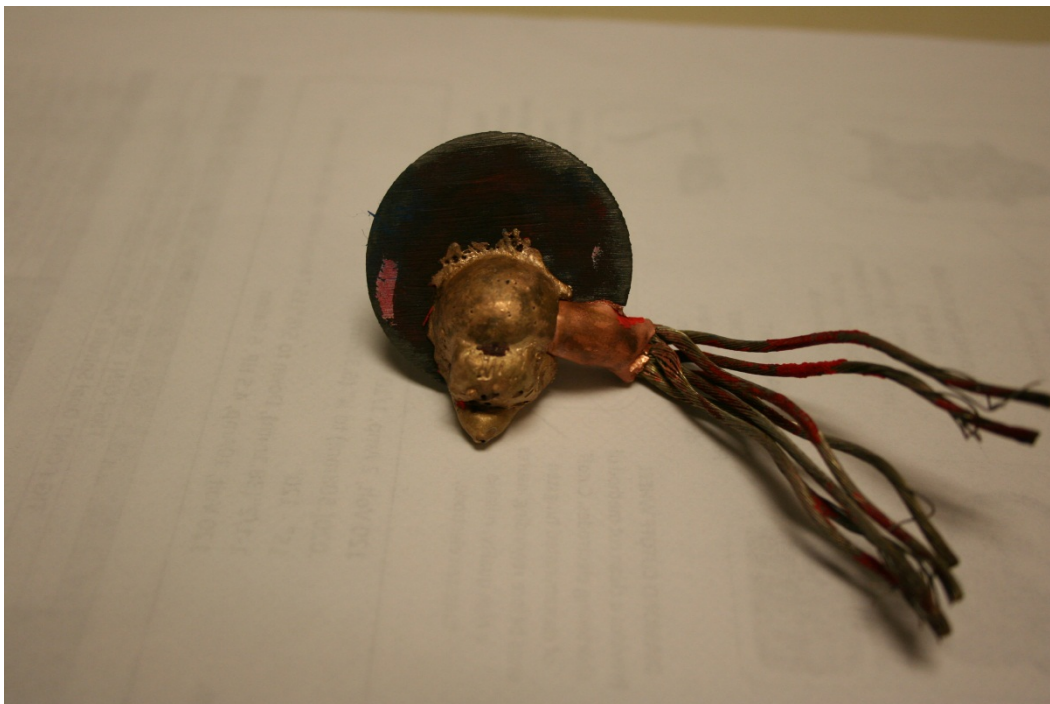
Figure 3. Removed Section

A section of rail with an ultrasonic testing (UT) indication next to the RWI joint was provided for evaluation. This section was obtained from a freight line. The presence of defects next to RWI joints was noted in the TTCI work as a concern. This section was removed before fracture of the rail occurred by drilling from the backside of the RWI joint in the web. A group of photos of the extracted crack-containing section is shown in Figures 3–5. The crack is apparent in Figure 5 where it is running into and parallel with the round column of material.

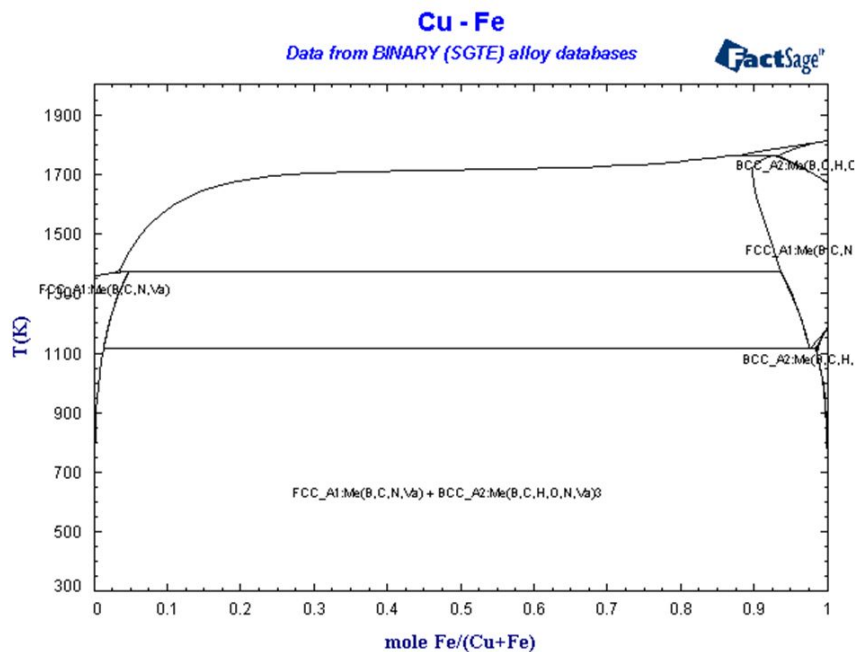
Figure 21. Phase Diagram: Copper Solubility in Iron at Elevated Temperatures

It is possible that the steel immediately adjacent to the weld interface was melted by an overheated weld alloy. This condition allows the copper to dissolve into the molten steel and, upon cooling, decorate the grain boundaries in inter-dendritic regions. It is possible that the increase in temperature allowed the copper to go into solution in the steel in the areas adjacent to the fusion boundary. This theory is supported by the copper-iron phase data shown in Figure 21. Copper solubility decreases upon cooling and it is rejected along the grain boundaries. Figure 22 shows the presence of copper in the HAZ next to the crack.

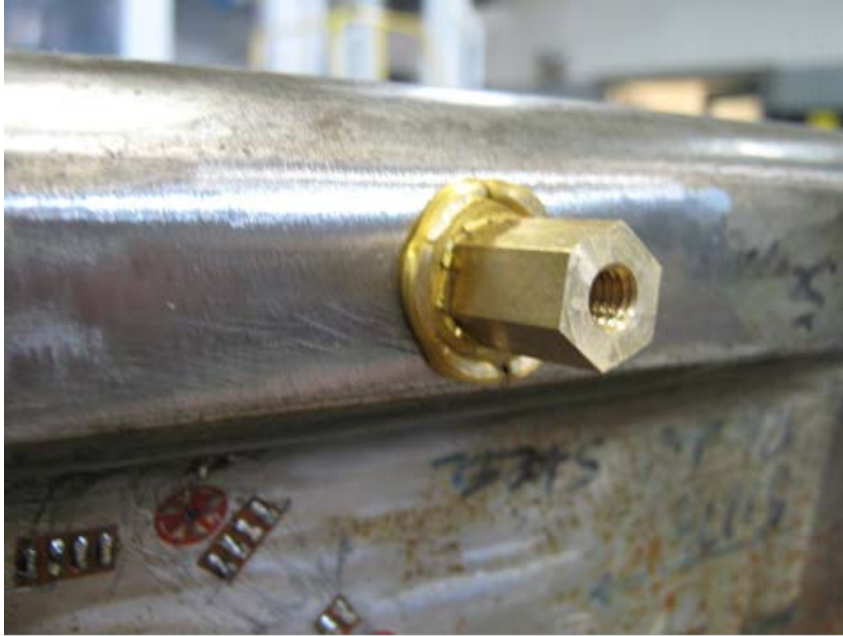
Figure 40. IFW Joint Prior to Corrosion Testing

A photograph of each bond type prior to corrosion testing is shown in Figures 40 and 41.

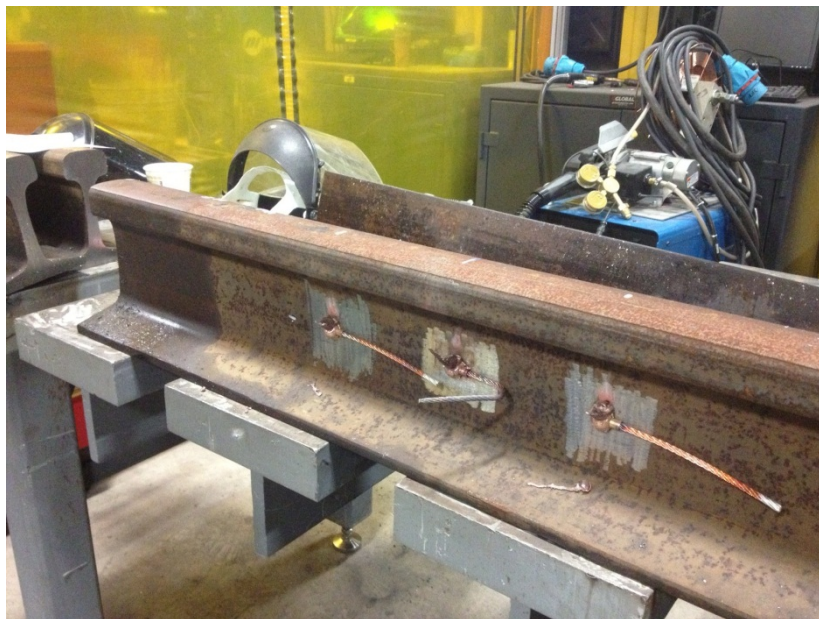
Figure 41. CAD Joint Prior to Corrosion Testing

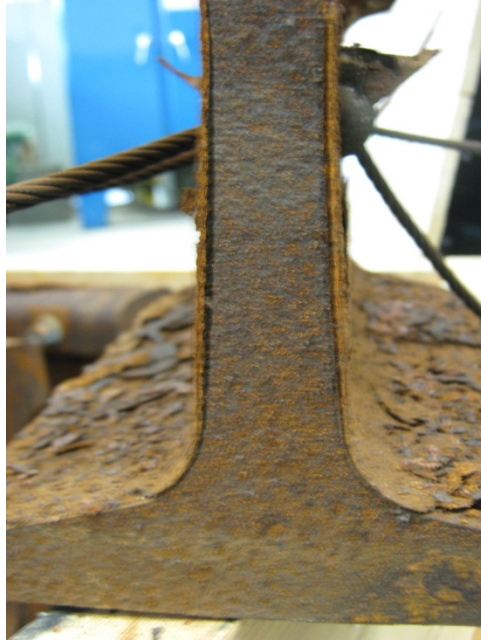
Figure 42. End View of Rail Showing Corrosion Products' Accumulation on Rail Web

EWI measured approximately 0.200 in loss of material in the rail head width. The loss of material is obvious in Figure 42. The corrosion products are apparently scabbing away from the parent rail.

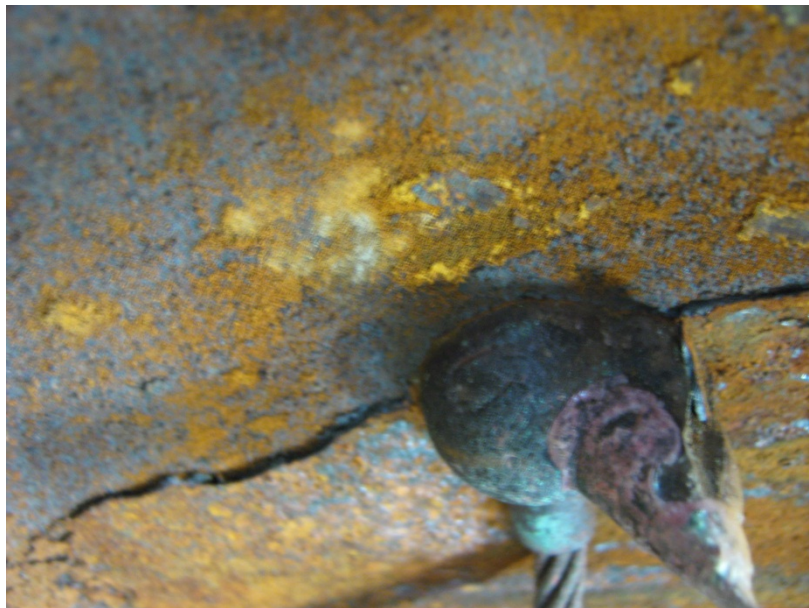
Figure 43. CAD Weld after Corrosion Test

Photographs of the corroded test samples are shown in Figures 43 and 44.

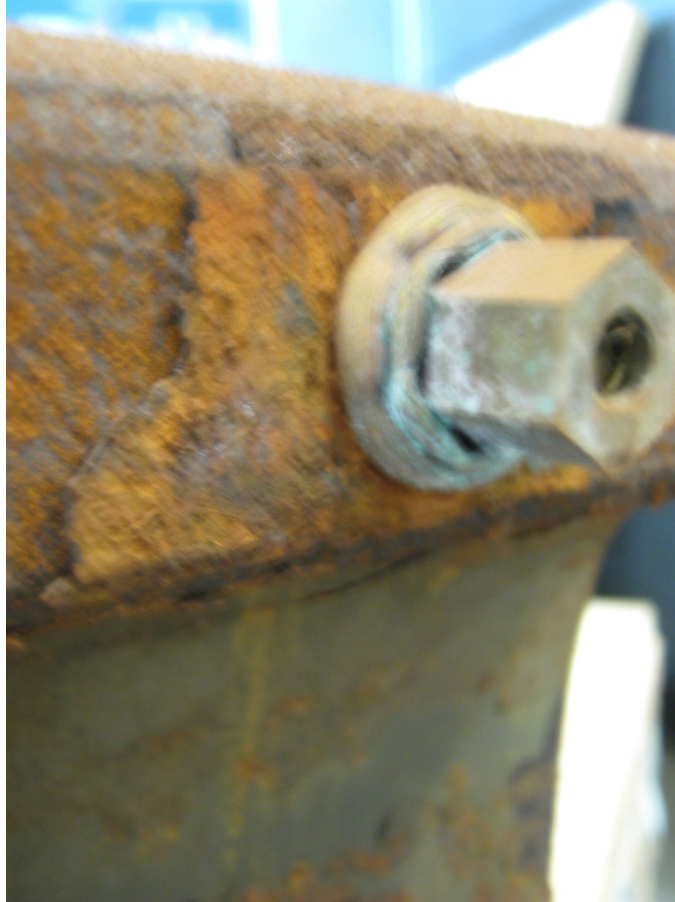
Figure 44. Inertia Friction Weld after Corrosion Testing

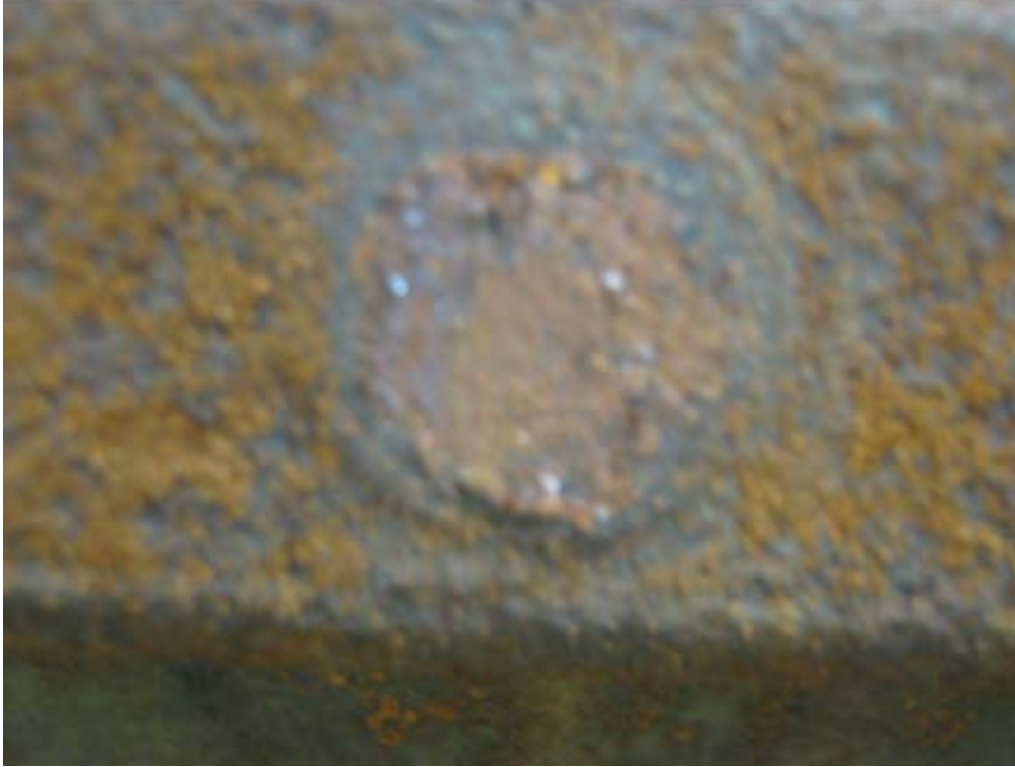
Figure 45. Low Quality IFW Joint due to Misalignment

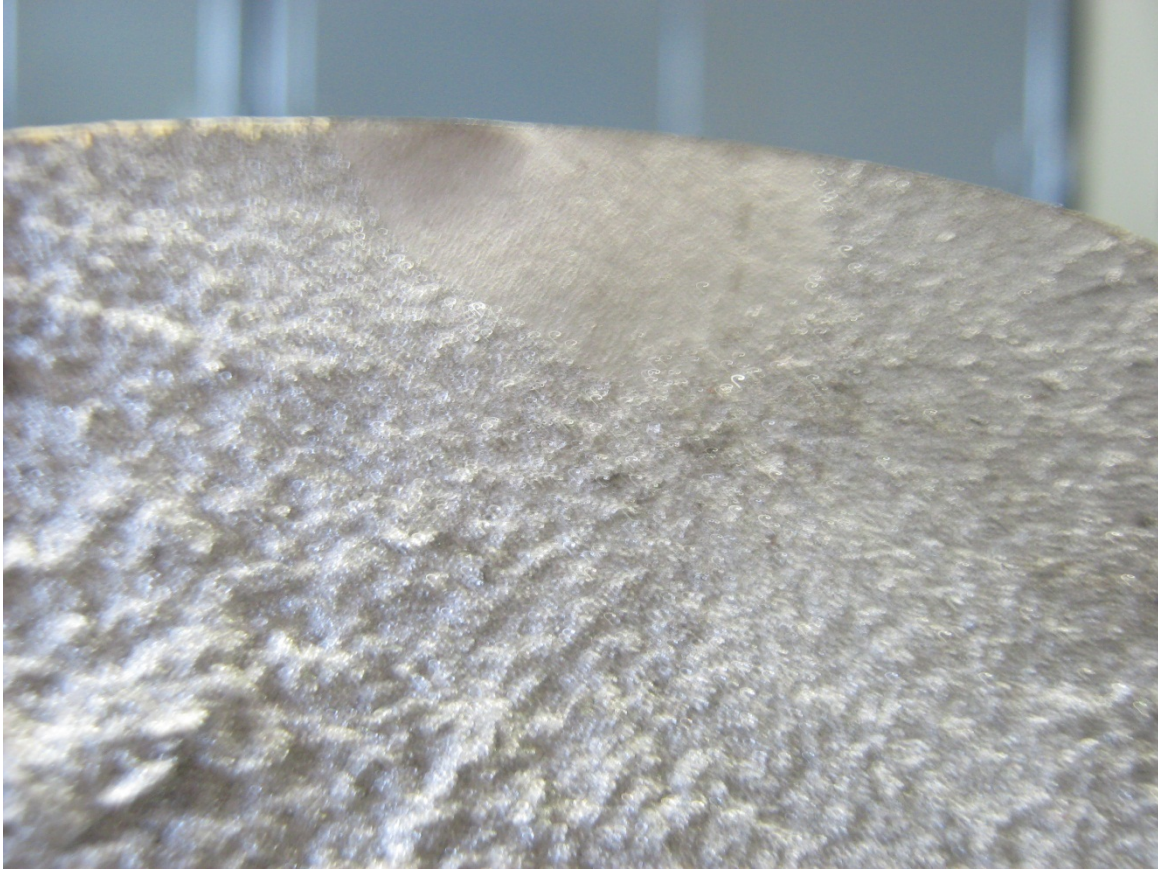
Figure 47. Fatigue Failure Driven by Surface Pitting on Rail Head

Most of the observed failures originated at surface defects on the rail head. Most failure initiated from the surface of the rail where tiny corrosion pits acted as stress risers, as shown in Figure 47. In normal track service, it is unlikely that these pits would initiate cracks because the constant rolling friction of the train wheels acts to close the pits.

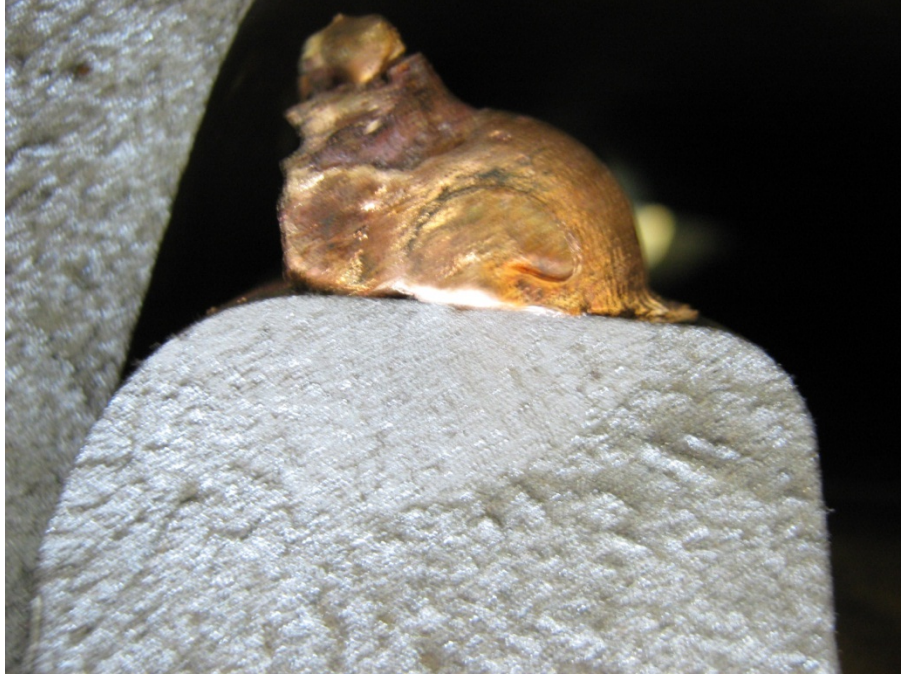
Figure 48. CAD Weld Driven Failure due to Formation of Martensite

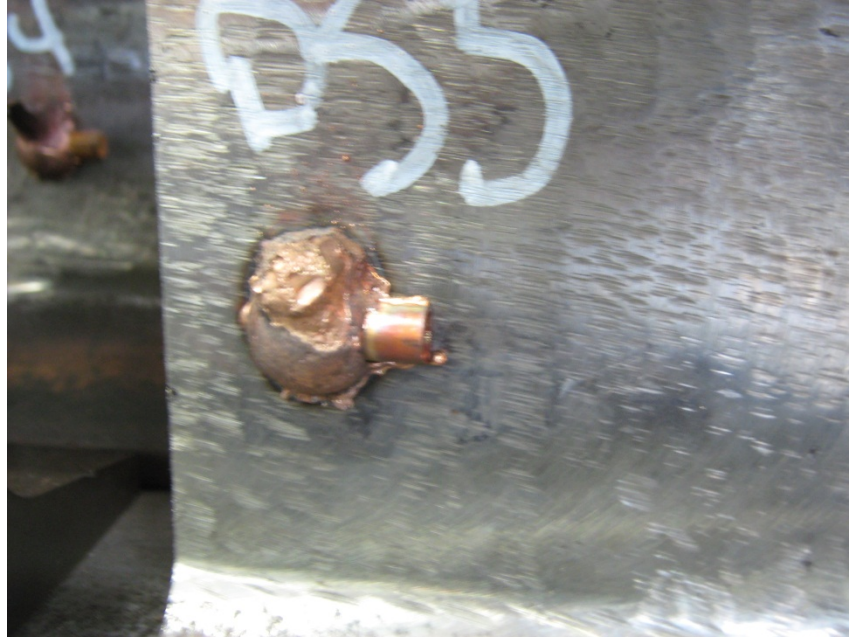
Figure 50. CAD Weld Typical Failure Showing Wire Strand Pullout

Figure 50 shows the resulting failure of a CAD weld joint where the wire has simply pulled out of the CAD weldment. All joints in the CAD welds failed in this manner. This failure mode acts as a fusible link application in a RWI joint.

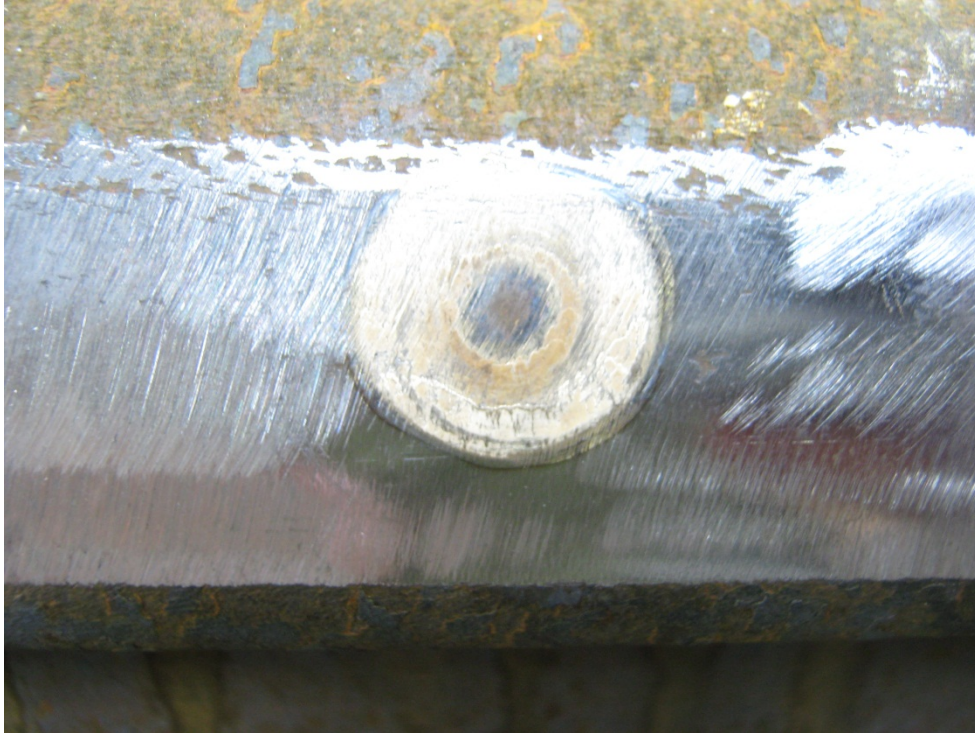
Figure 52. IFW Shear Test Failure Surface

Figure 52 shows a typical failure from a shear test of the IFW joints. It is apparent in the photograph that the rail surface was irregular—leading to a lower load failure of the weld joint. This conclusion is evidenced by irregular areas of the stud material transfer onto the rail and the apparent peak on the rail surface. The high strength joints show that the IFW joint is at least as strong as the exothermic weld joints, from a wire restraint standpoint. Additionally, they show that the stud can pull away from the rail without damaging the underlying rail material while providing a high strength joint.

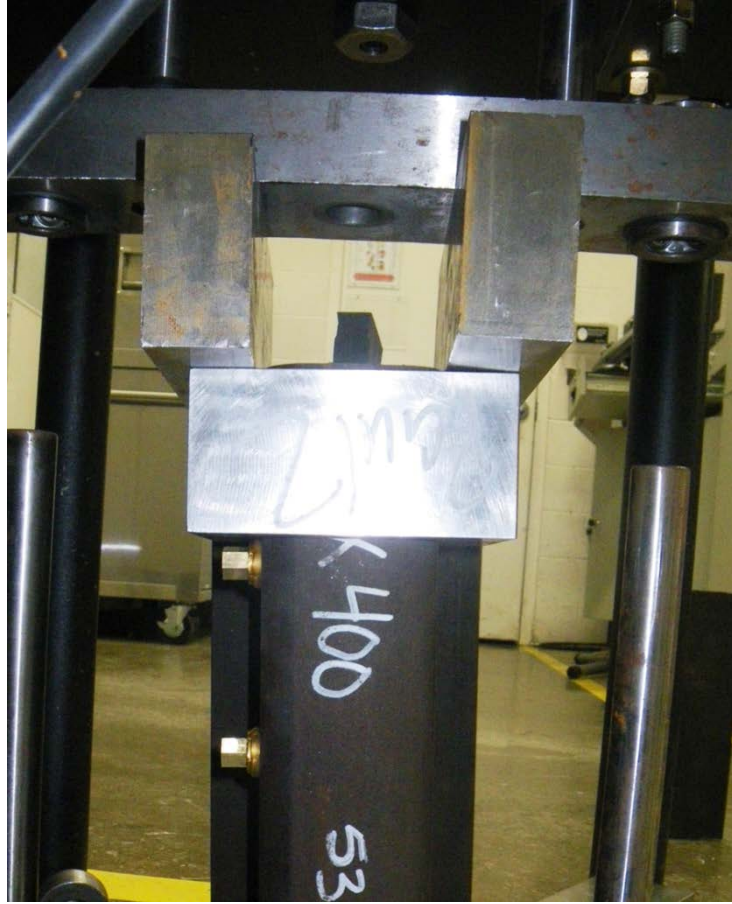
Figure 53. Impact Fixture Applied to IFW Joint

Figure 53 shows the impact test fixture installed in a drop tower applied to the IFW joint. Figure 54 shows the test fixture as applied to the CAD weld joint. The fixture was designed to apply the load energy directly to the welded joint, approximately 0.030 in from the interface.

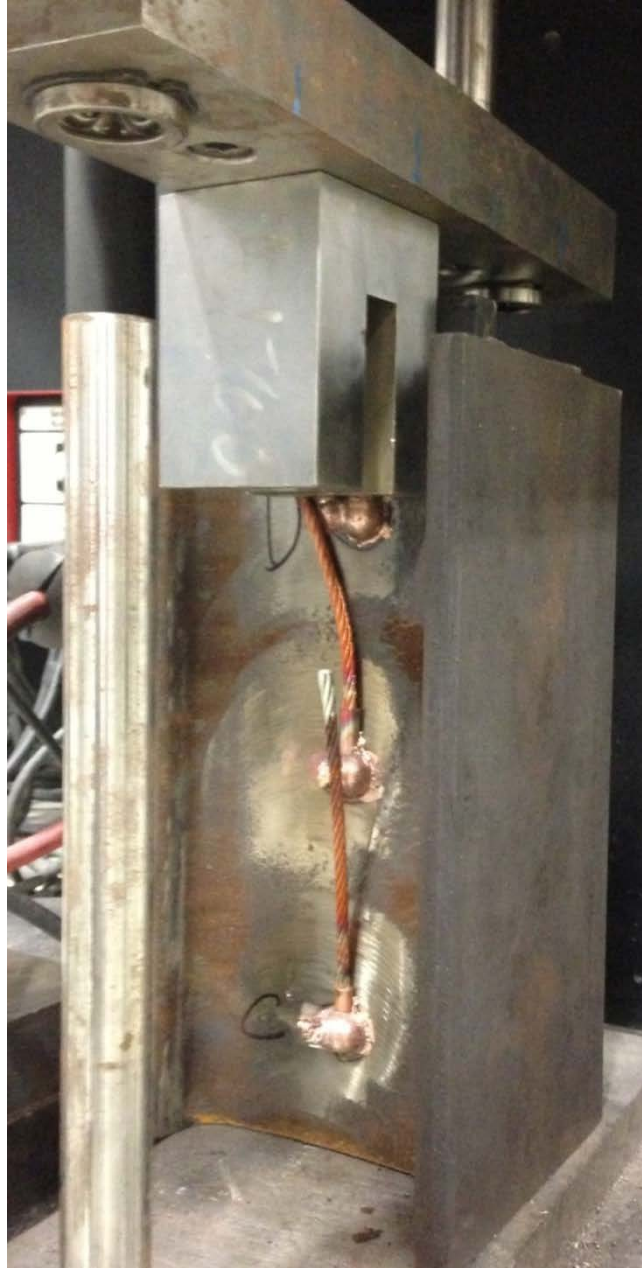
Figure 54. Impact Fixture Applied to CAD Joint

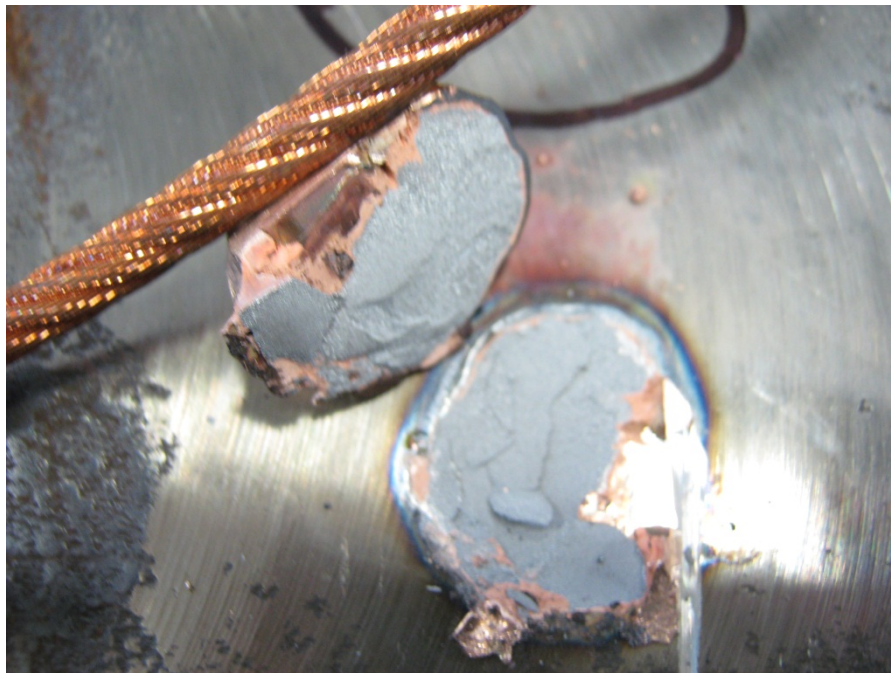
Figure 55. Fractured CAD Weld

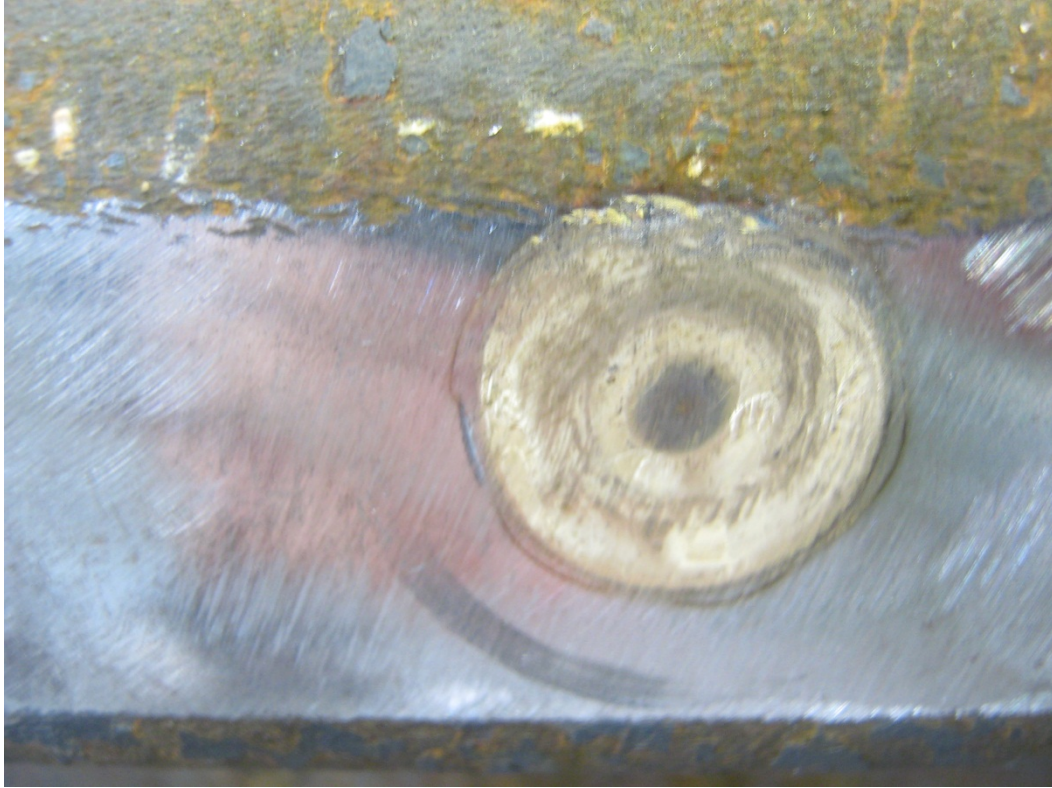
Figure 76. IFW Joint Displaying Characteristics of Axial Misalignment
