U.S. Department of
Transportation

**Federal Railroad
Administration**

Trespass Event Risk Factors

1. AGENCY USE ONLY (Leave blank)	2. REPORT DATE November 2014	3. REPORT TYPE AND DATES COVERED Technical Report July 2013 - May 2014	
4. TITLE AND SUBTITLE Trespass Event Risk Factors		5. FUNDING NUMBERS 51RR97A5-MLA49

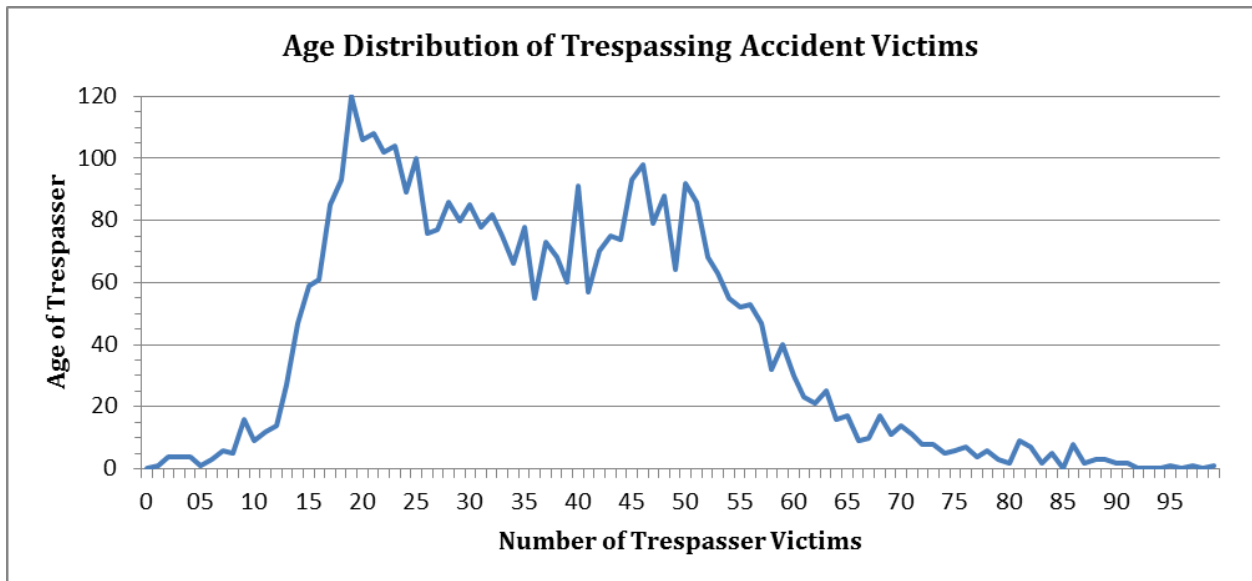
Figure 1 displays the age distribution of trespassing accident victims, as recorded in the FRA casualty data. In brief, trespassing accidents happen to people of all ages, from infants to the elderly. There are, however, some general trends. The number of trespassing victims peaks at age 19 and stays elevated through the early 20s. It rises again at age 40 and is elevated from 45 through 50.

Figure 1. Age distribution of trespassing accident victims

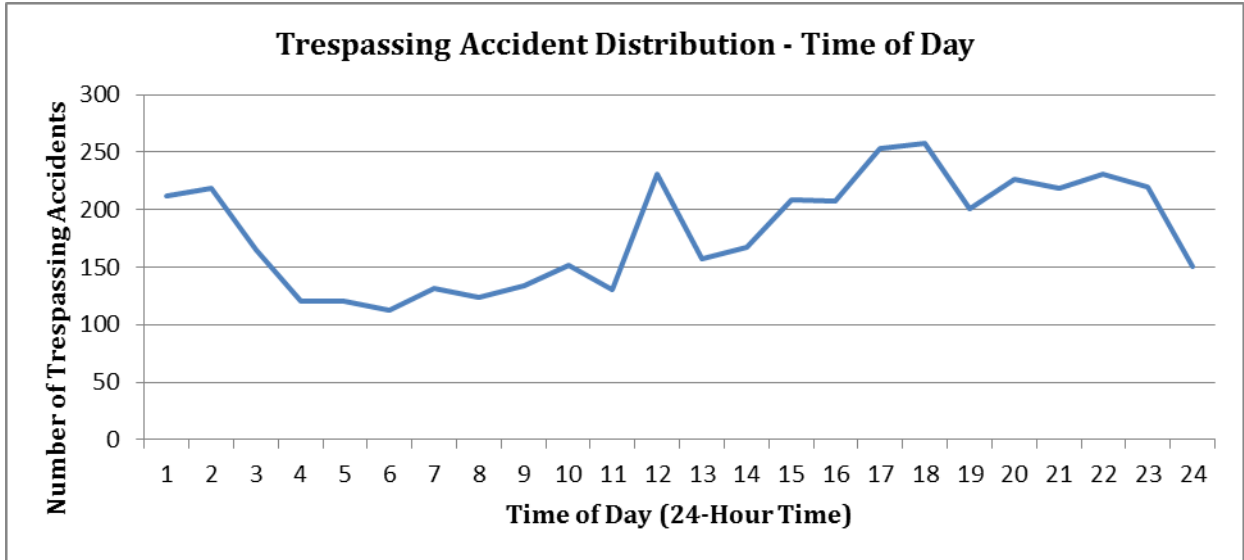
Trespassing accidents occur at all hours of the day. They peak at 12 p.m., again between 4 p.m. and 6 p.m., then remain elevated throughout the evening. The occurrence of trespassing accidents is considerably lower, by approximately 30–50 percent, throughout the morning. Figure 2 shows the distribution of trespassing accidents from 2008 to 2012, as gathered from FRA casualty reports, according to the time of day during which the accidents occurred.

Figure 2. Distribution of trespassing accidents according to the time of day during which the accidents occurred

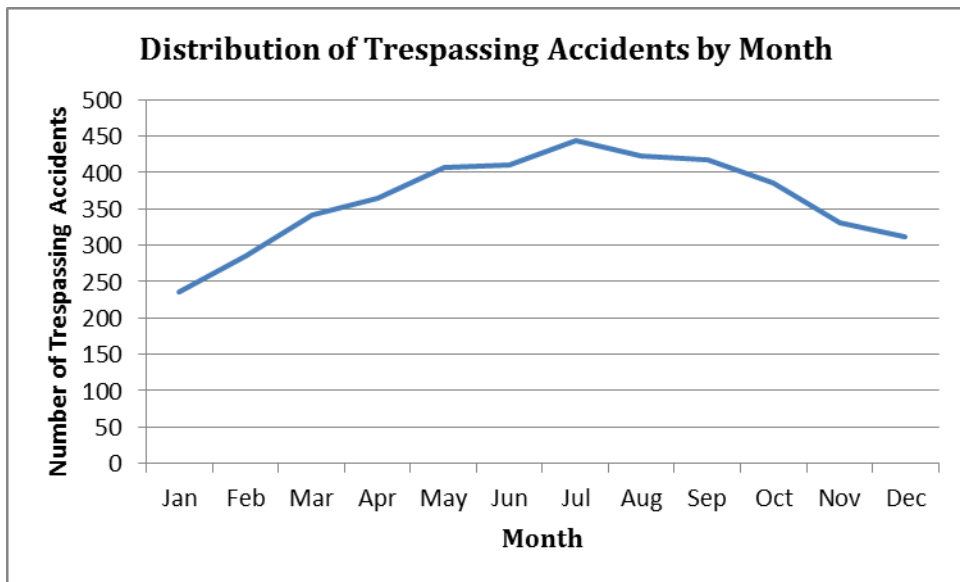
Trespassing accidents occur in all seasons and all months of the year. Figure 3 shows the distribution by month of trespassing accidents reported to FRA from 2008 to 2012. There is a notably distinct pattern of more casualties by railroad trespassing in the summer months, presumably because people are more likely to be walking outdoors. This same pattern can be observed for each year in which data was collected; the number of trespassing accidents consistently falls in the winter and rises again in the summer. Figure 4 shows the number of trespassing accidents by month from the 5-year time period over which data was collected.

Figure 3. Distribution of trespassing accidents by month in which they occurred

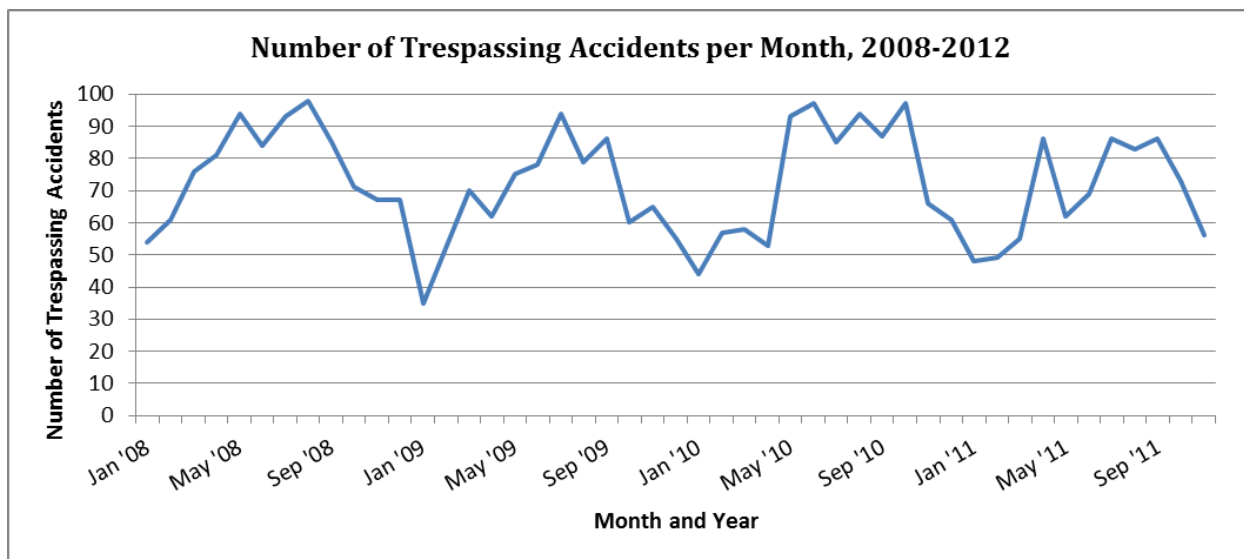
Figure 4. Number of trespassing accidents per month

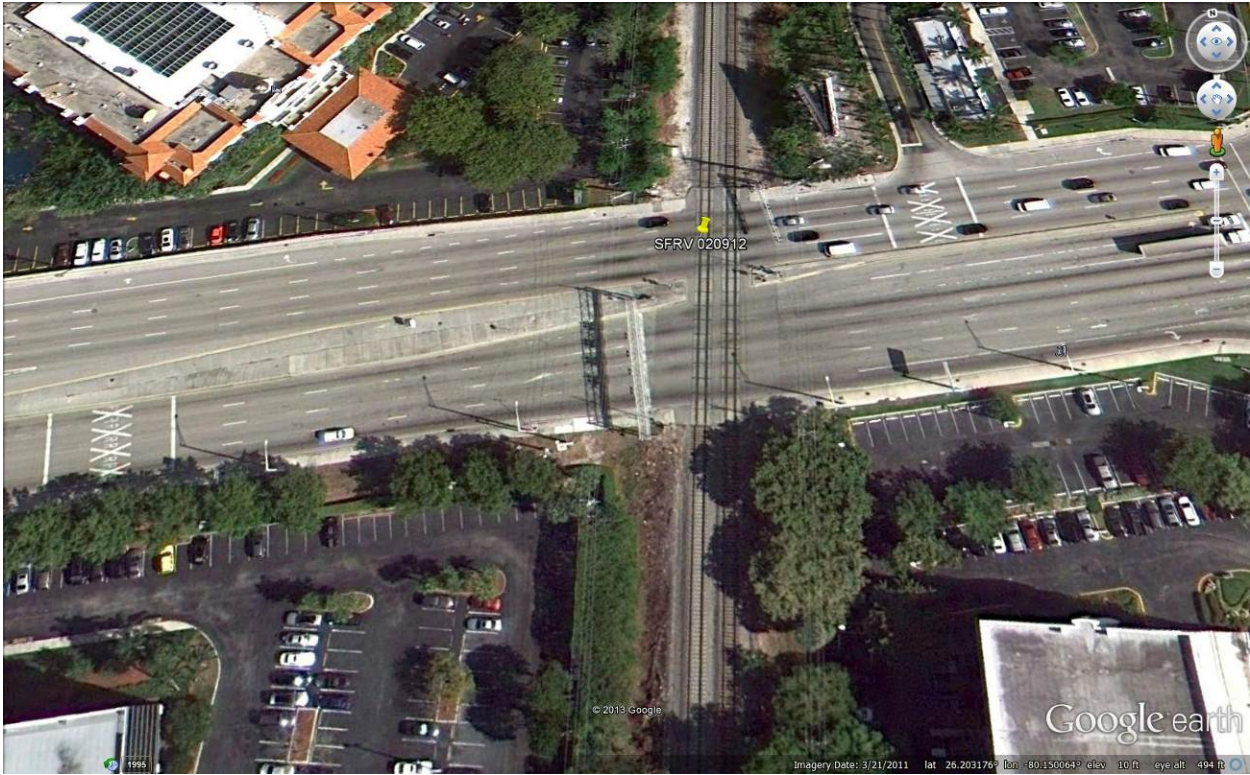
For 40 of these accidents, latitude and longitude coordinates were provided and were plotted into Google Earth to provide a better idea of the types of crossing environments in which these accidents occurred. At least seven locations had a single-track ROW, 13 occurred on a two-track ROW, two occurred on a ROW with three or more highway lanes, one occurred at a highway-rail grade crossing with at least eight highway lanes, and at least four occurred in multi-track/switching areas. Figures 6 and 7 show Google Earth images of a multiple-lane highway-rail grade crossing and a multi-track switching area, respectively. In both figures, the yellow “thumbtack” symbol marks the trespass accident. From this limited data, it appears that more complicated crossing areas, with multiple lanes and tracks, present more of a hazard. It is possible that in areas with many trains, pedestrians grow overly accustomed to the crossings. Likewise, in areas where there are few trains, residents may underestimate the risk.

Figure 6. Trespass accident location marker on multiple-lane highway-rail grade crossing

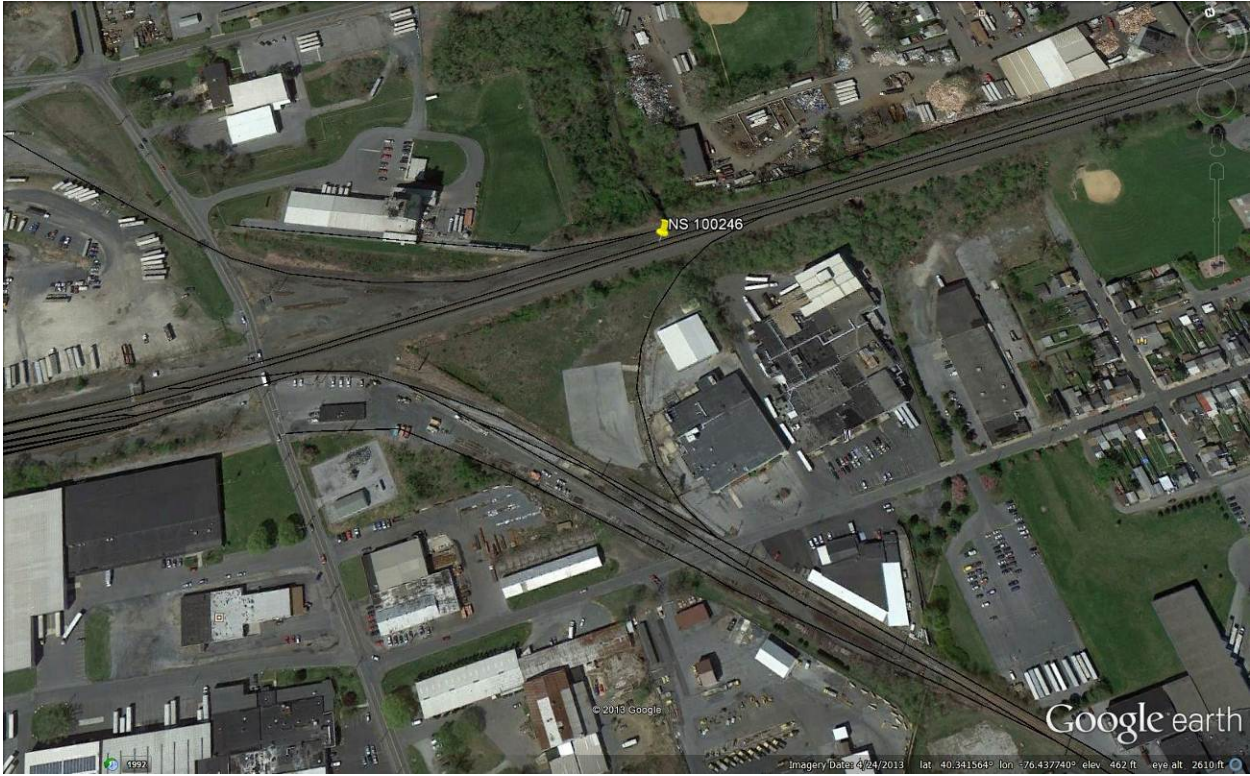
Figure 7. Trespass accident location marker in switching area

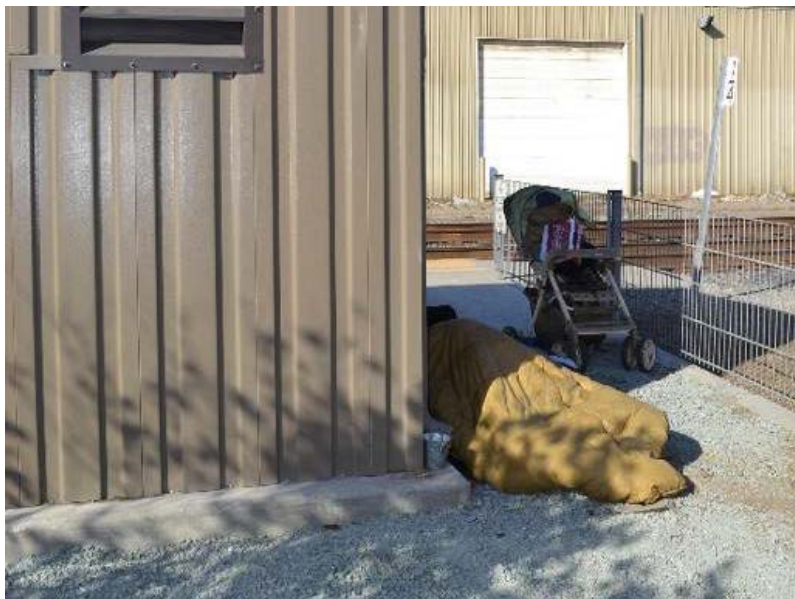
the trespasser as homeless. Figure 8 is a photo of a homeless trespasser who has set up a camp on a platform beside a wheelchair lift enclosure at a passenger station in California.

Figure 8. Trespasser sleeping on passenger station platform, with ROW in background

Eight accidents in which the trespassing victim was homeless were positively identified from the FRA RAIRS data. These trespassing events included the violation of crossing devices, an assault at a station, and pushing a shopping cart along the tracks when struck. The data is possibly skewed toward accidents in which the trespasser survived (six of the eight accidents), which might be the only way to obtain information about the trespasser’s personal economic situation. There is no RAIRS data field entry to indicate that the trespasser was homeless, so only the narrative reports provided any indication. Often, railroads have a difficult time learning anything about the victims, especially by the time the report needs to be submitted to FRA, so these eight reports are likely unrepresentative of the total number of trespassing incidents involving homeless individuals. Railroad infrastructure can be attractive to the homeless because it provides many options for shelter. There were even more accidents reported that described the trespasser as sleeping on the track or under platforms, but the reports did not definitively identify

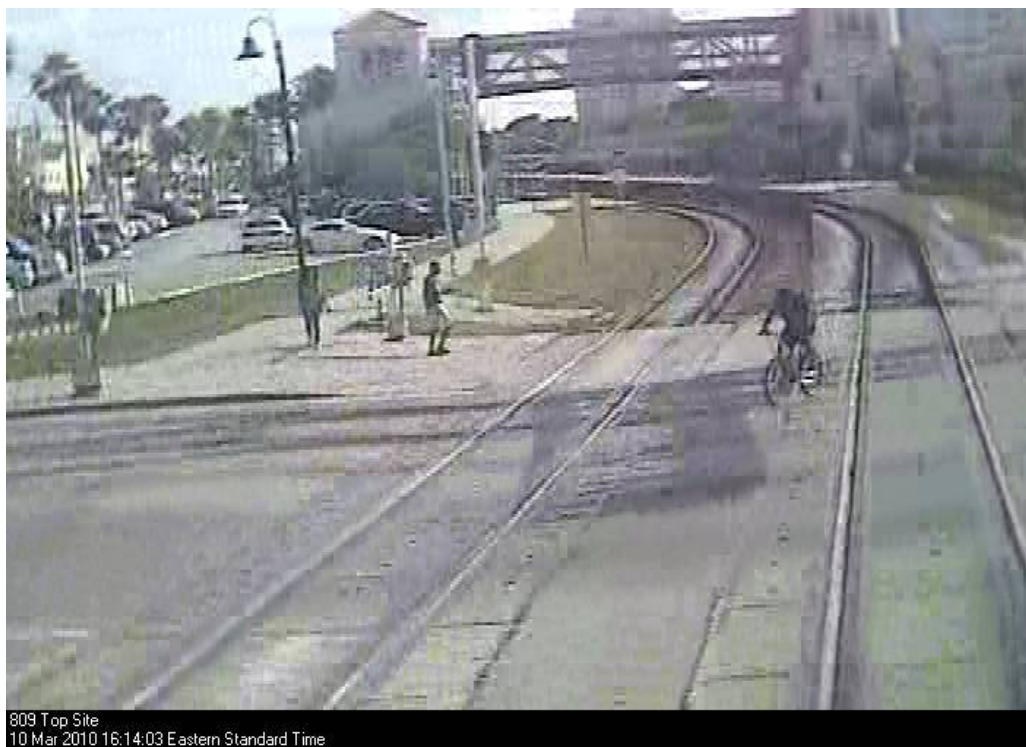
Between March 5, 2010, and July 5, 2010, a camera onboard the locomotive recorded several trips along the West Palm Beach ROW. Samples were collected during all time periods of operation and during all days of the week. The video was then reviewed for evidence of trespassers. Figure 10 provides a sample screen shot of a recorded trespassing event.

Figure 10. A trespassing event recorded using a camera placed in a locomotive

Some limitations to the data were discovered during the analysis. The video was often grainy; the early morning runs occurred in the dark or at times of limited visibility, and the camera placement was such that the video did not follow curves, so sometimes only one side of the track was visible. There are other inherent limitations to this data collection method, the most prominent of which is that it is still not comprehensive. Data is only collected during the discrete times a train passes a certain point. Despite these limitations, this data provides a unique

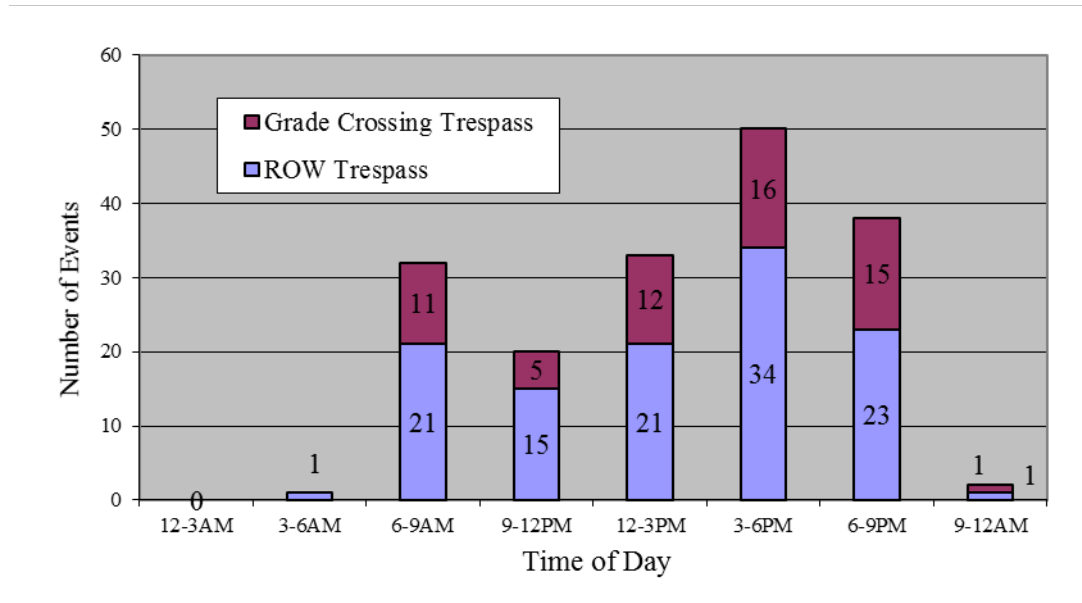
The time of day at which the incidents occurred was recorded. This information is provided in Figure 11 for 3-hour blocks of time. Twenty-eight percent of recorded trespassing events occurred between the hours of 3 p.m. and 6 p.m., more than during any other block of time. (Of course, data was only collected when the trains were running, so the late night and early morning data is limited or non-existent.) According to this data, trespassing is more prevalent in the latter half of the day, particularly in the early evening. This is true for both ROW and grade crossing trespassers.

Figure 11. Time of occurrence of trespassing incidents along the SFRTA corridor

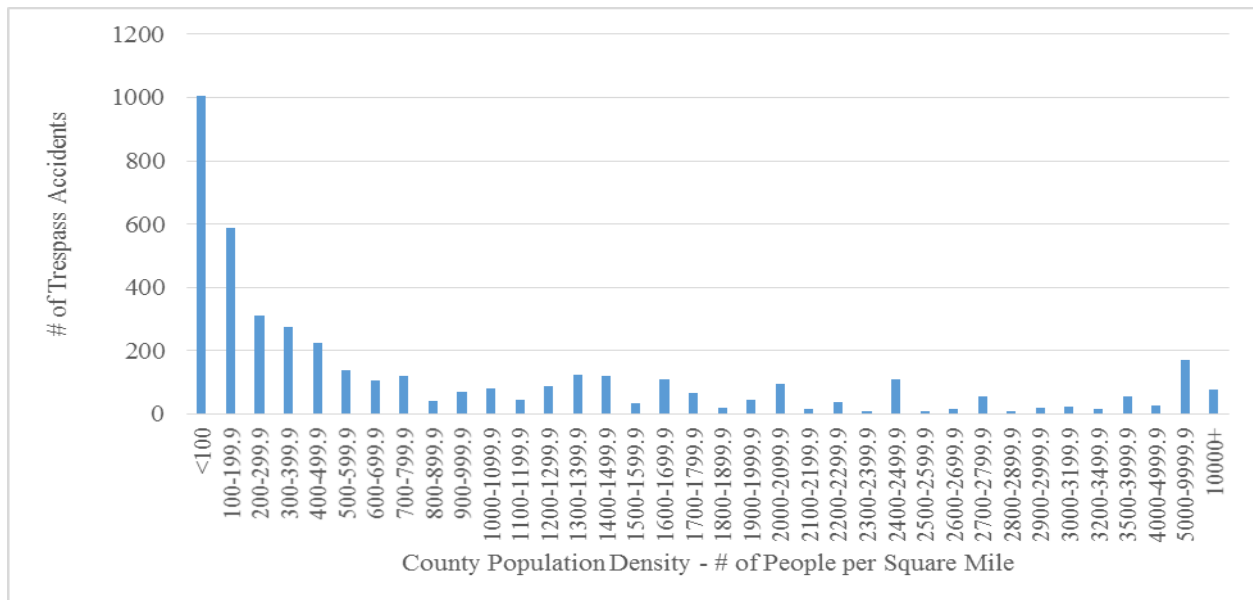
The median population density in 2010 (number of people per square mile) of U.S. counties with at least one trespass accident between 2008 and 2012 was 113.15. Figure 12 shows the number of trespassing accidents that occurred in counties of various population densities. It is immediately apparent that the vast majority of trespassing accidents occurred in counties with low population densities—counties that are mostly rural. There are many more rural counties than urban ones in the United States, but there are still many trespassing accidents in those few urban areas. Urban areas can be “hot spots” for trespassing activity; however, the chart below indicates that most trespassing accidents do not occur in areas of high population density.

Figure 12. Population density (county) and trespass accidents

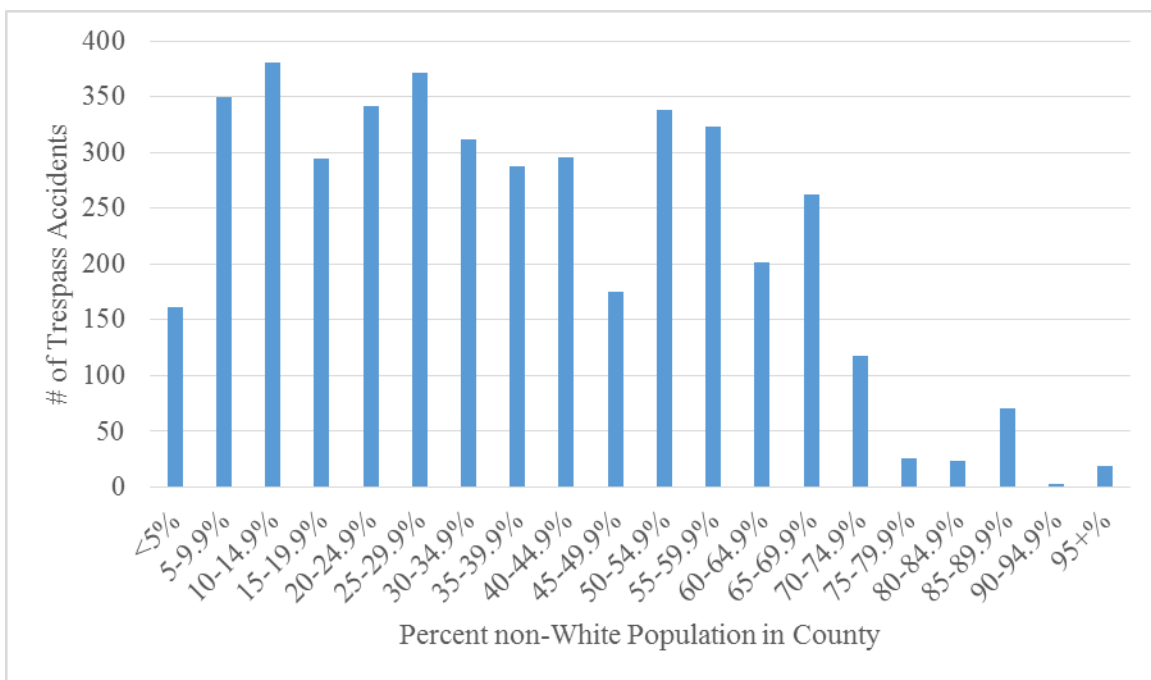
The median minority rate in 2010 (percent of total population of non-white ethnicity) of U.S. counties with at least one trespass accident between 2008 and 2012 was 20.25 percent. Figure 13 shows the number of trespassing accidents that occurred in counties of differing racial compositions according to minority rate. A significant number of trespassing accidents occurred at all minority rate percentage intervals, although the majority of trespassing accidents occurred in counties with higher than the median minority population rates. This suggests that there may be a slight correlation between minority population rate and trespassing accidents, and that those accidents may disproportionately occur in counties with higher minority compositions. More data, particularly exposure data and a comparison with counties in which trespass accidents did not occur at all, would be needed to test this correlation before a conclusion could be made.

Figure 13. Percent minority rate (county) and trespass accidents

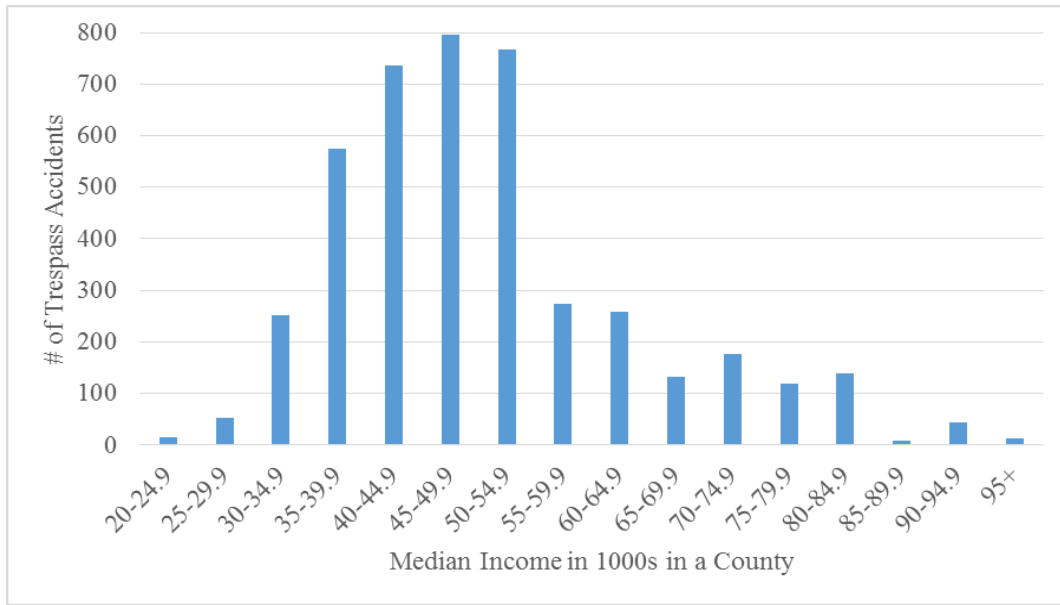
The median household income in 2009 in counties with at least one trespassing accident was \$43,665. (This is the “median of the median” for counties with at least one trespassing incident.) Figure 14 shows the number of trespassing accidents that occurred in counties with various median household income levels. Most trespassing accidents occurred in counties with ‘at or just slightly higher than the median’ income levels, indicating that there is no correlation between the numbers of trespassing accidents and relatively low household income.

Figure 14. Median income (county) and trespass accidents

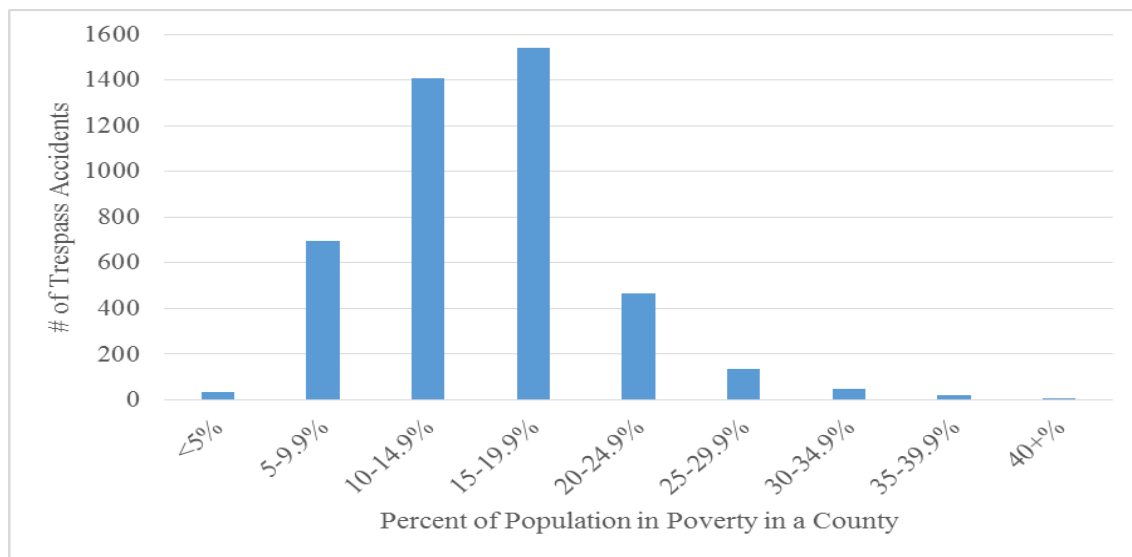
The median poverty rate in 2009 (percent of total population with an income below the designated poverty thresholds [18]) in U.S. counties with at least one trespassing accident between 2008 and 2012 was 14.9 percent [19]. This is slightly higher than the 2009 overall U.S. poverty rate of 14.3 percent. Figure 15 shows the number of trespass accidents that occurred in counties with different poverty rates. It shows that trespassing accidents did not occur disproportionately in counties with either low or high poverty rates; most accidents occurred in counties with close to the median poverty rate. This finding indicates that trespass accident occurrence is not correlated with impoverished communities, which agrees with the findings for household income.

Figure 15. Poverty rate (county) and trespass accidents

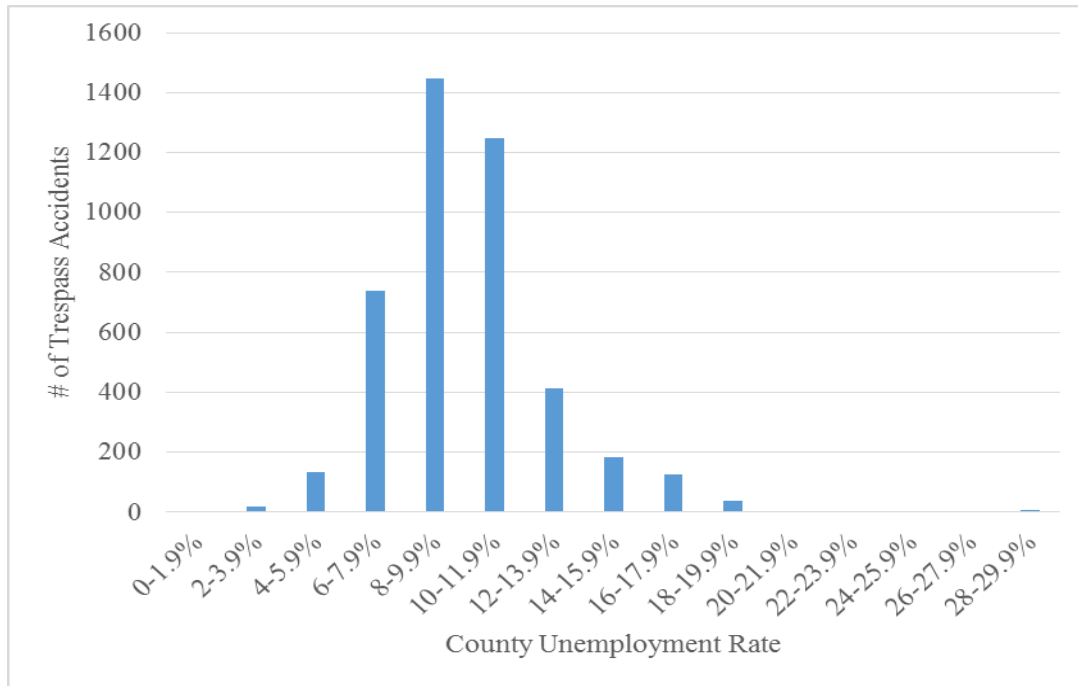
The median unemployment rate in 2010 in U.S. counties with at least one trespassing accident between 2008 and 2012 was 9.3 percent. Figure 16 shows the number of trespassing accidents that occurred in counties with varied unemployment rates. Most trespassing accidents occurred in counties with ‘at or near the median’ unemployment rates, and unemployment is not significantly correlated with the occurrence of trespassing accidents.

Figure 16. Unemployment rate (county) and trespass accidents

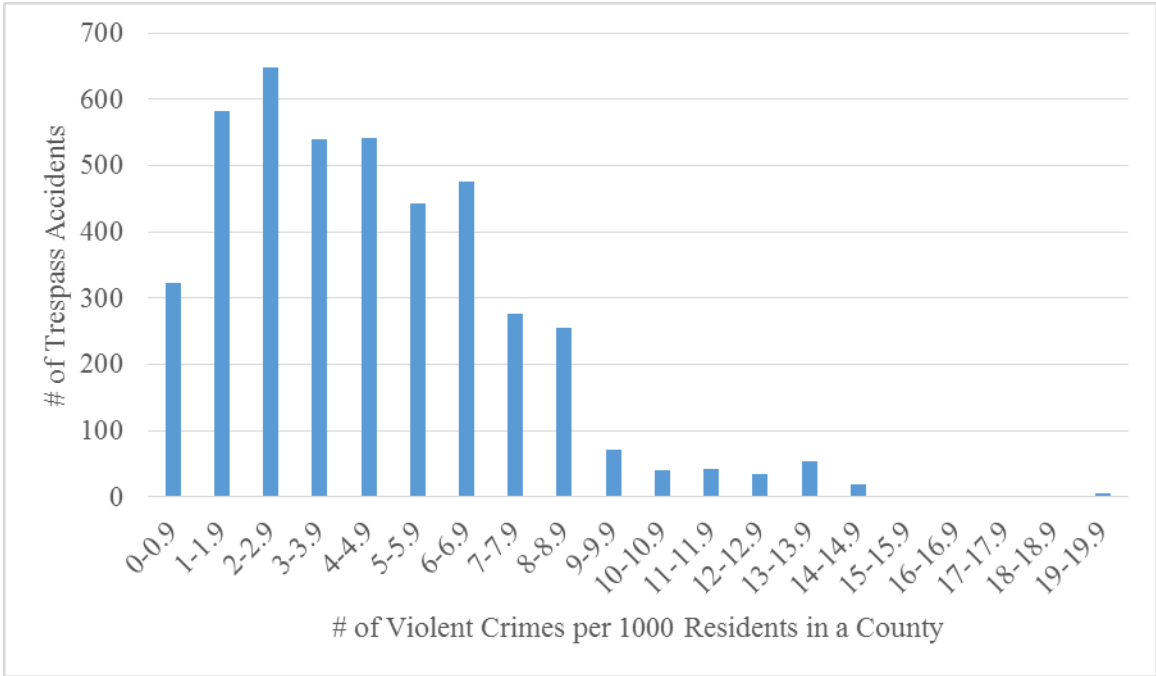
The median violent crime rate in 2008 (number of violent crimes per 1,000 people) in U.S. counties with at least one trespassing accident was 2.75. Figure 17 shows the number of trespassing accidents that occurred in counties with different crime rates. It shows that trespassing accidents peaked in counties with close to the median crime rate, but that more accidents overall occurred in counties with higher than the median crime rate. This finding suggests that trespassing has a slight correlation with violent crime rates.

Figure 17. Violent crime rate (county) and trespass accidents
