U.S.
Department
**Federal
Railroad
Administration**

ACOUSTIC DETECTION OF ROLLER BEARING DEFECTS: PHASE II, FIELD TEST

1. AGENCY USE ONLY (Leave blank)		2. REPORT DATE August 2003	3. REPORT TYPE AND DATES COVERED FRA, Nov.-Dec. 1996	
4. TITLE AND SUBTITLE Acoustic Detection of Railcar Roller Bearing Defects: Phase II, Field Test Report			5. FUNDING NUMBERS DTFR53-93-C-00001, Task Order 111

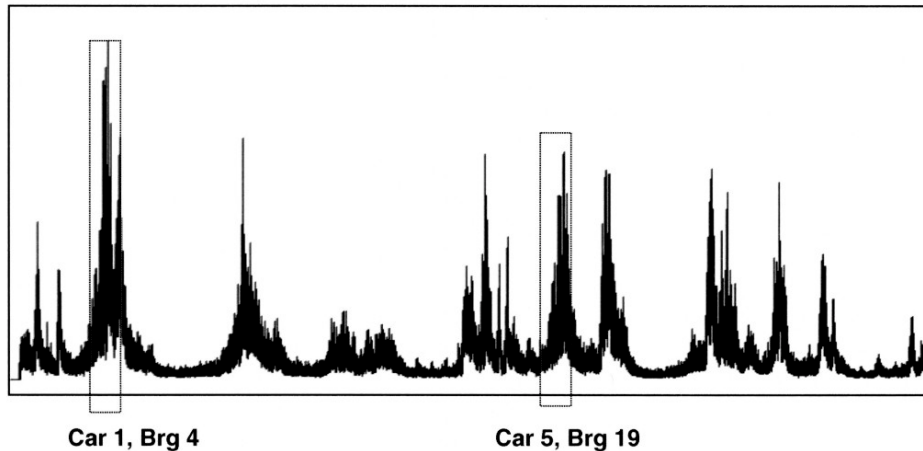
Figure 11. CD Data File 24AP1N30.001 after Envelope Detection Processing is Applied
 (Dotted boxed portions of the above signals are discussed more thoroughly in *Technology Digest* 96-004 issued February 1996)

Figure 11 shows the time data from Figure 10 after it has been detected by the envelope. This process extracts a smooth outline tracing of the upper portion of the time based signature and ignores the negative part of the signal. Details of the envelope detection process and its potential for defect diagnostics have been discussed thoroughly in *Technology Digest* 96-004 issued by TTCI February 1996. The bearing defects shown in Figures 7 and 8 generated the acoustic outputs that have been boxed in with dotted lines in Figure 4.

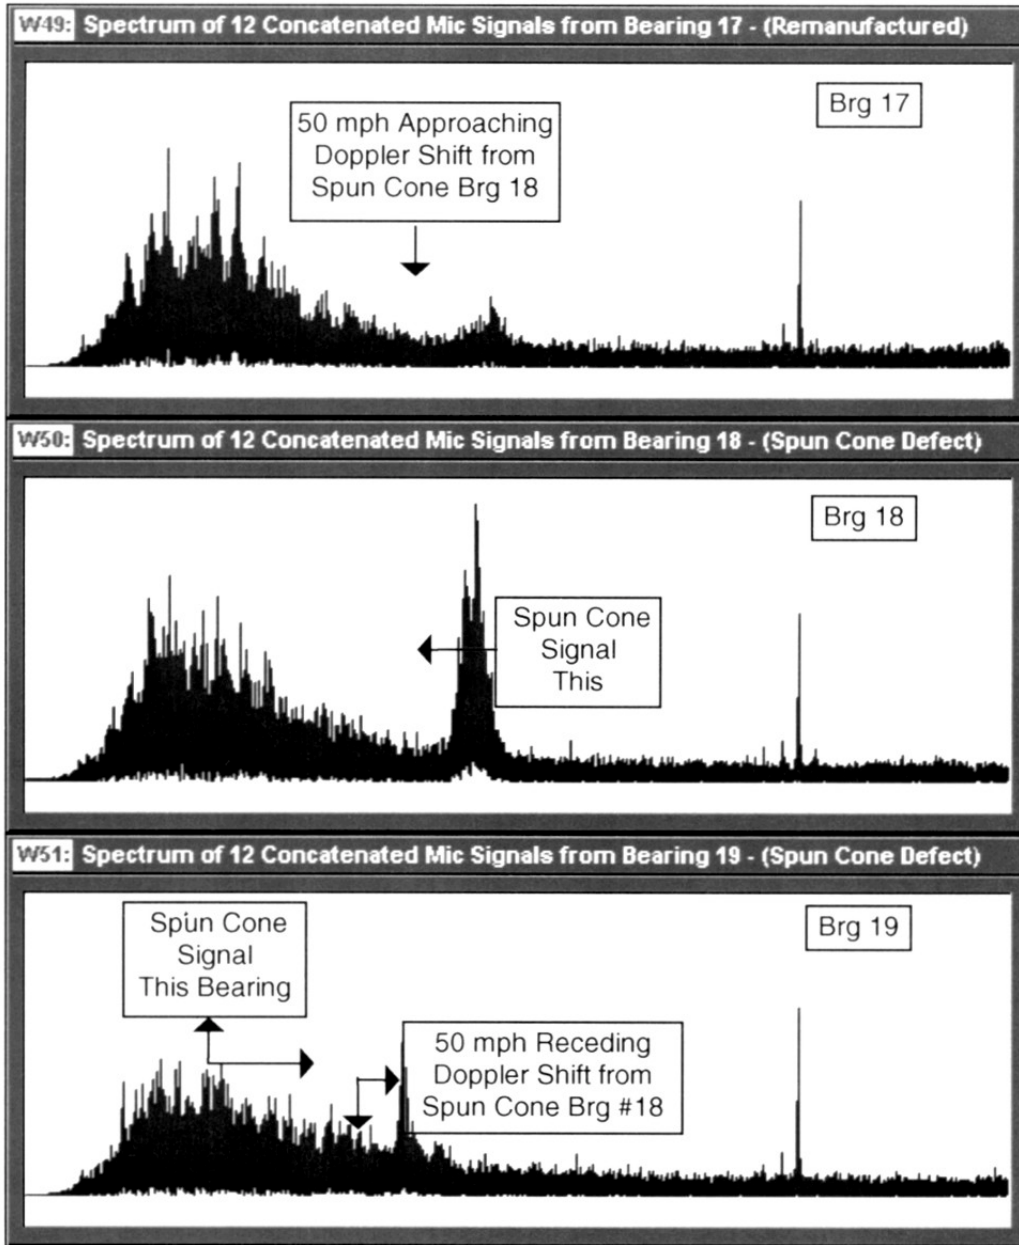
Figure 16. Spectral Plots from 12 Microphone Matrix Signatures for 3 Bearings
 Note High Amplitude 18 KHz Signature, Doppler Shifts, and Microphone Spill-Over of Sounds to Adjacent Bearing's Reference Points of View During Run

Note to Figure 16: Sound of Bearing 18 from 17's microphone point of reference is on approach (i.e. Doppler shifted frequency higher). Also from Bearing 19's microphone point of reference, the sound of Bearing 18 is receding (i.e. Doppler shifted frequency lower). Distance from Bearing 18 to Bearing 17 is 10 feet and distance from 19 to 18 is about 40 feet, so the observed level of 18's sound in Bearing 19's record is lower than it is in the spectral record of 17. The source of the sharp peak at 32 KHz on the right side of each spectrum in unknown.

Figure 16 is a composite of three spectra. The spectra shown here are higher in resolution than previously discussed. The increase in resolution is possible since the data from each spectrum comes from a composite of signals collected from 12 microphones positioned along the track. The composite signal is a long timeframe concatenation of 12 separate time slices taken from the 12 microphone files stored on a CD from a single test run.

Due to the greater noise from bearing 18 relative to its neighbors, each spectrum of Figure 16 contains the full acoustic response from the spun cone. Time slices from the array can be selected so as to be centered on any bearing as it passes through the array. Any set of slices selected for tracking a single bearing are either just before (or just after) another bearing in the train. As a result, the acoustic energy from one bearing's output can spill over into an adjacent bearing's timeframe, if the defective bearing signal is loud enough.

Figures 16 and 17 show a variety of signal characteristics collected from axles (bearings) 11, 15, 17, 18, and 19 in consist two. The train running speeds were 50 mph 60 mph. The interesting feature is that all the defective bearings emitted high frequency sounds, above 15 kHz. These vibrations were observed in several microphones in the wayside array. Since several microphones were in a linear array, it is also possible to review signals from any single bearing as it approached (or receded) from any of the centrally located microphones. Doppler shifts from loud approaching (or receding) bearings were observed.

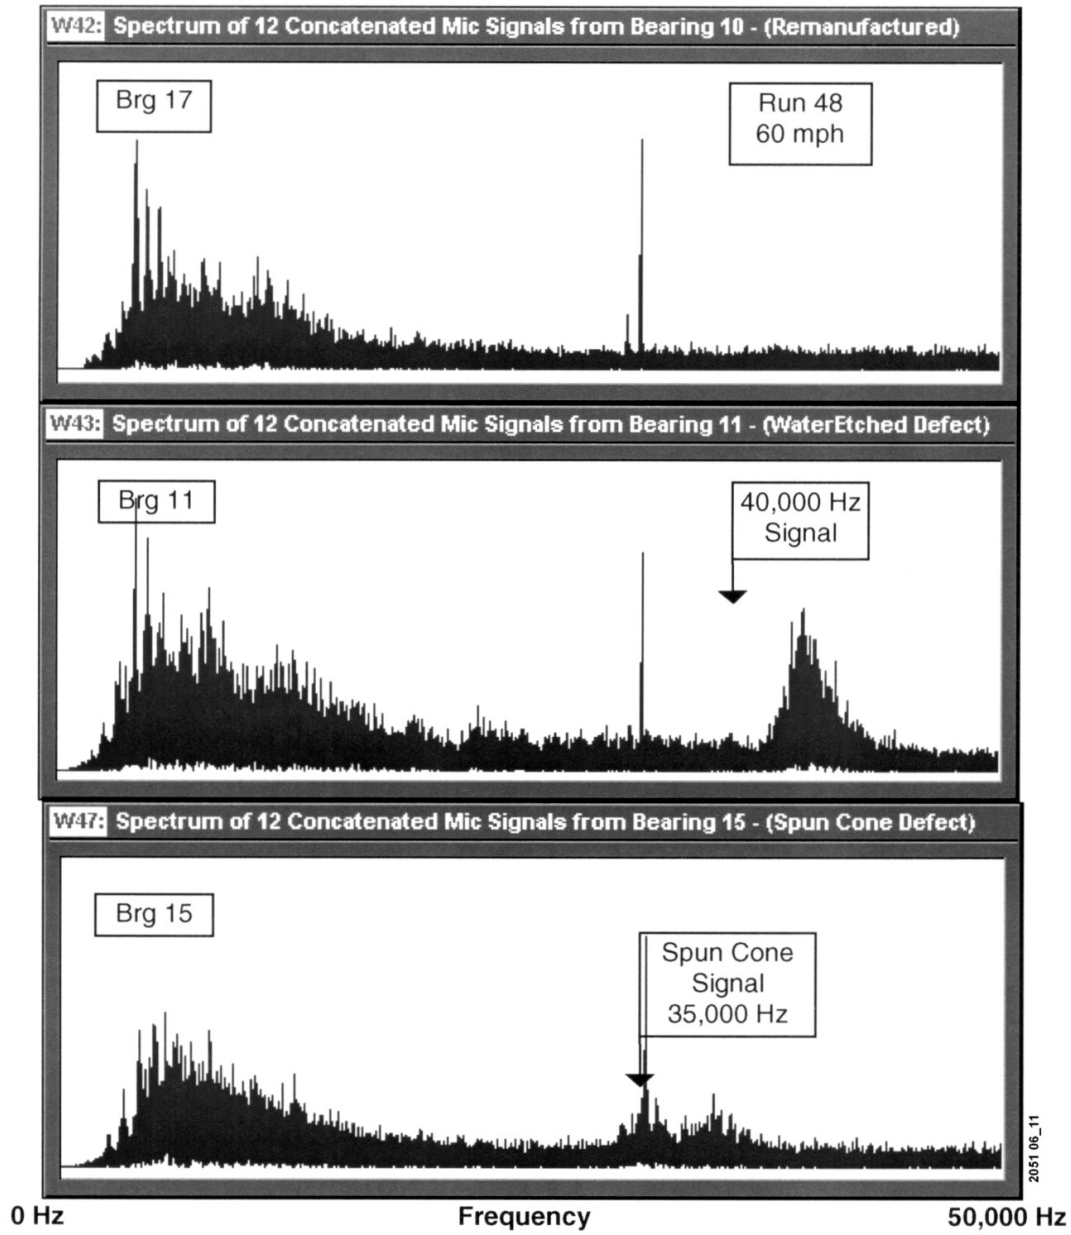
Figure 17. Spectral Plots from 12 Microphone Matrix Signatures for 3 Bearings
 Note Significant High Frequency 35-40 KHz Peaks in Defective Bearings

Note to Figure 17: Signal at 40 KHz has a greater amplitude than shown since the microphones attenuated signals above 30 KHz. Peak spacing in the 3 to 6 KHz range is about 640 Hz which is the same as the side bands on either side of the 32 KHz signal. The source of the sharp peak at 32 KHz to the right of center has not been established.

Figure 17 is another composite of three spectra that shows the acoustic character from three additional test bearings. As before, the displayed spectra are derived from time slices taken from all 12 microphones in the sampling array, and cover the range of frequencies from 0 to 50 kHz. The top portion of the display comes from a bearing which has no internal defects. It is one of the re-manufactured test bearings. The middle plot is derived from a bearing with internal water etched surfaces, and the lower tracing is from a bearing containing an inherent spun cone.

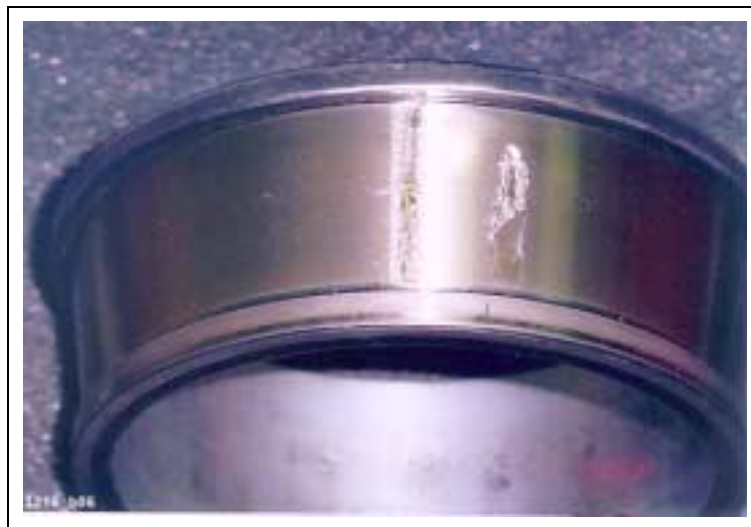
B6.

BEARING #30	CLASS F “MULTIPLE CONE SPALL” SERIAL # 31401	
CONE	Inside	Race	Many small spalls	Fig. B6
		Rollers	No Defects Observed	
	Field Side	Race	One line spall and other spalls	Fig. B7
		Rollers	No Defects Observed	
CUP	Inside	Loaded Zone	No Defects Observed	
		Not Under-Load	No Defects Observed	
	Field Side	Loaded Zone	No Defects Observed	
		Not Under-Load	No Defects Observed	
		BEARING #31	CLASS F “MYSTERY” SERIAL # 1041	
CONE	Inside	Race	Multiple repaired spalls	Fig. B17
		Rollers	Broken	Fig. B17
	Field Side	Race	No Defects Observed	
		Rollers	No Defects Observed	
CUP	Inside	Loaded Zone	Multiple Spalls, color shows excessive heat	Fig. B16
		Not Under-Load	No Defects Observed	
	Field Side	Loaded Zone	Multiple Spalls	Fig. B15
		Not Under-Load	No Defects Observed	
		BEARING #32	CLASS F “MULTIPLE CUP SPALL” SERIAL # 34576	
CONE	Inside	Race	No Defects Observed	
		Rollers	No Defects Observed	
	Field Side	Race	No Defects Observed

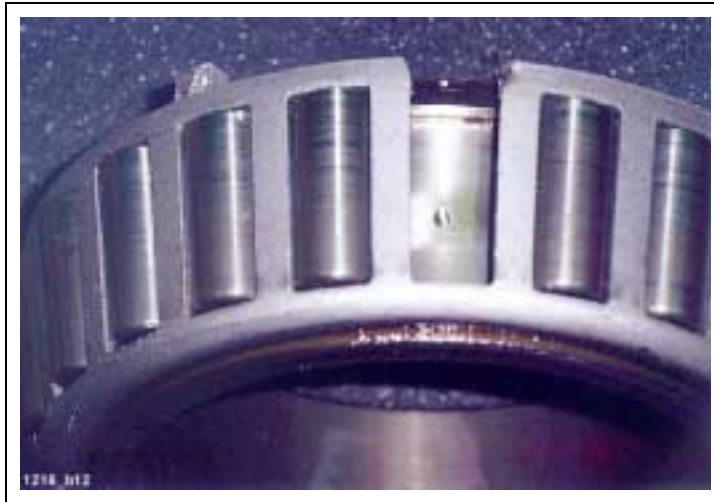
B11.

BEARING #7	CLASS F E "SINGLE CONE SPALL" SERIAL # 34593	
CONE	Inside	Race	Single ½" line spall manufactured by grinding	Fig. B11
		Rollers	No Defects Observed	
	Field Side	Race	No Defects Observed	
		Rollers	No Defects Observed	
CUP	Inside	Loaded Zone	No Defects Observed	
		Not Under-Load	Single small repaired spall	Fig. B10
	Field Side	Loaded Zone	No Defects Observed	
		Not Under-Load	No Defects Observed	
		BEARING #9	CLASS E "BROKEN ROLLER" SERIAL # 83622	
CONE	Inside	Race	No Defects Observed	
		Rollers	No Defects Observed	
	Field Side	Race	No Defects Observed	
		Rollers	Single ½" flat manufactured by grinding	Fig. B14
CUP	Inside	Loaded Zone	No Defects Observed	
		Not Under-Load	No Defects Observed	
	Field Side	Loaded Zone	No Defects Observed	
		Not Under-Load	No Defects Observed	
		BEARING #11	CLASS E "WATER ETCH" SERIAL # X-167	
CONE	Inside	Race	Three very small spalls	Fig. B22
		Rollers	Three each have very small spalls
