U.S. Department  
of Transportation

**Federal Railroad  
Administration**

# **ACOUSTIC DETECTION OF RAIL CAR ROLLER BEARING DEFECTS: PHASE III, SYSTEM EVALUATION TEST**

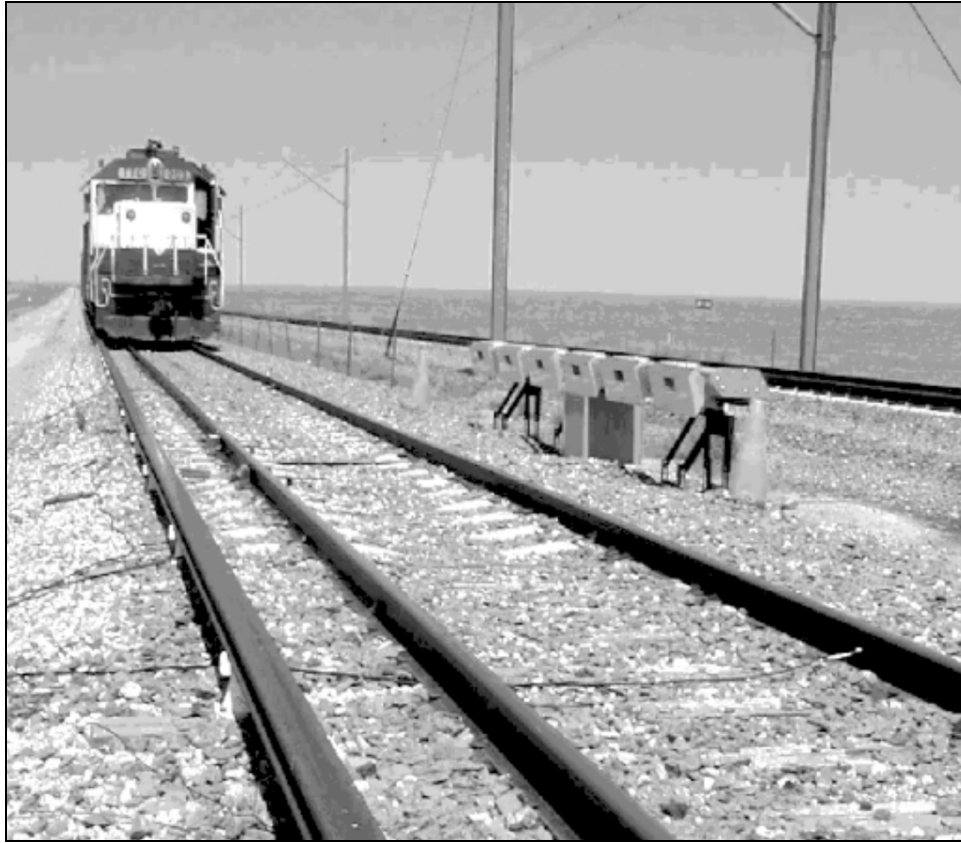
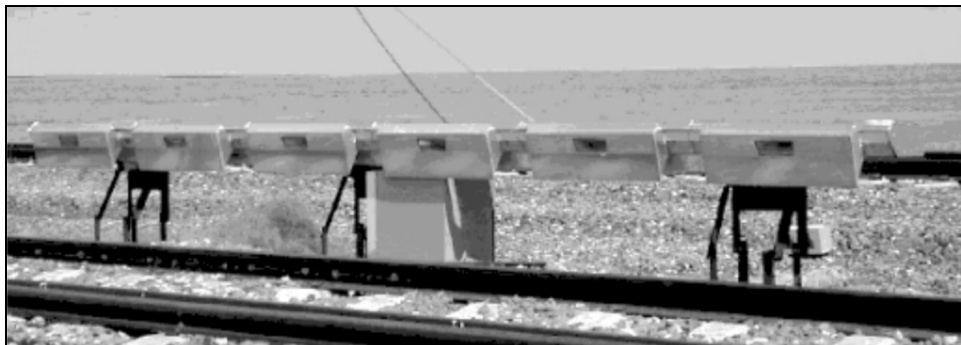
**Figure 1. Test Train and TCI Microphone Array**

Figure 1 shows the trackside microphone enclosure, and Figure 2 shows the track mounted wheel sensors. In addition to the wheel detectors clamped to the rail, a traditional island track circuit was used to alert the system for train presence. The wheel detectors, typically used in hot bearing detection systems, were used to calculate vehicle speed, wheel (bearing) position relative to the microphones, and to estimate bearing class from axle spacing. These wheel detectors are magnetic probes that respond to the proximity of the wheel flanges passing over the sensor element.

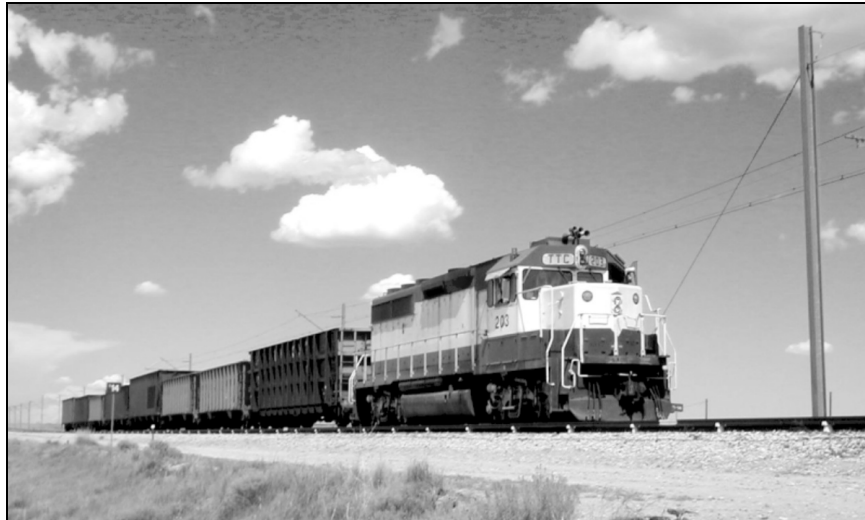
**Figure 3. Test Train Makeup**

Figure 3 shows the makeup of one of the test trains. Wheelsets and/or trucks were switched between cars to place defective bearings under different loads. Each car was weighed on a certified scale either before or after testing (see Section 2.0, Table 2). The test train was operated past the wayside instrumentation from both directions.

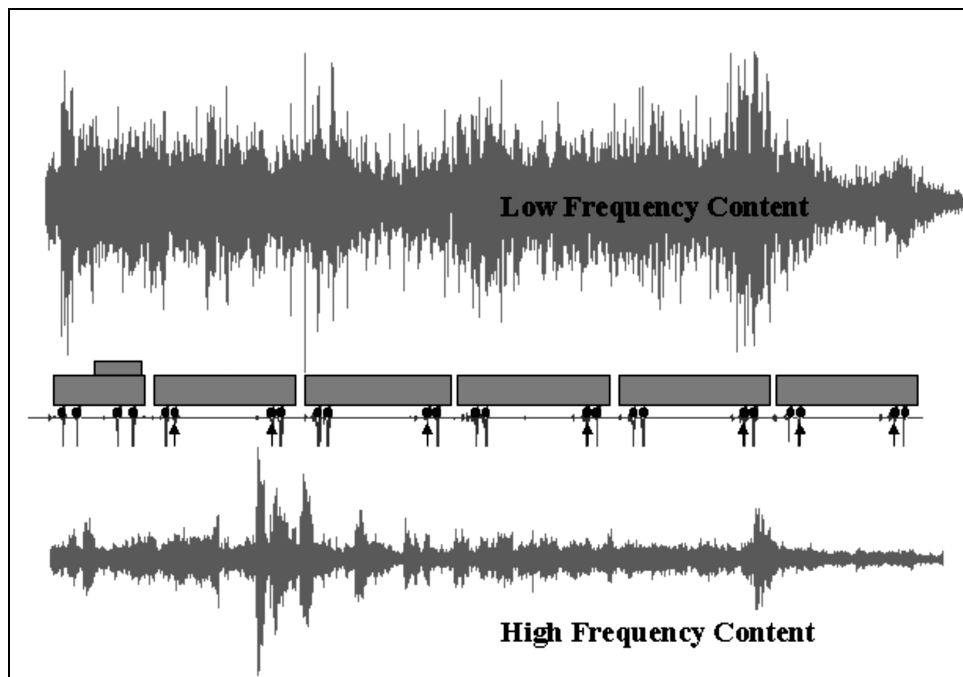
Figure 4. Typical Microphone Time History

A typical raw microphone time history for a passing train is given in Figure 4. Data has been broken down into the low-frequency content of the signal (above) and the high frequency (below). The graphic depicting the consist properly positions the wheelsets with respect to the signal, and the small vertical arrows give the position of defective bearings in this particular consist.

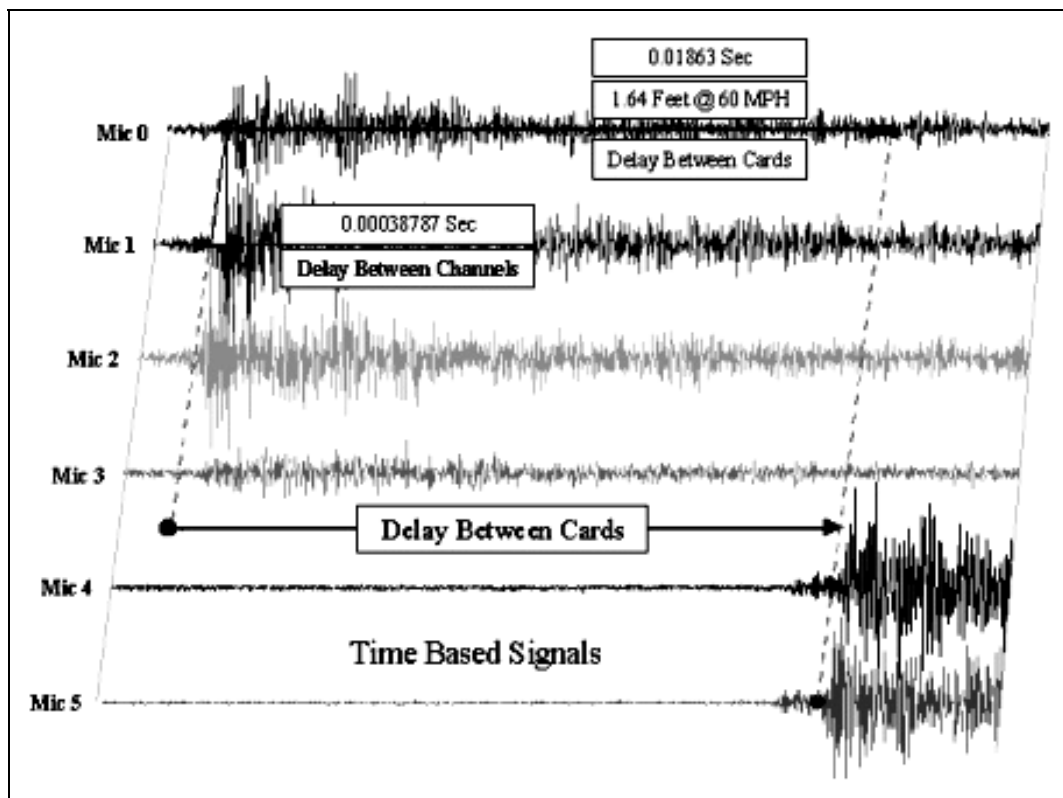
**Figure 5. Example of Multiple Microphone Signal Delays**

Figure 5 shows an example of the multiple microphone signals from the test, the small delay encountered between channels, and the larger delay encountered between A/D boards in the computer.

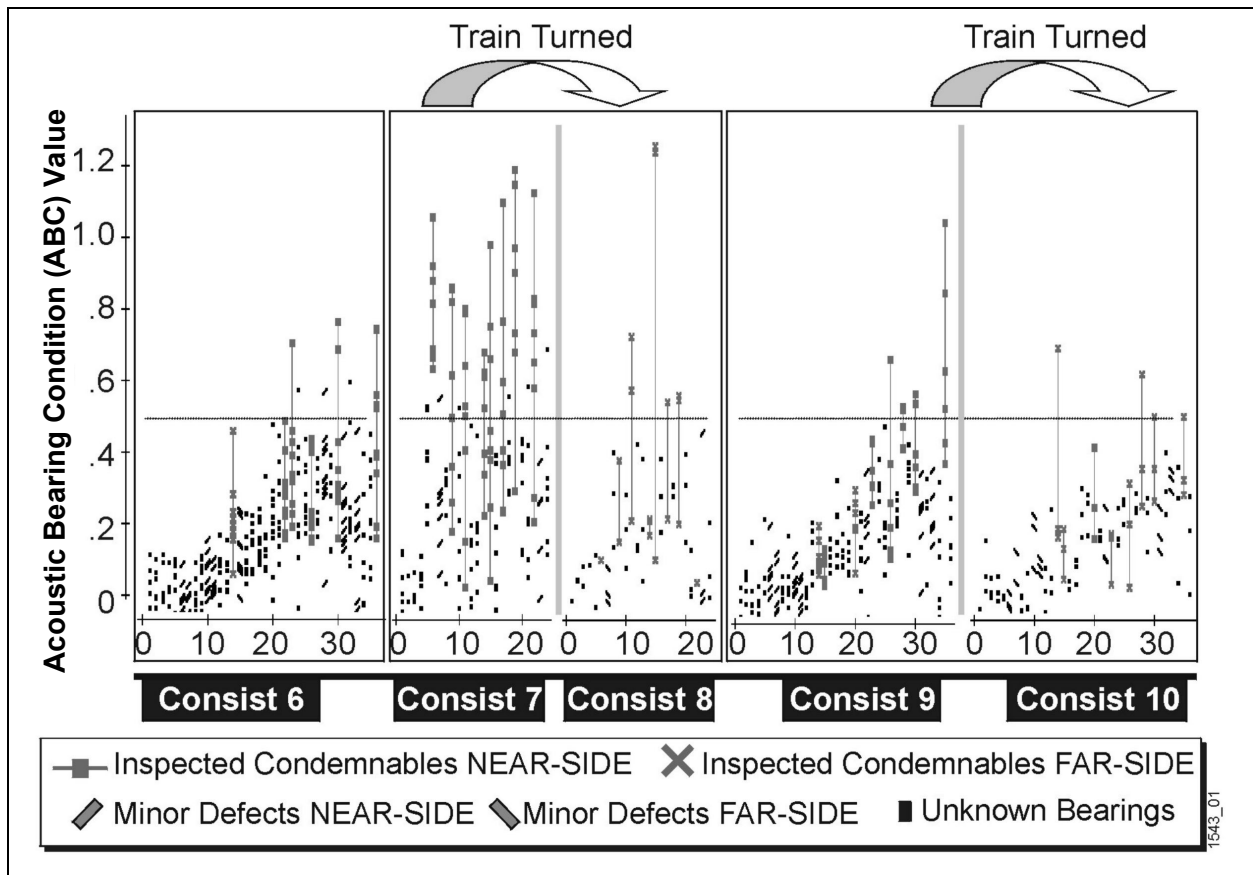
**Figure 6. Graphical Output for Expert Model Results**

The expert system model output shown in Figure 6 contains the results from the detector for all test runs with all five consists. It shows that consists 8 and 10 were run with the train direction reversed and defective bearings on the opposite side from the detector. Few defects were detected from those two consists compared to the previous consist before the train was reversed. The figure also illustrates that this expert system selects only defective bearings, with a few exceptions.

Figure 6 also illustrates that not all defects will be “heard” or recognized each time they pass the detector. Observe the numerous defects that have low ABC values, mixing with the good bearings. This analysis, complicated by the extraneous noise, mixes the defects with many of the unknown but assumed good bearings. A given threshold, shown by the dashed line here at an ABC value of 0.5, would not identify some defects. Besides illustrating a variation in detectable

The expert system model developed from this data is a complex one. In spite of the noise issues, this model is almost accurate enough to be useful in revenue service, as Figure 6 shows. It is expected that further training with more and varied bearing defects would improve this performance.

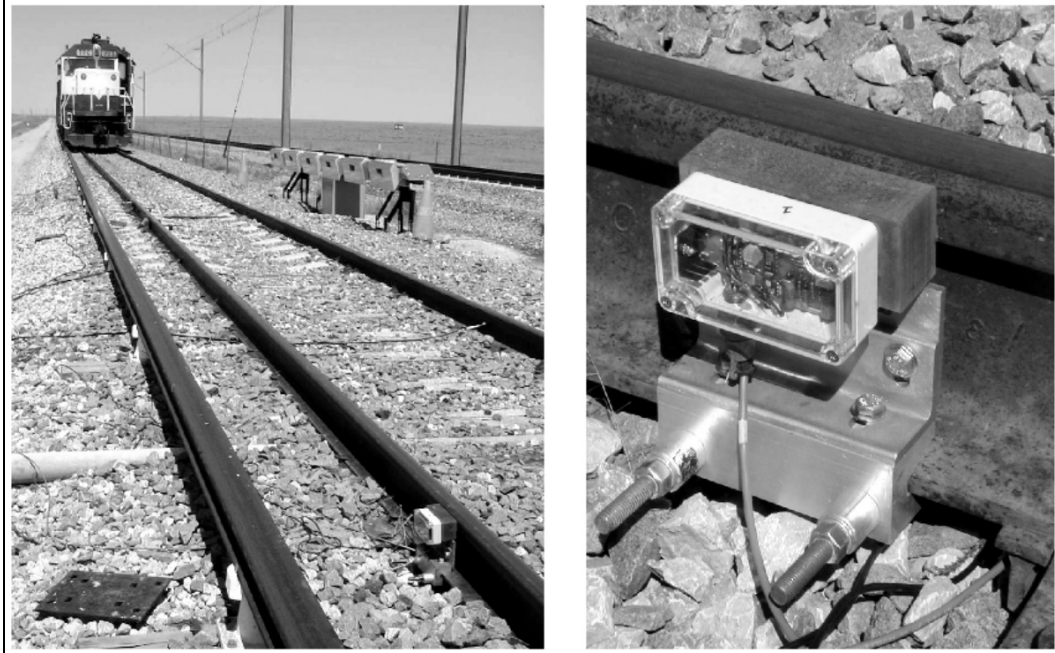
**Figure 7. FRA Test Train and Encore Electronics, Inc. Wheel Size Monitor**

Figure 7 shows two photographs of the tested wheel size monitor under development by Encore and placed in test during the FRA/TTCI wayside test program. The photo on the left shows the sensor mounted on the rail in front of the test train. A close-up photo of the electronic prototype monitor is on the right side. The prototype shown has its electronics encased in plastic, but the final design will have all sensing elements and the electronic components encased in a welded steel package.

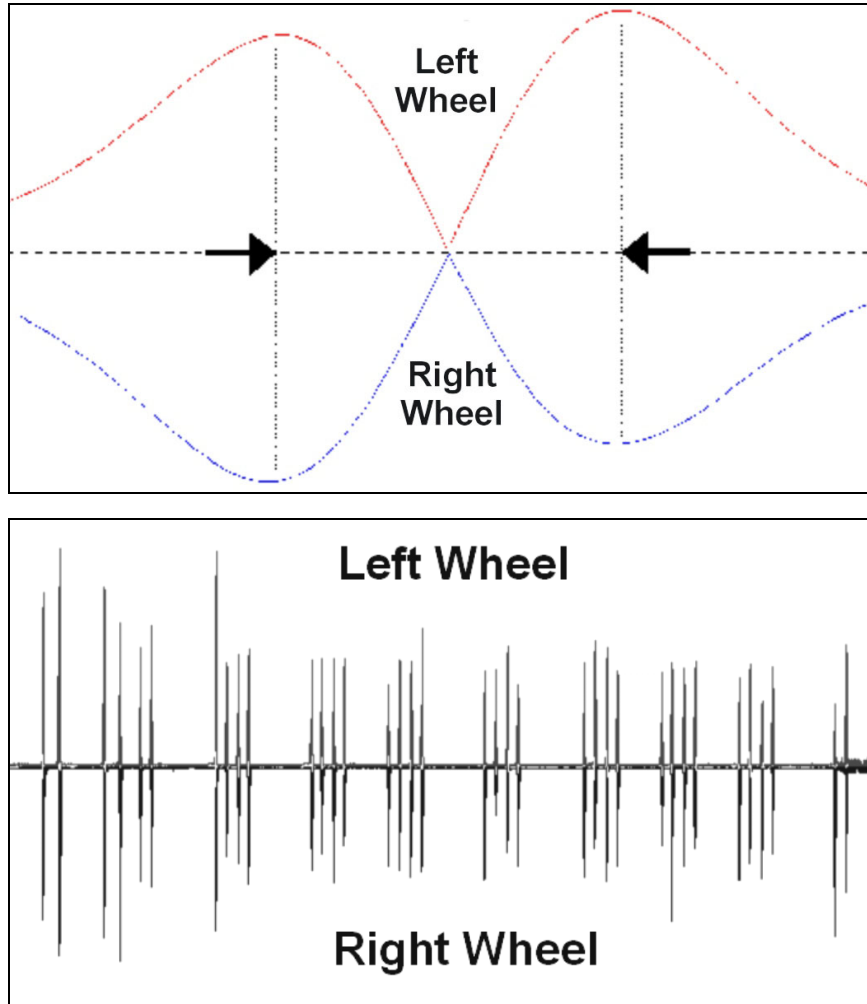
Figure 8. Encore Wheel Sensor Response

The Encore wheel monitor provides a signal, which is close to a “half-sine-wave,” for every wheel that passes (see Figure 8 for a detailed view of responses from a single wheel and test train). The peak response (changing slope & height) of the monitor’s signature is related to a passing wheel’s diameter. The monitor’s output is a measure of wheel curvature because the detector is sensitive to the proximity of a wheel’s outer flange. The monitor is typically fixed to the gage side of the rail. The output waveform of the monitor is also speed dependent because the waveform is proportionally compressed along the time-based axis as passing wheels run faster. This means that most applications require these monitors to be set up in pairs.

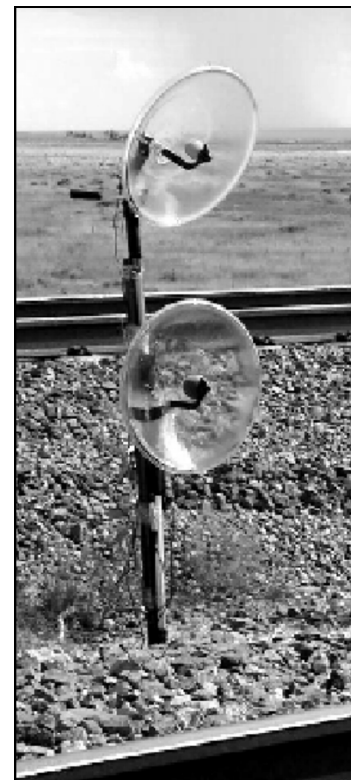
**Figure 9. NSEW Parabolic Microphones**

NSEW used four separate microphones during the Wayside Acoustic Test Evaluation program to record passing bearing signatures from the test trains. Two microphones were of the “parabolic” design and are shown in Figure 9, as they were mounted in the test recording program. A parabolic microphone is an ideal long standoff non-contacting sensor and is effective as a remote acoustic monitor of rolling element bearings. Acoustic signals emitted by defective bearings can be picked up from remote locations with a parabolic microphone. Even in the presence of high background noise parabolic reflectors can amplify sounds coming from specific line-of-sight locations.

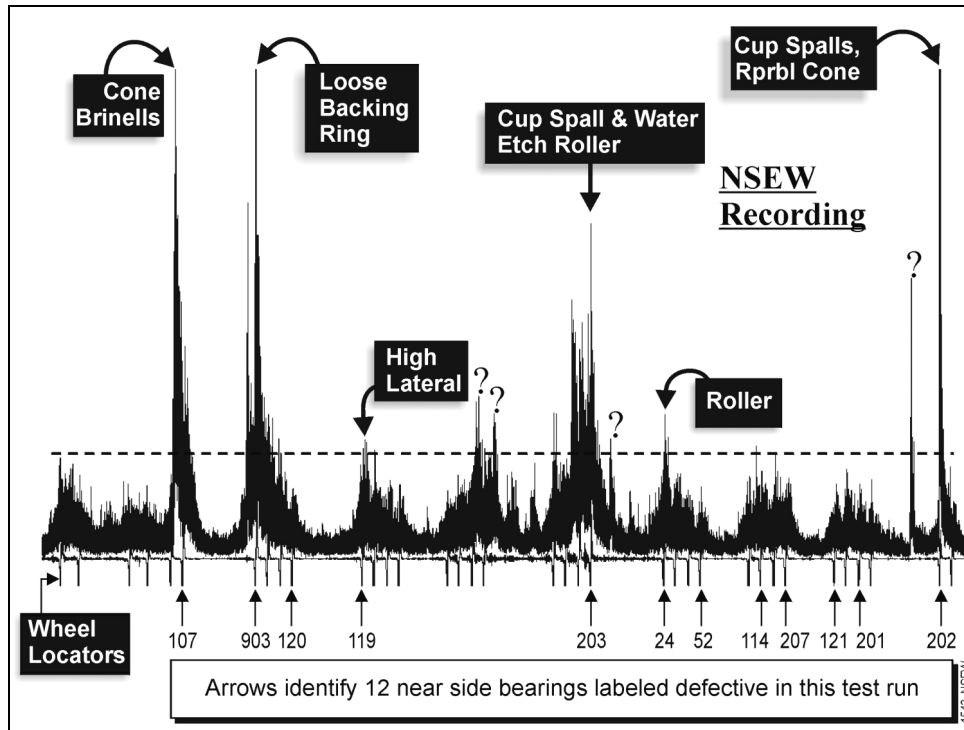
Figure 10. NSEW Recording of Passing Train

Figure 10 illustrates one of the NSEW recordings of a passing test train. The figure was derived from post processing one of the deployed microphones. Several specific bearings with known degraded components in the test consist can be identified from this simple graphic (i.e., 6 of the 14 total defects present, if wheel flats are ignored). Flags have been attached to the top of the defective passing bearings with the highest peaks in the figure. The arrows at the base of the display confirm that bearings were in the consist at the locations indicated by the flagged bearings. This simple diagnostic display is instructive because it uses only the peak rankings of the passing bearing’s processed acoustic output to accurately locate several defective bearings.

However, note that some defect types will not be found with this type of analysis because they may generate small amounts of acoustic output even though they contain defects. This can be seen from the graphic where arrows are pointing to bearings – yet they have small amplitude acoustic peaks above them.

With this simple diagnostic approach more (or less) bearings could be “culled-out” by changing the “detection” level (dashed line in the graphic), which is arbitrary, and in practice is set by experience. A pre-set detection level provides a higher (or lower) degree of detection accuracy depending upon the number of defects that pass their tendency to provide the high level outputs required of this scheme, and the details of the post-process chosen to generate the acoustic curves displayed. If a higher cut-off level is used to cull-out defective bearings, it tends to provide greater accuracy in defect identification — but fewer bearings are culled for inspection. Likewise, if the detection level is lowered with this scheme, many called-out bearings would contain no defects at all because even the best bearings generate some sound.

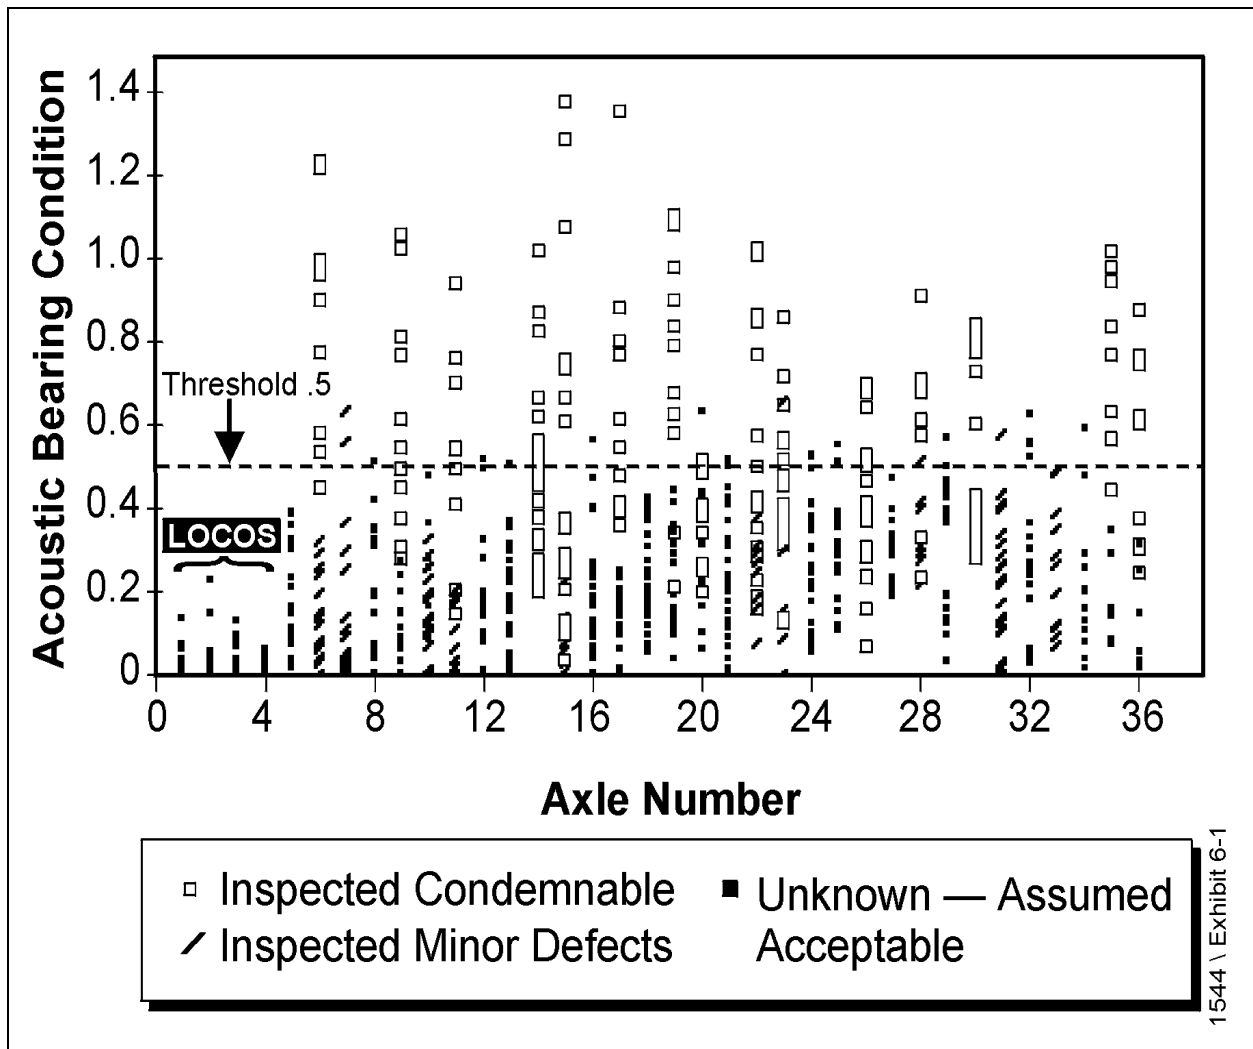
Figure 11. ABC Value versus Axle Number

The horizontal axis provides the axle location of the bearings as they went by the wayside array. Three separate consists, with axle counts ranging from 24 to 36, were run by the detector during the test cycle. The first four axles in the display represent locomotive bearings. All other data points are derived from test car bearings.

The large “squares” are from shop-confirmed inspected defective bearings with at least one or more condemnable mounted component(s). Right slanted “slash-marks” are from bearings with one or more, non-condemnable, yet visually detectable component defect(s). The small “lightly-shaded” dots are from bearings that were not inspected but were assumed to be acceptable by AAR standards.

There are 54 “condemnable” defects that have ABC values greater than 0.80 in the displayed plot. There were no non-condemnable bearings that produced ABC outputs above this arbitrary cut-off level.

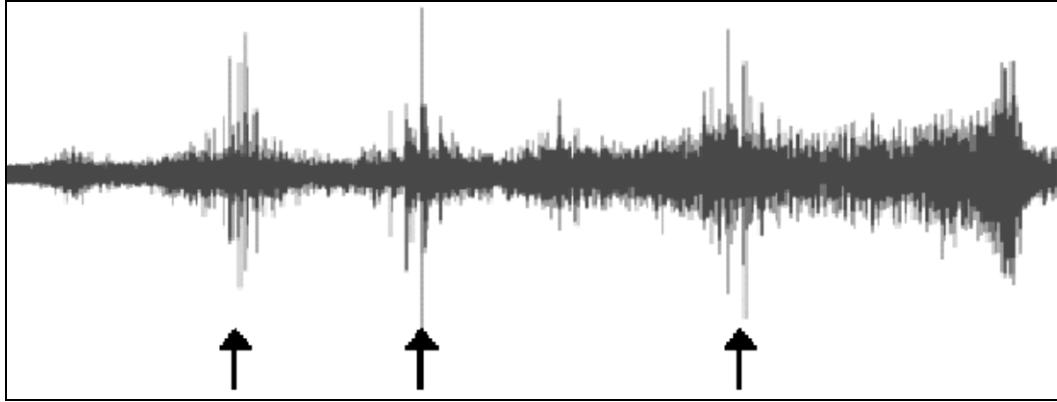
**Figure 12. Train Acoustic Time History with Wheel Flats**

Figure 12 contains a typical acoustic signature from a complete train pass that has at least three “flat” wheels. The center of each passing flat wheel is indicated with an arrow at the base of the plot. The wheel indicated by the arrow in the middle has a single flat spot on its periphery. The other flat wheels have multiple flats that generate more than one impact per revolution of the wheels. This is evident even from the highly compressed plot.

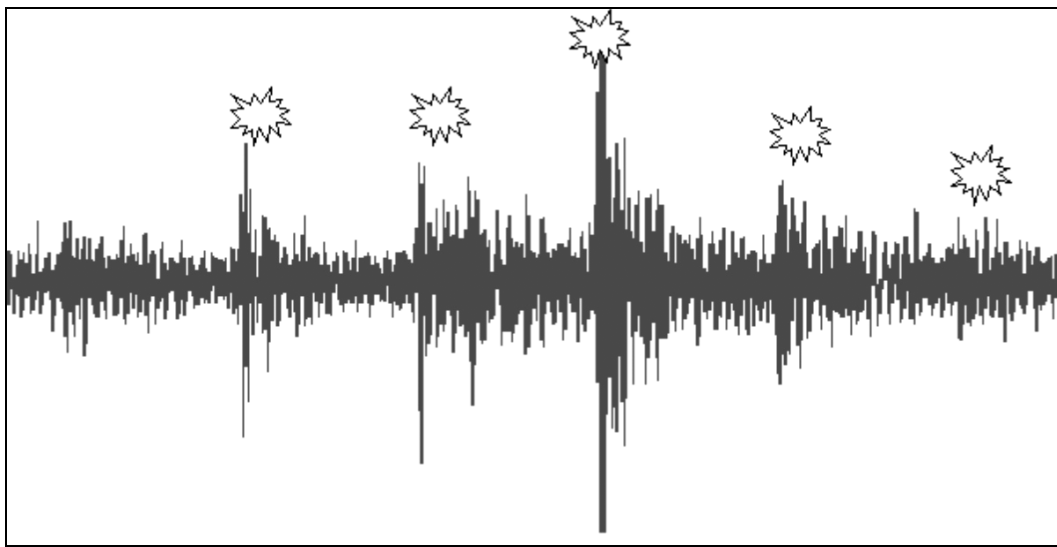
**Figure 13. Close-up View of Acoustic Time History of a Single Flat Wheel's Multiple Impacts**

A close-up view of one of the passing flat wheels is shown in Figure 13. Five impacts can be seen at equally spaced intervals. Even with the evidence of the impacts, however, there are many other acoustic variations intermixed in the signature. The question is whether the acoustic information from bearing defects can be detected even though the impacts are present. In most cases, the answer is yes. But in other cases, the bearing signature will be degraded. Since a large flat on a wheel can generate once per revolution signals with potentially broad band frequency content, it may ultimately “mask” the defect signatures produced by bearings.

The main reason the bearing signatures can often be discerned (even when wheel impacts are present) lies in the differing character of the frequencies generated by wheel flats versus bearing defects. Much like speech can be heard over hammering in a production plant, some bearing signals can be heard when wheel impacts are nearby or on the same wheel. An impacting wheel generates large amplitude signals, but a bearing generates a steadier repetitive periodic acoustic output. It is on these subtle differences that most of today's diagnostic schemes depend. Steady periodic signals from defective bearings essentially ride the wave of the impacting wheels. Just as specific words can be heard over hammer blows so can bearing defects. The flat wheels used in this test were not likely to have exceeded the removal criteria for a wheel flat detector per AAR standards.
