U.S. Department  
of Transportation  
**Federal Railroad  
Administration**

# **Locomotive-Based Top of Rail Friction Control Implementation Results and Issues Phase 1: Atomized Spray/Friction Control Product**

DOT/FRA/ORD-04/09

February 2003  
Final Report

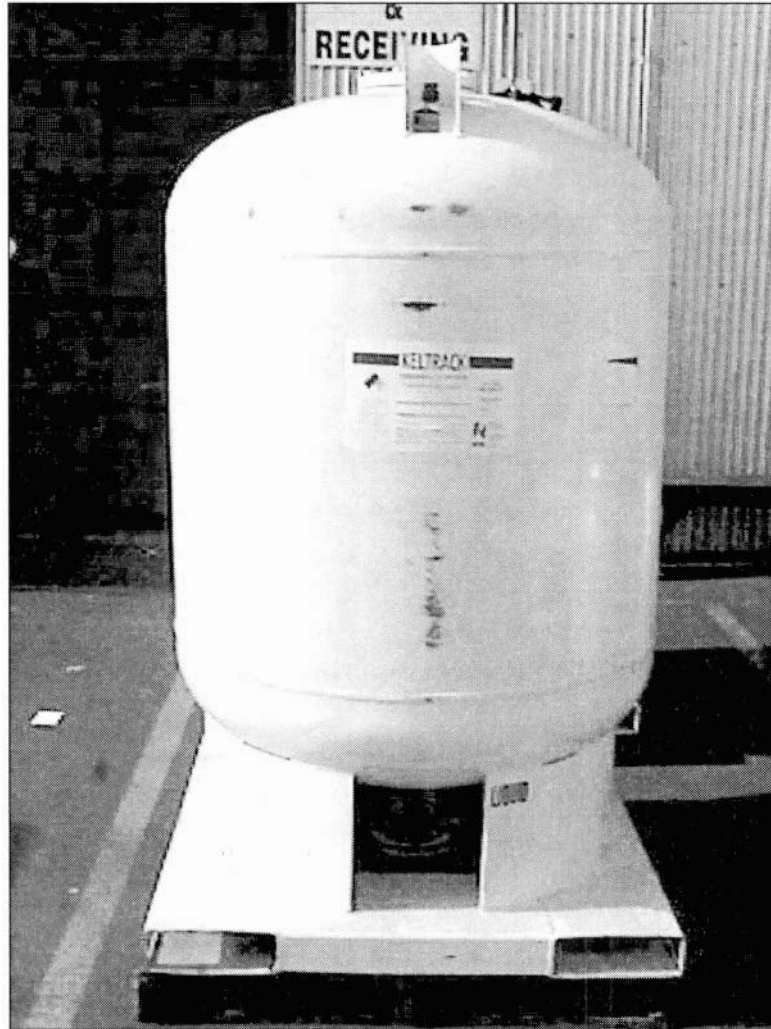
**Figure 2. Pressurized Bulk Refilling Tank, CHI-TECH System, Provided by Portec Rail Products**

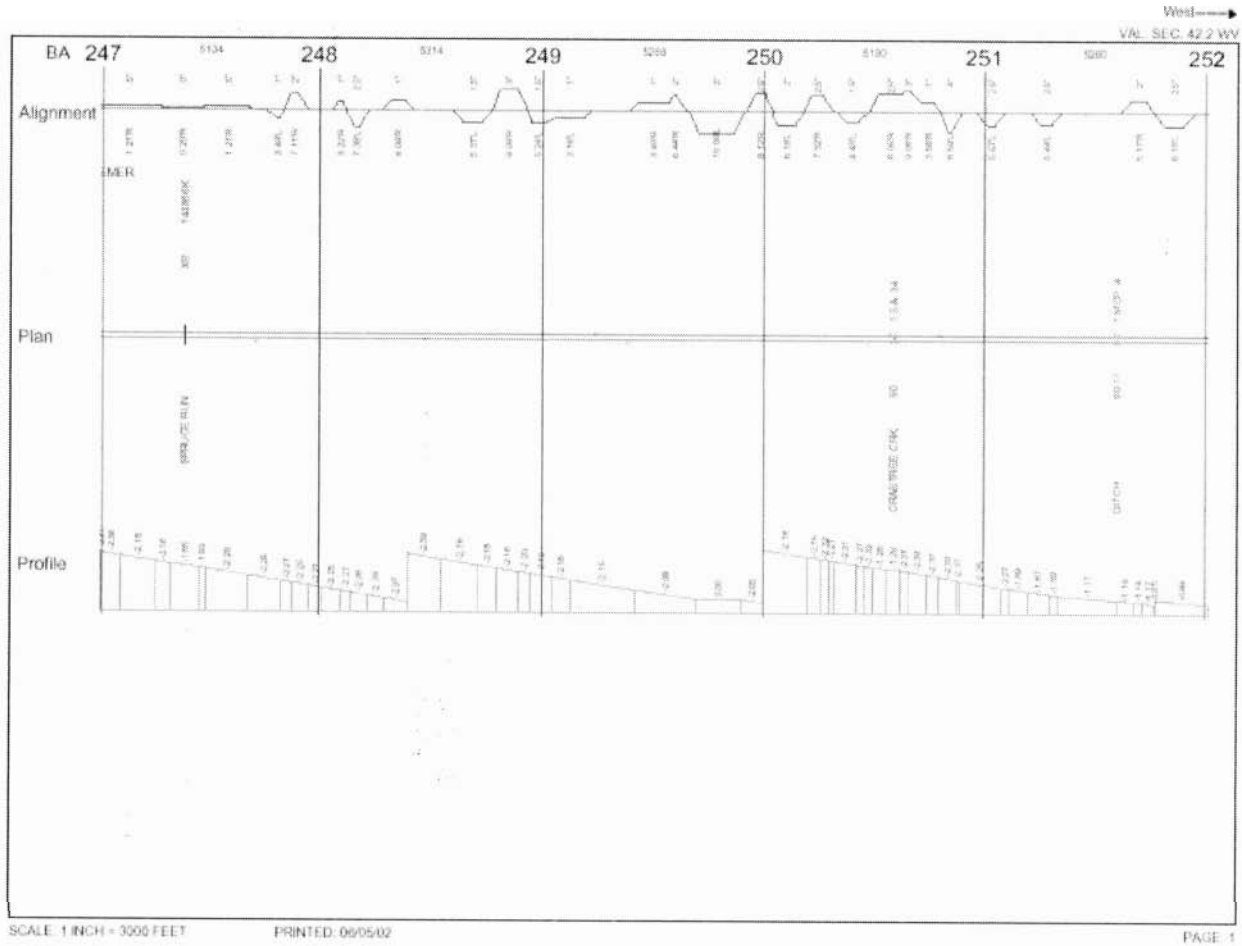
Figure 4b.S Track Chart MP 247 to 252, Showing Area Surrounding Load Monitoring Station at MP 251.7

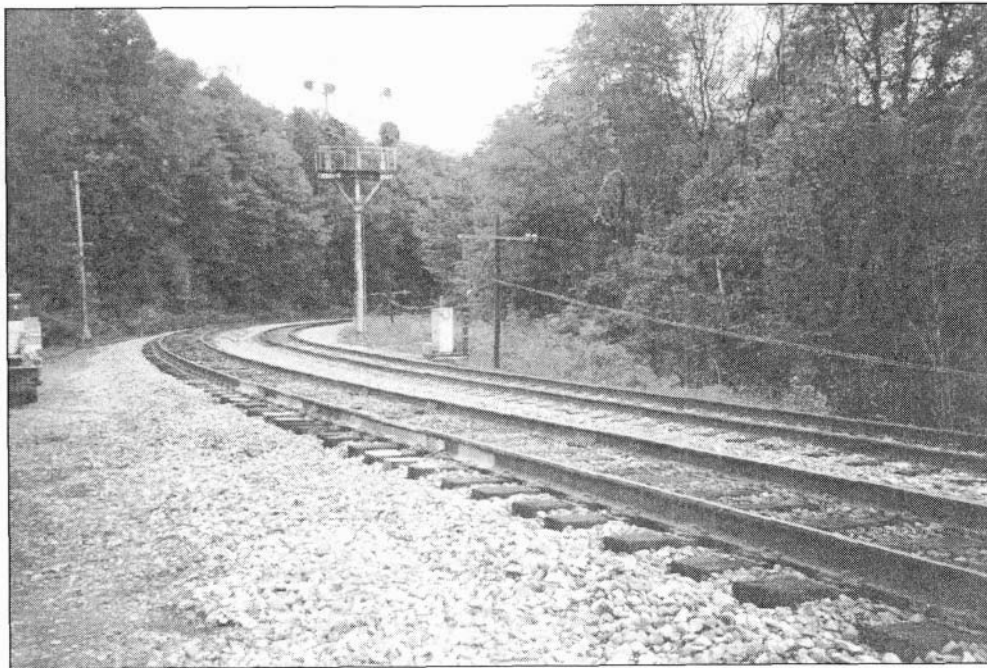
Figure 5. **WV** Monitoring Station Site at MP 251.7

The lateral force monitoring station was installed on a 7-degree curve near MP 251.7. The EB mainline was selected because most traffic is loaded coal trains traveling up a 2.4-percent grade. The grade at the measurement site reduces to approximately 1.8 percent for a short distance, but is between 2.2 and 2.4 percent on either side. Figure 5 shows an overall view of the measurement location.

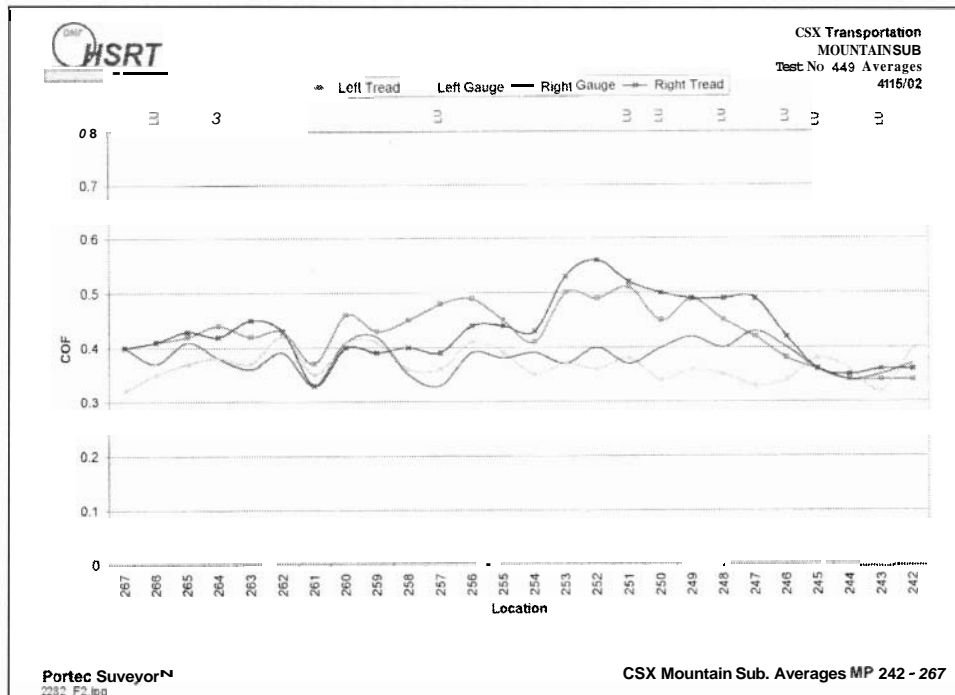
Figure 8. Rail Friction Map of 25 Miles - During TOR Implementation, April 2002

measurements, especially between mileposts 248 and 258. Comparing the two periods suggests that dry rail readings (top of rail friction coefficients  $> 0.45 \mu$ ) were generally present during the "as is" baseline period, while during the TOR operation a top of rail friction of  $0.3 \mu$  to  $0.35 \mu$  was present in many locations. It should be noted that some heavy rain was experienced the evening prior to the inspection run in April 2002, and that some sections of track had no train operations after the rain, while others were subjected to at least one empty train pass. Track with no train passes had a film on the railhead during the friction measurement pass. Possible implications of this film are discussed below.

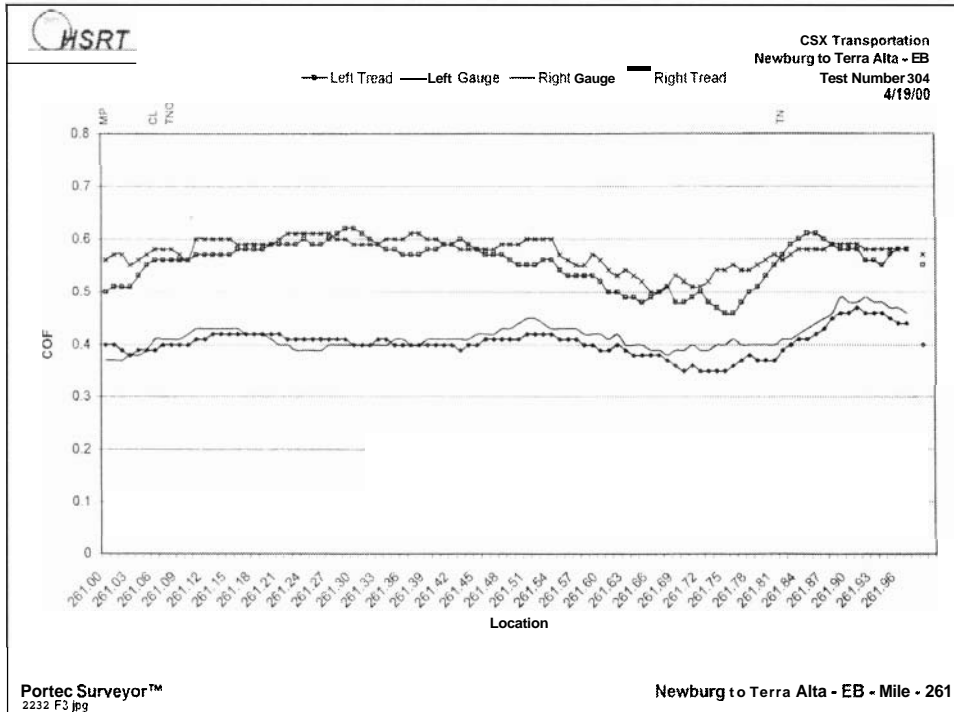
Figure 9. Rail Friction in Frostburg Tunnel (MP 261.1-261.9), During non-TOR Application Baseline Period April 2000

Examining the data in Figure 9 suggests the top of rail (two upper lines) was very dry (friction  $> 0.5 \mu$  for most of the tunnel), while data in Figure 10 shows a marked drop in top of rail friction to a value of about  $0.3 \mu$  to  $0.35 \mu$  for the entire length of the tunnel. As no rain or other weather affected the rail, data suggests that the friction control product being applied by the TOR systems was producing top of rail friction to the desired level.

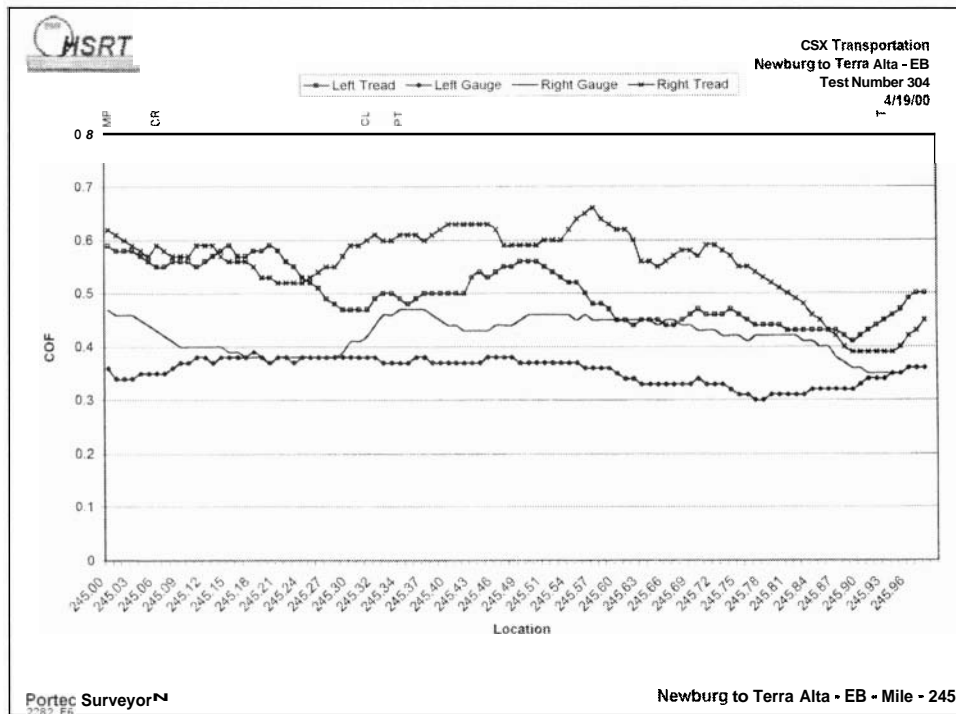
Figure 12. Rail Friction near MP 245 — Baseline Period

Figures 11 and 12 indicate a drop in TOR friction from  $>0.5 \mu$  to a value of about  $0.4 \mu$  near the lubricator at MP 246 and MP 245. The  $0.4 \mu$  friction gradually returns to the dry levels of  $>0.5 \mu$  about  $\frac{1}{2}$  mile farther up the grade.

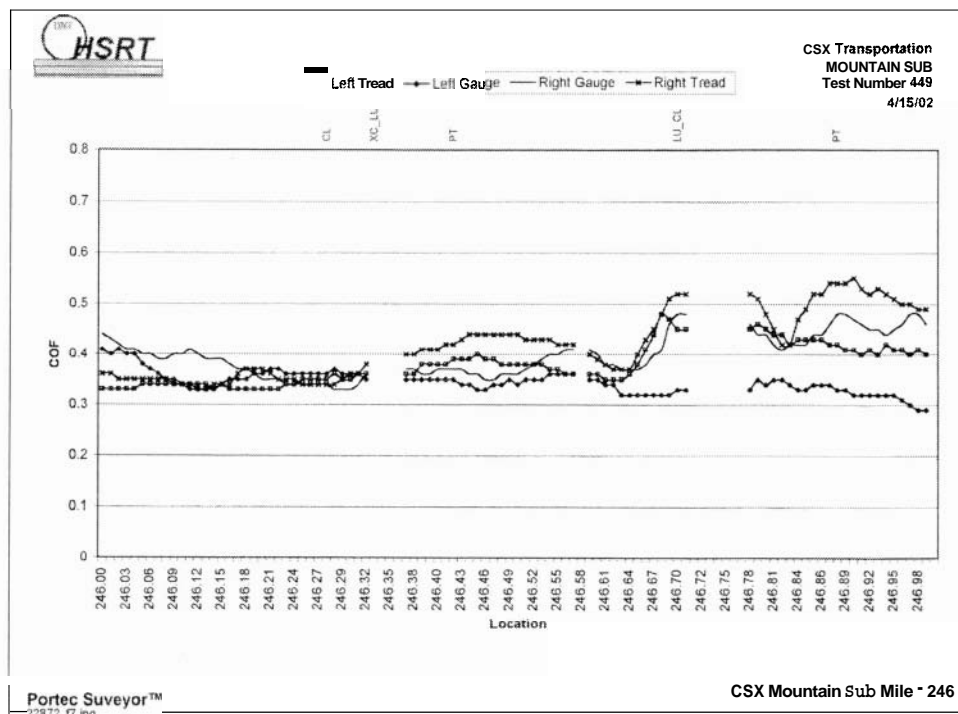
Figure 13. Rail Friction near MP 246 — During TOR Implementation Period

Figures 13 and 14 show the same sites as Figures 11 and 12 during the TOR application period. Referring to Figure 13, rail to the right of approximately MP 246.6 (increasing milepost order) exhibited the film described above, while rail to the left of MP 246.6 (descending milepost order) was wiped clean from passage of the hi-rail truck. Data shows that the top of rail friction remained at  $0.33 \mu$  to  $0.38 \mu$  for most of the remaining rail. This suggests that the friction control product being applied was having the desired effect on rail that was clean, while rusty rail affected tribometer data.

Examining Figure 13 shows that the lubricator at MP 246.7 was functioning, as friction values for the gage and top of rail dropped at the lubricator site. Farther up the grade from this location (in the direction of predominant traffic), the one rail near lubricators located at MP 243.9 and MP 243.3 (refer to Figure 15) exhibited a drop in friction at the gage face and top of rail. The distance of effectiveness was short, generally less than 0.2 miles. This pattern was repeated at several locations on this segment.

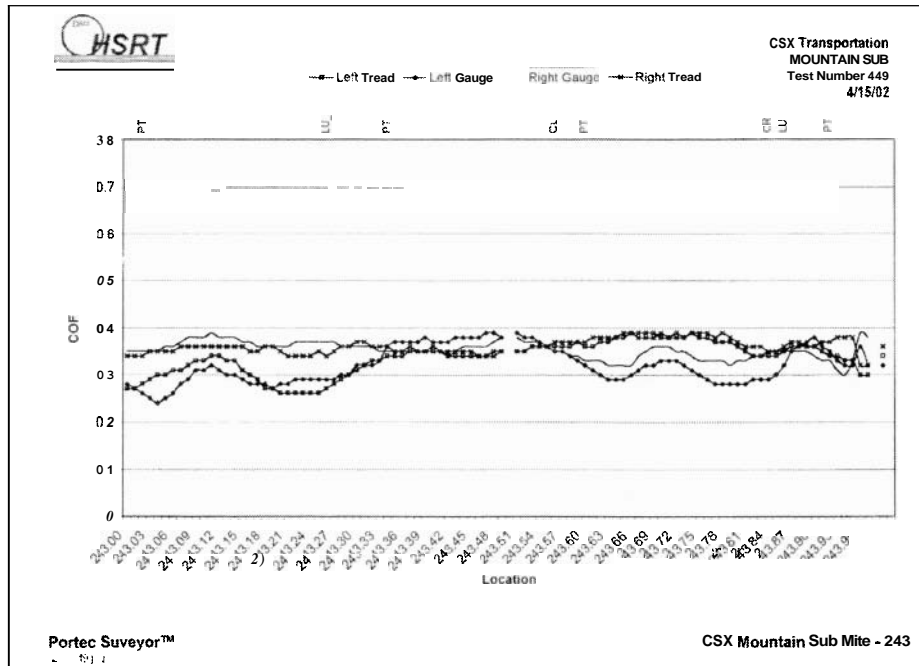
**Figure 15. Rail Friction Patterns from Wayside Lubricators at MP 243.3 and 243.9**

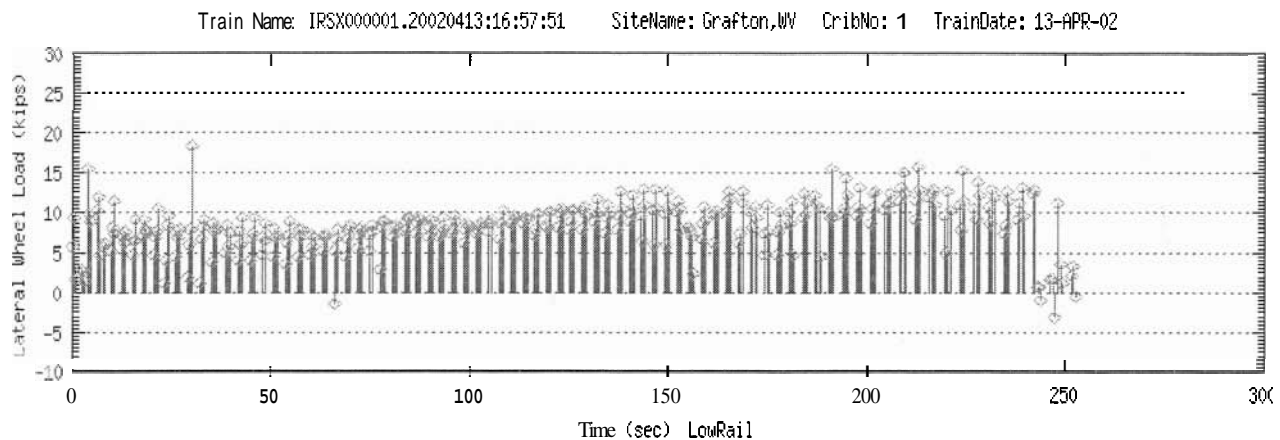
**Figure 23. Low Rail Lateral Force History of Third TOR-Equipped Train During TOR Implementation Period — Train Pass at 5:00 p.m. on April 13,2002**

Figures 22 and 23 represent the lateral forces applied by train TOR3, which was the third consecutive TOR-equipped train that passed this location. Examining Figure 22 (high-rail data), the front to rear differential is still apparent, and the overall forces are lower at the front of the train than the rear. Low rail data (Figure 23) shows more discernable front to rear differential when compared to data from TOR1 (Figure 20).

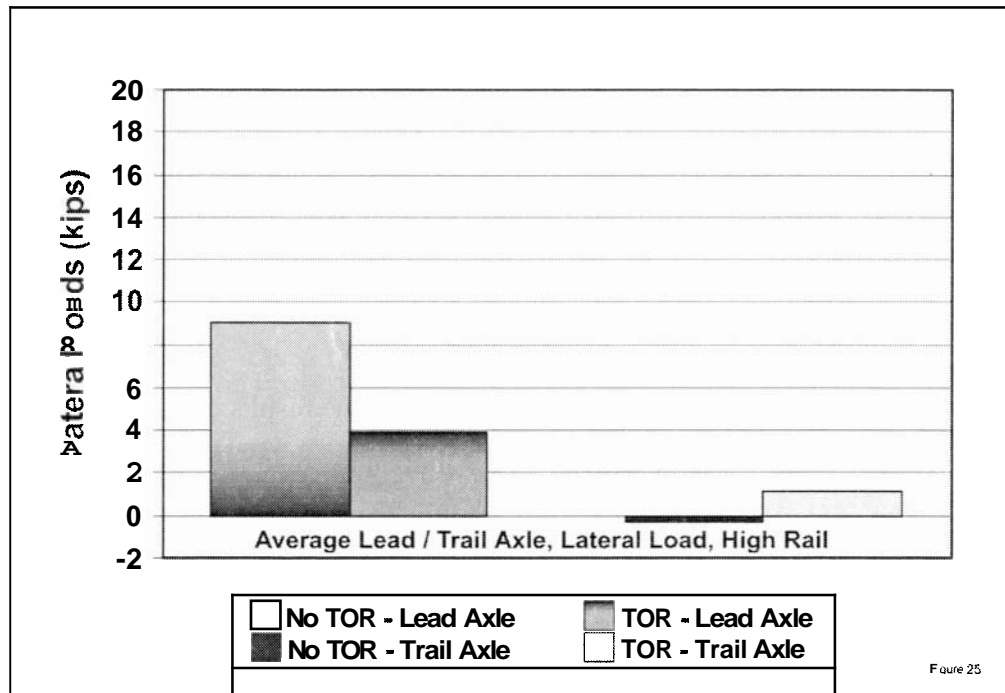
**Figure 25. Low Rail Force Data from a Typical Baseline and Second TOR Equipped Train for both Leading and Trailing Axles**

By combining lead and trailing axles for each location, the truck side forces can be estimated. These also exhibited a reduction, approximately 40 percent on both the low and high rails. The values shown in Figures 24 and 25 are from two distinct trains. Cases could be found for a

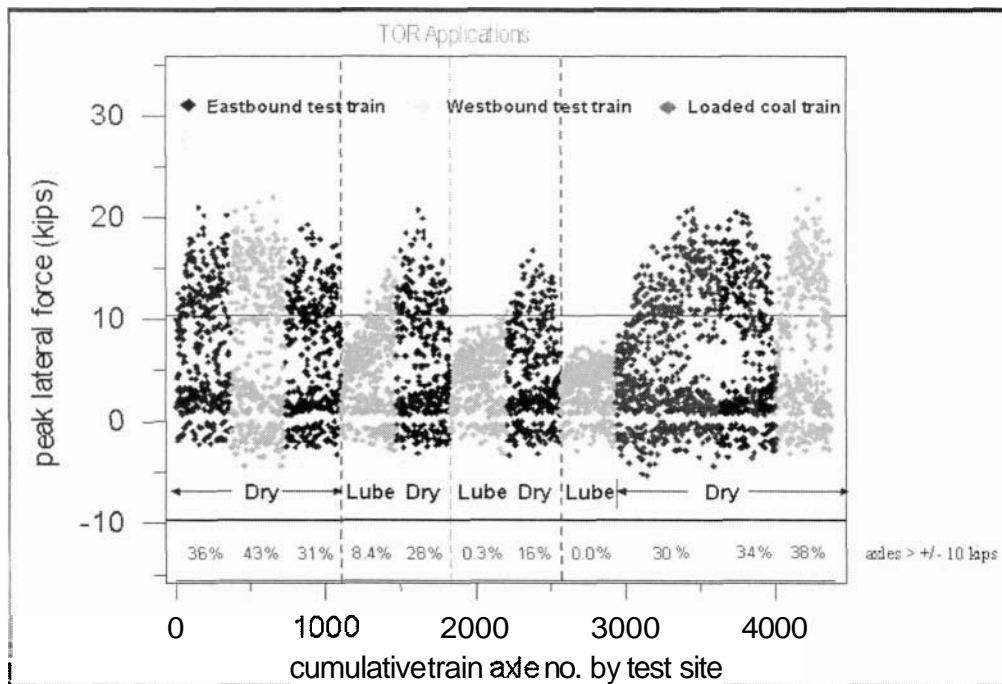
**Figure 27. Lateral Force Station Data: High Rail, Crib 2, 8-Degree Curve on NS Showing Effect of Multiple TOR Train Passes on Lateral Forces (data collected and reduced by NS)**

Figure 26 shows the lateral force data collected by NS research and test personnel on the high rail of the 8-degree curve. A number of performance issues regarding TOR application, can be observed by evaluating data on this plot. However, the primary concern related to this implementation evaluation project is the effect of multiple train friction product buildup. Long-term reliability and maintenance issues of the TOR system were secondary as vendor and railroad representatives inspected and adjusted the system before testing.

Examination of lateral forces for passes 1-3, all non-TOR baseline runs, show consistent forces, with at least 30 percent of the total axles exhibiting lateral forces exceeding 10 kips. Pass 4, which was the first run with the TOR system activated, indicated an immediate and significant drop in lateral forces, with only 8.4 percent exceeding the 10-kip level. Also, as can be observed by examining Figure 26, lateral forces at the front of the train were significantly lower than at the rear, which follows the pattern observed at other sites where one pass of a TOR train has been monitored.

The "peaked" pattern of lateral forces generated during Pass 5, which is the reverse back-up move, suggests several items. Note that during the backup move, the first cars to pass the site were from the east end of the train consist, which was the farthest from the TOR applicator.
