NIAGARA FRONTIER TRANSPORTATION AUTHORITY VEHICLE TESTS

1. Report No.		2. Government Accession No.		3. Recipient's Catalog No.	
4. Title and Subtitle NIAGARA FRONTIER TRANSPORTATION AUTHORITY VEHICLE TESTS				5. Report Date November, 1983

6. Performing Organization Code	
7. Author(s) G. Arnold, N. Blume, E. Heisey, B. Swearingen, G. Walker				8. Performing Organization Report No. TTC-002(UMTA-FR84)

9. Performing Organization Name and Address Association of American Railroads (AAR) Transportation Test Center Pueblo, Colorado 81001				10. Work Unit No. (TRAIS)

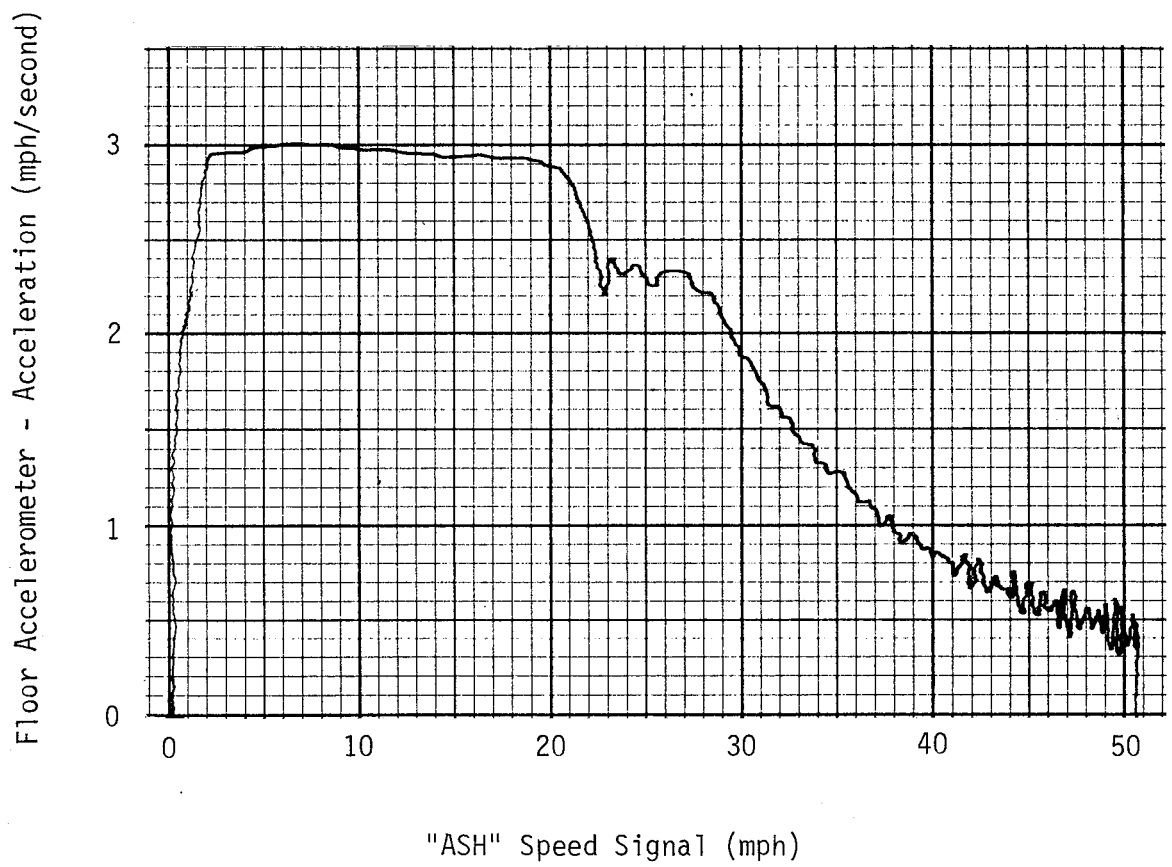
FIGURE PER1. ON-BOARD PLOTTER CHARACTERISTICS OF RUN 37.

#37 ACCELERATION
36.818 ELAPSED SECONDS

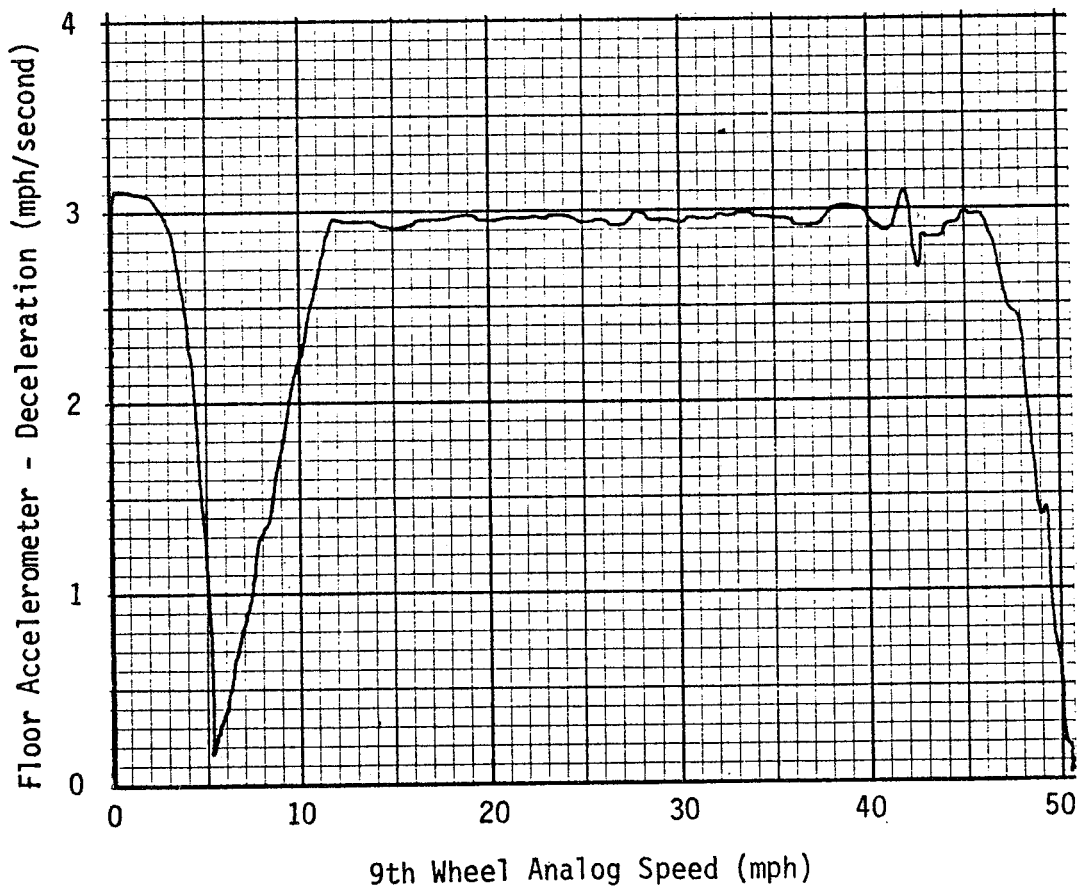
FIGURE PER14. DYNAMIC ONLY DECELERATION AT AW2.
