U.S. Department
of Transportation
**Federal Railroad
Administration**

STUB SILL TANK CAR RESEARCH PROJECT: FULL-SCALE DAMAGE TOLERANCE TEST

December 1998
Final Draft Report

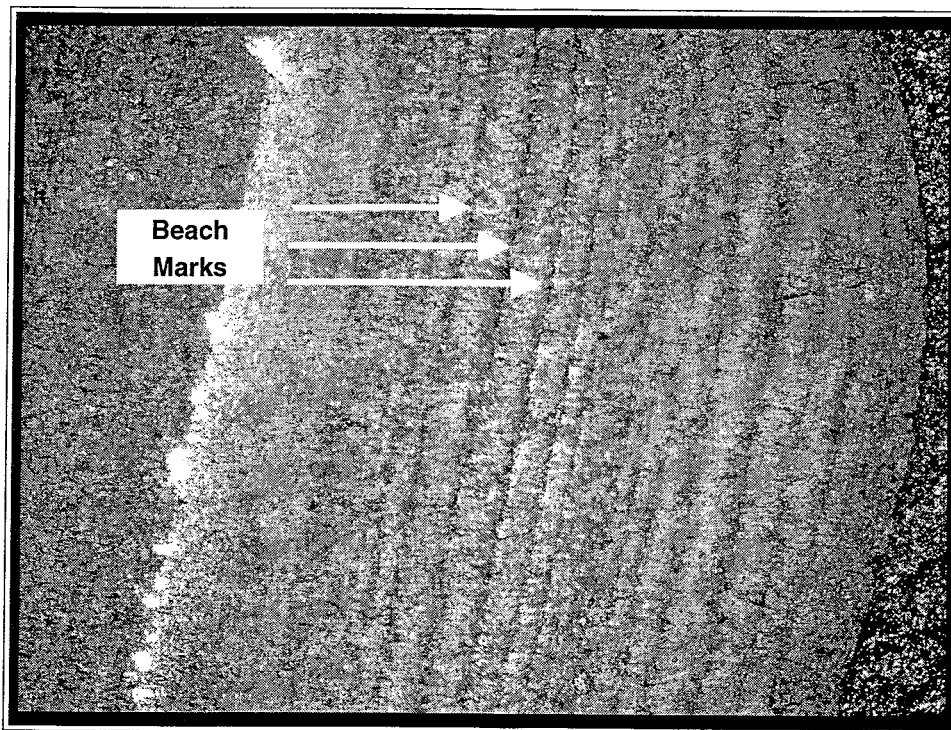
Figure 27. VCF Load Stud Fracture Surface at 6.6x Magnification

During the last leg of the test (at about 293,000 spectrum miles), a stud from the A-end VCF actuator broke and the test was paused for machine repair. Upon examination of this stud, it was apparent that it had fractured by fatigue (as opposed to a static overload fracture), and the cracks had been growing through it during several previous tests. In addition, beach marks (striations) from the marker banding in this test were evident even on a macroscopic scale. The stud was sent to SwRI for further inspection and confirmation of these conclusions, which is detailed by Benac et al. (1998). This was significant, as it was the first indication (before the post-test sectioning of the car) that the marker banding techniques used during the full-scale test were effective. Figure 27 depicts one of the load stud fracture surfaces.
