U.S. Department
of Transportation
**Federal Railroad
Administration**

STUB SILL TANK CAR RESEARCH PROJECT: FULL-SCALE DAMAGE TOLERANCE TEST

June 1998
Draft Report

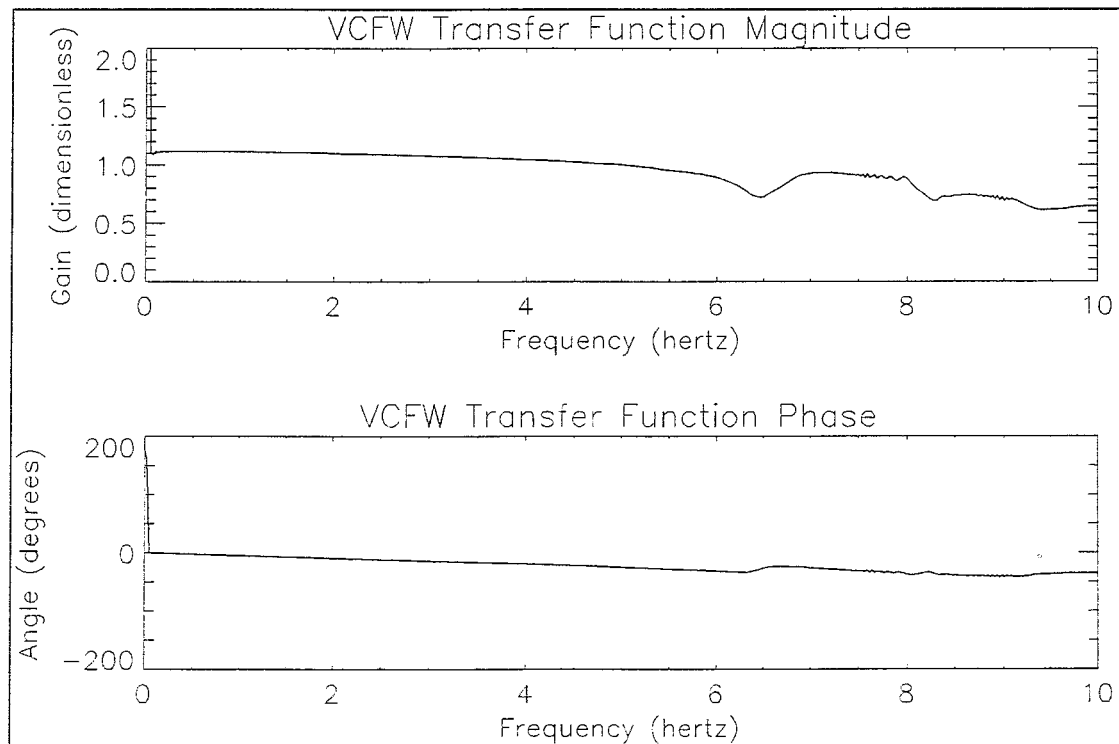
Figure 10. VCF System Transfer Function

After all of the actuators were calibrated and tuned and the test car was mounted on the machine, constant-force frequency sweeps of the system were performed to determine optimum actuator response (and any system resonant frequencies). Through calculated response/command transfer functions, it was determined that longitudinal and vertical coupler force response deteriorates at frequencies above 2 and 5 hertz, respectively. One explanation for the relatively poor response of the longitudinal actuator (in addition to the sheer volume of hydraulic oil it requires) may be the inertial nature of the mass being pushed against (the mechanical “slop” in the system). There were small longitudinal gaps between contact points throughout the Simuload/test car system, creating a series of tiny impacts and nonlinearities every time the actuator changed direction and crossed through the null position. These nonlinearities, when combined with any excited system resonances, could increase longitudinal force control difficulty at higher frequencies. The system transfer function for the west vertical coupler actuator (acting independently) is shown in Figure 10.
